Failure analysis of stainless steel lanyard wire rope

A. Sambasiva Rao

Defence Metallurgical Research Laboratory, Kanchanbagh, Hyderabad, 5000258, India

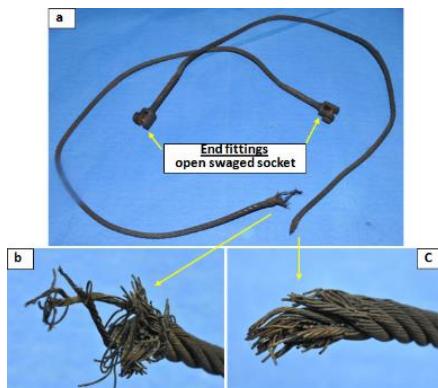
The broken wire rope in as-received condition is shown in Figure 1(a-c). This displays dark brownish colour. The wire rope supplied with two broken ends (Figure 1a). This consists of many small diameter wires wound together into strands and then these strands are knit jointly into a wire rope. The end fittings of the wire rope are fastened with open swaged socket. Broken end region displays several wires unwound and loosen from their strands (Figure 1b and c). Chemical composition of the wire rope indicates that the wires are made using austenitic stainless steel AISI 304 grade (Table 1).

Fig. 1. Photograph of failed wire rope: (a) as-received condition, (b) one end of the broken rope, (c) another end of the broken rope displays several wires unwound from its strands and loosens from their strands.

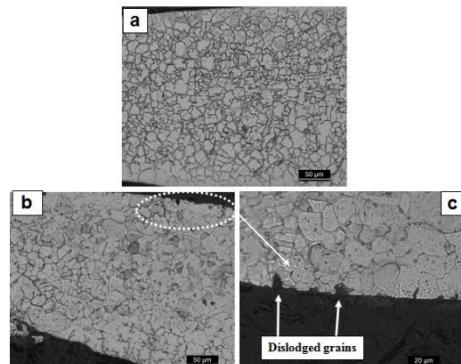
Optical microstructures of failed wire rope are shown in Figure 2. This displays the presence of typical equiaxed austenitic grains along with annealing twins (Figure 2a). The average grain size is ~ 15 µm (ASTM No. 8.5). The grain size near and away from failed region appears to be same. The optical microstructure of the wire exhibits two

features namely (a) overall grain size is nearly uniform from center to periphery and (b) several cracks along the grain boundaries at the periphery of the wire rope ([Figure 2b and c](#)). Presence of annealing twins within the equiaxed austenitic grains indicates that the wire rope is used in annealed condition ([Figure 1, 2a](#)). This also suggests that the rope wires are initially prepared by wire drawing and subsequently annealed. In addition, several grains have been dislodged from periphery of the individual broken wire ([Figure 2b and c](#)). The dislodged materials have broken and separated from the wire along the grain boundaries. This clearly reveals that the grain boundaries have significantly weakened during service. Very close to the fractured area, the microstructure exhibits extensive material degradation due to grain boundary weakening.

Fig. 2. Optical micrograph of failed wire rope shows (a) austenitic grain structure with annealing twins, (b) few grains are dislodged from the grain boundaries at the surface near fracture and (c) high magnification of dislodged grains.

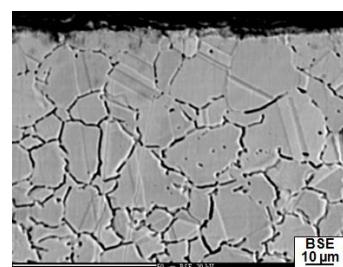
BSE micrograph close to the fracture obtained in un-etched condition exhibits continuous thin film along grain boundaries ([Figure 3](#)). This observation is analogue to the optical microstructure ([Figure 2](#)). The X-ray elemental mappings of Cr, O, Cl, Ni and Mn elements of failed wire rope in un-etched condition obtained by EPMA are shown in [Figure 4](#). Elemental distribution mapping reveals that the grain boundaries are enriched with Oxygen, Chlorine and Chromium. On the other hand, uniform distributions of Nickel and Manganese are observed in the matrix.

Fig. 3. EPMA-BSE microstructure of the individual wire near failed end showing dark network along grain boundaries.

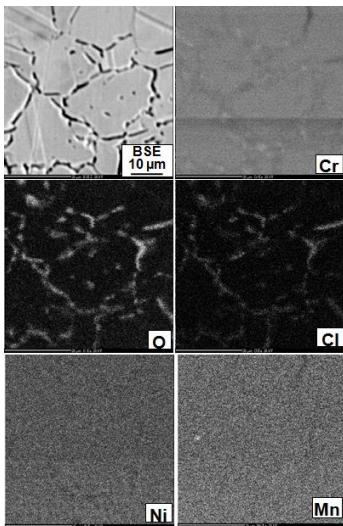
Fig. 4. X-ray elemental distribution mappings of Cr, O, Cl, Ni and Mn obtained by EPMA illustrates enrichment of Cr, Cl and O along the grain boundary.

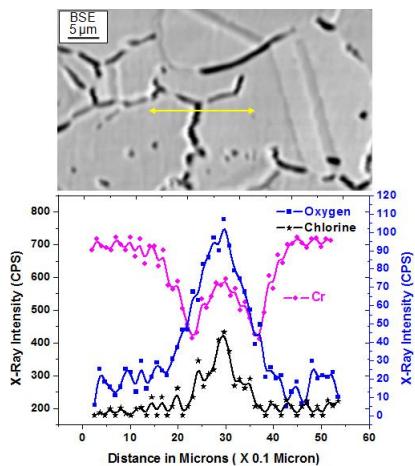
In order to confirm the results of elemental mapping, X-ray line scan technique has been employed for Oxygen Chlorine and Chromium elements and results are shown in [Figure 5](#). This reflects evidently that the line scan profiles have validated the enrichment of Oxygen, and Chlorine at the grain boundary. Line profile has also displayed the chromium enrichment at the grain boundary as well as the depletion at either side of the grain (i.e. vicinity of grain boundary). The weakening of grain boundaries along with dislodged materials from the periphery of the wire therefore indicates that the rope is exposed to corrosive environment during the service. Presence of Cl and O at the grain boundaries in the form of thin film supports the same.

content / vapours from humid atmosphere have initially reacted with chromium oxide passive film formed on the surface of the wire and then diffused within the material along the grain boundaries. The depletion of the Cr in vicinity of the grain boundaries supports the same (Figure 5). This has resulted in the failure of the wire rope in intergranular mode due to substantial weakening of grain boundaries.

Fig. 5. EPMA Line profile of the elements O, Cl and Cr across the grain boundary demonstrates as reflected in the X-ray mappings.

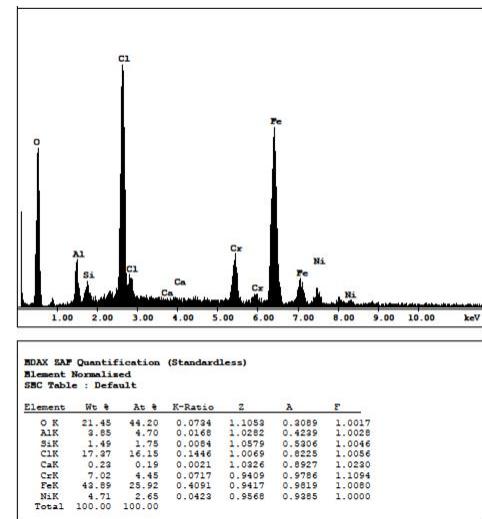
wire does not show distinctive mode of fracture features. These are similar to mud cracks with oxide layer ([Figure 6b-d](#)). The Energy Dispersive Spectroscopy (EDS) spectrum taken on fracture surface of the failed rope near the actual fractures has revealed the presence of chlorine and oxygen in addition to matrix elements ([Figure 7](#)). These results are well agreement with those obtained by EPMA analysis ([Figure 4 and 5](#)). All the wires in the failed rope have shown similar behaviour.

Fig. 7. EDS Spectrum taken from the fracture surface of the failed individual wire exhibits presence of O and Cl in addition to matrix elements.

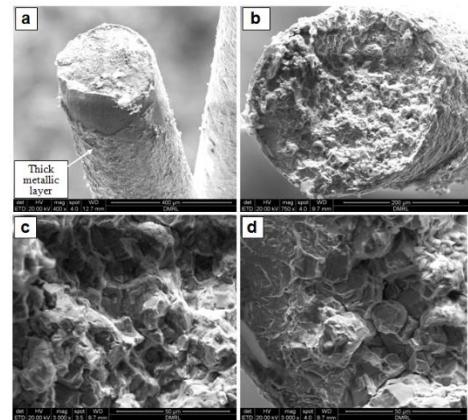
The results of the tensile tests of the failed and unused wires have been utilized to explain the occurrence of typical fracture features of the failed wire rope. The fracture surfaces of tensile tested specimens of the failed and unused wires are shown in [Figure 8](#) and [9](#). The flat fracture with no reduction in the cross sectional area is seen in the failed individual wire ([Figure 8a](#)). The fracture surface of the wire appears to be rough and clearly reveal the presence of intergranular fracture ([Figure 8c-d](#)). The failed wire clearly shows typical brittle fracture in spite of the presence of corrosive debris. Fracture surface of tensile tested wire of the failed rope displayed a thick metallic layer covered around the circumference of the failed wire.

However, a part of the thick layer of the individual wire has fallen away from close to tensile fracture during tensile deformation (Figure 8a).

Unused wire rope has undergone significant necking before tensile failure and finally failed in ductile mode. This clearly suggests that the failed wire rope has slowly deteriorated during service and then suddenly failed with intergranular fracture mode. It appears that the crack propagated along the weak grain boundaries and finally failed in brittle mode of fracture (Figure 8).

Fig. 8. SEM fractographs of tensile tested failed wire rope: (a) low magnification and (b-d) High magnification reveals flat fracture with intergranular mode of failure.

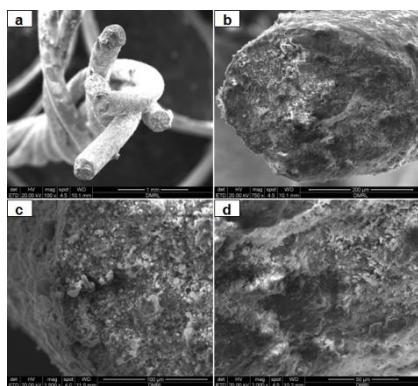
The fracture surfaces of failed wire rope near the actual fractures are shown in [Figure 6 \(a-d\)](#). Thick layer of foreign material deposition is exhibited over the fracture surface of the individual wires and also all around the surface of each wire. In fact fracture surfaces of the failed rope have shown the presence of corrosion debris which has masked the actual fracture ([Figure 6](#)). The fracture surfaces of the wire appear to be rough and the individual

Fig. 6. SEM fractographs of individual failed wire obtained at (a) Low magnification and (b-d) high magnification show thick layer deposition of corrosion debris over the fracture surface.
