Thermographic study of the pathological manifestations due to humidity and of the conservation state of the Santa Maria Basilica's roof

DOI: <https://doi.org/10.21041/ra.v12i1.567>

This paper analyzes the current state of the roof of the Basilica of Santa Maria, Alicante, Spain. This building dates back to the 13th century and is catalogued. For the analysis of the efflorescence observed, an analysis of the constructive typology is carried out, as well as a visual analysis of the state of the same, describing the existing pathological manifestations, both in the exterior area of the roofs, as well as in the interior area of the rooms under them. For the technical analysis of the possible leaks from the roof to the interior rooms of the basilica, a watertightness test and the verification through the control of the variation of temperatures by means of thermographic analysis are carried out. It can be concluded the existence and position of leaks that have damaged this listed building.

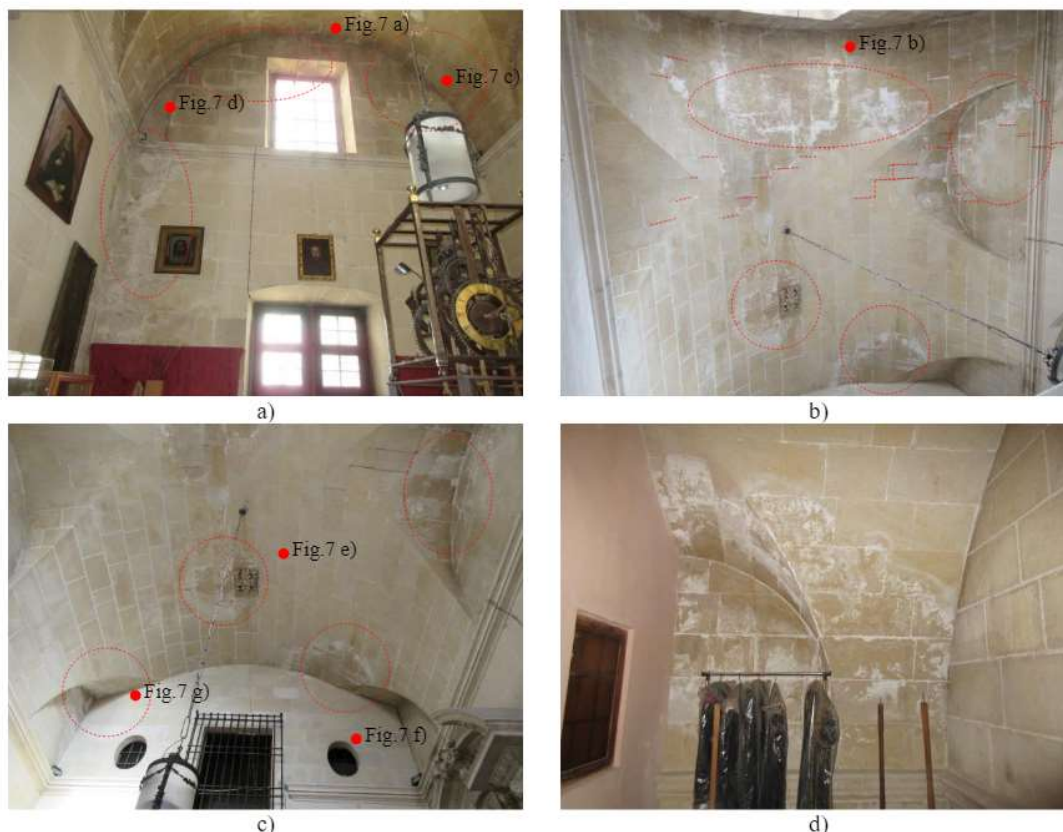
On the other hand, if the accumulation of salts mentioned above corresponded to hygroscopic salts, these would tend to retain water from the air when the relative humidity exceeds a certain limit value, which could generate a false mechanism of the presence of moisture due to hygroscopic condensation, with the possible appearance of stains, but caused simply by the absorption of water vapor from the air due to the effect of the hygroscopicity of the salts and not by the real presence of a source of water by filtration or capillarity. For this reason, a general cause of moisture pathology in historic buildings is the appearance of efflorescence due to local seepage phenomena caused years ago that have subsequently been reactivated. That is to say, the appearance of new moistures on the masonry would not be due to the real presence of a new water seepage, but due to the hygroscopicity of the salts on the surface of the rocks. Grossi and Esbert (Grossi and Esbert, 1994) show a deep bibliographical review on the effects of soluble salts in the deterioration of monumental rocks. In this sense, in the interior of the analyzed church, different efflorescences and stains are observed, which suggest the existence of filtrations, Figure 2.

Figure 2. Photos of rooms under roof 2: a) East facade, b) Lower view of the roof, c) Lower view of the roof with vault partition wall, d) Upper adjoining room after division with partition wall. Photos of rooms under roof 1: e) Lower view of the roof area next to the exterior facade, f) Lower view of the roof in contact with the body of the church. Figures a), b), c) include the tomography points of Figure 7 with a red dot.

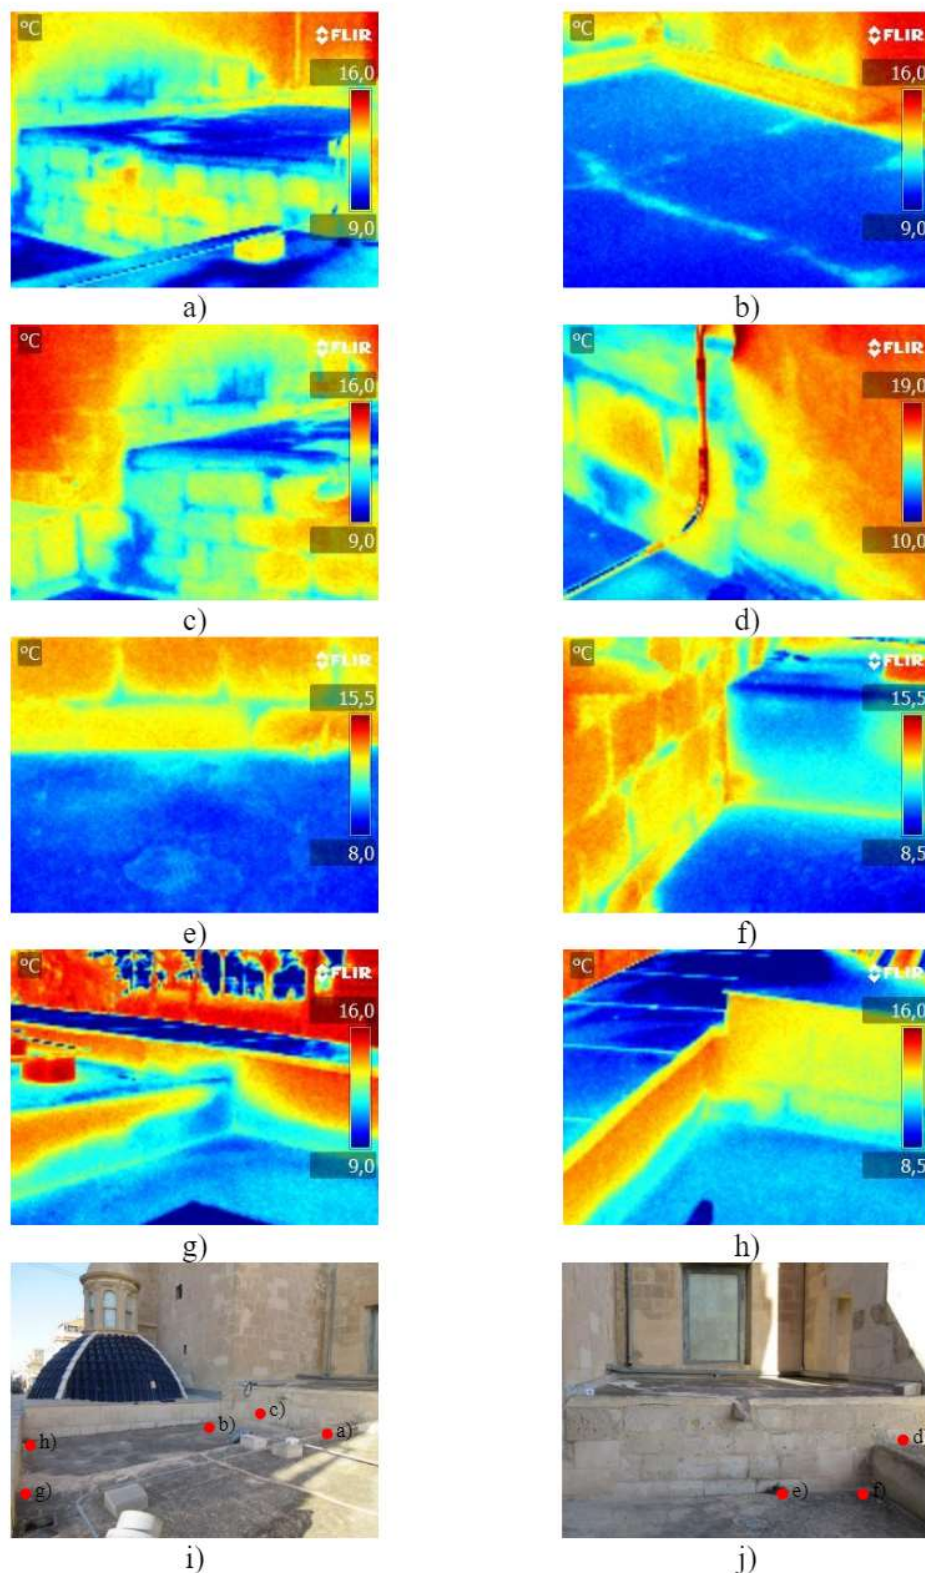
Regarding the results of the thermographic analysis of roof 1, Figure 3 shows the images for both the upper and lower areas of the roof. Figure 3 (a) shows an overview of the upper part of the roof. In this image, all the possible pathological manifestations previously mentioned can be identified. In the first place, it can be seen how after the watertightness test and the pouring of the water on part of the vertical façade enclosures and 10 h after the test, part of the humidity is preserved due to the high absorption capacity of the stone in the facing. In this image, it can also be seen how the area of the parapet, the water has accumulated more than in the area located just in the area of the gutter. A detail of this area can be seen in Figure 3c, where it can be observed not only the entry and accumulation of water in the lower area, but also the water filtered through the joints between the masonry pieces. On the other hand, it should also be noted the abrupt change in thermal characteristics at the joint between the parapet and the wall corresponding to the rigid protection of the upper skirt, Figure 3a-3c. The joint between the two materials is clearly observed and it can be seen how part of the water poured from the end of the skirt has dripped down the facing, being stored in the area of the joint, due to the absence of the correct realization of the detail of the end of the skirt. In relation to the gutter, however, no leakage problems have been detected. On the other hand, Figure 3b shows a detail of the gutter for the passage of the installations. In this image, it can be seen in green, the rear area of the gutter, where water has been stored, due to the lack of watertightness of the joint and the absence of a protection device to prevent water from dripping

down the face and leaking behind the gutter. On the other hand, Figure 3d shows a detail of the lack of watertightness of the right end of the parapet, in the area of connection of the end of the skirt, the parapet and the buttress, marking the area that is currently very deteriorated, being an obvious sign of lack of waterproofing. Also in relation to waterproofing problems, it can be seen in Figure 3e, the absence of the waterproofing in the contact area of the lower skirt with the parapet, as well as the presence of vegetation in the rightmost area of the photo, where the temperature is higher. In addition, the current state of waterproofing of the damaged area of the sill can be evaluated by means of this image. The results shown by thermography did not show the presence of watertightness problems. Finally, Figures 3g-3h show the dammed area during the test, where the process of capillary rise through the facing can be clearly observed, clearly exceeding the 5 cm of waterproofing strip currently in place at the junction of the skirt with the vertical facing, in the areas where it has been placed, since there is an absence of this construction detail in various parts of the lower skirt.

Figure 3. Thermography of roof 1: a) General view of the upper area, b) Detail of the installations gutter, c) Moisture in vertical facing and corner of parapet, filtration through masonry joints, d) Lack of watertightness in parapet and buttress, e) Lower skirt and vertical facing, f) Lateral connection of parapet skirt, g) and h) Capillarity, i) and j) location of the thermographs. The red dots indicate the location of the thermography in the associated image.

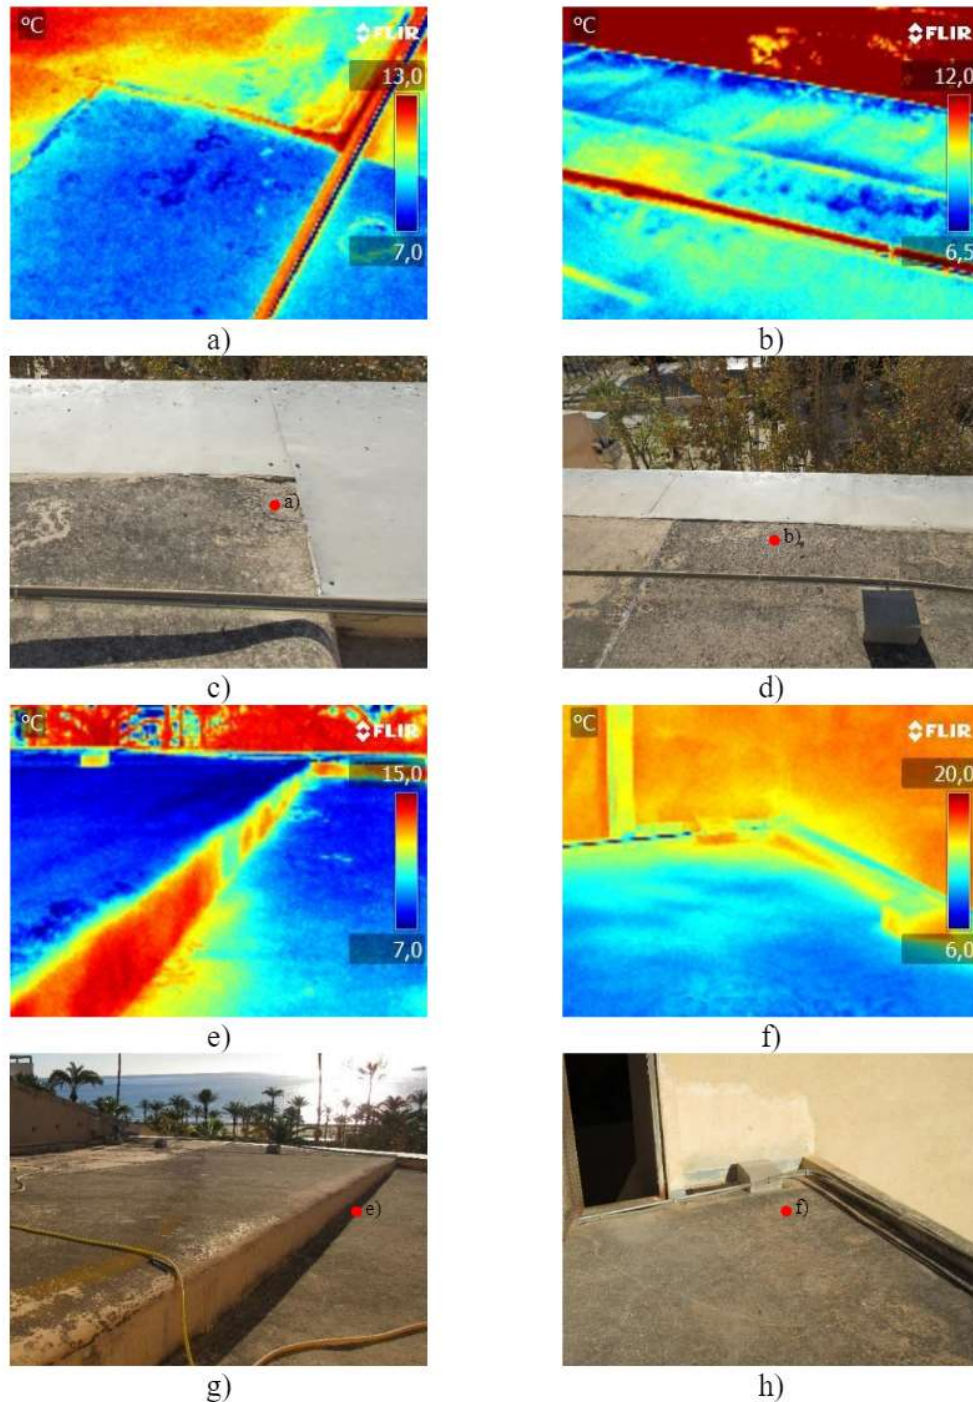
In relation to the results of the analysis of roof 2, Figure 4a and 4b show the detail of the absence of the perimeter joint, showing the difference in temperatures in the areas where the mortar is totally deteriorated, and the joint is without mortar between the end of the skirt and the facing. It is important not to confuse this with the red line associated with the passage of an installation pipe, since the area analyzed is the one associated with the end of the connection with the vertical face of the facade. These images show the lack of thermal insulation in the sections of the vertical facing, as well as areas with a colder tone, due to the water spilled during the load test. Figures 4c and 4d show a detail of this area without thermal camera application. On the other hand, Figure 4e shows the side skirt end zone. In this image it can be seen how the lack of thermal insulation in the vertical facing sections, as well as areas of colder tone, due to the water poured during the load test. This area is shown in a more greenish tone in the middle area of the photo. Also noteworthy is the contrast at the skirt end joint, clearly showing the position of the horizontal joint between the upper material and the support material. This joint, represented as a yellow line with cyan tones, presents an important state of deterioration, as could be observed during the visual analysis of the roof, Figure 4g. Finally, Figure 4f shows a detail of the perimeter end of the skirt, in the area near the access door to the roof. Figure 4 also includes digital camera images of the areas analyzed by thermal imaging. The comparison of these images allows observing the benefits of the use of thermography in the detection of pathologies, being this a support technique to the visual inspection.

Figure 4. Thermography roof 2: a) Deterioration of perimeter joint, b) Detail of failure in perimeter joint in contact of the skirt with the facade, c) and d) Image a) and b) with digital camera, e) Detail of the lateral end of the skirt and connection with the roof, f) Perimeter zone of the skirt in the access area to the roof; g) and h) Image e) and f) with digital camera. The red dots indicate the location of the thermography in the associated image.

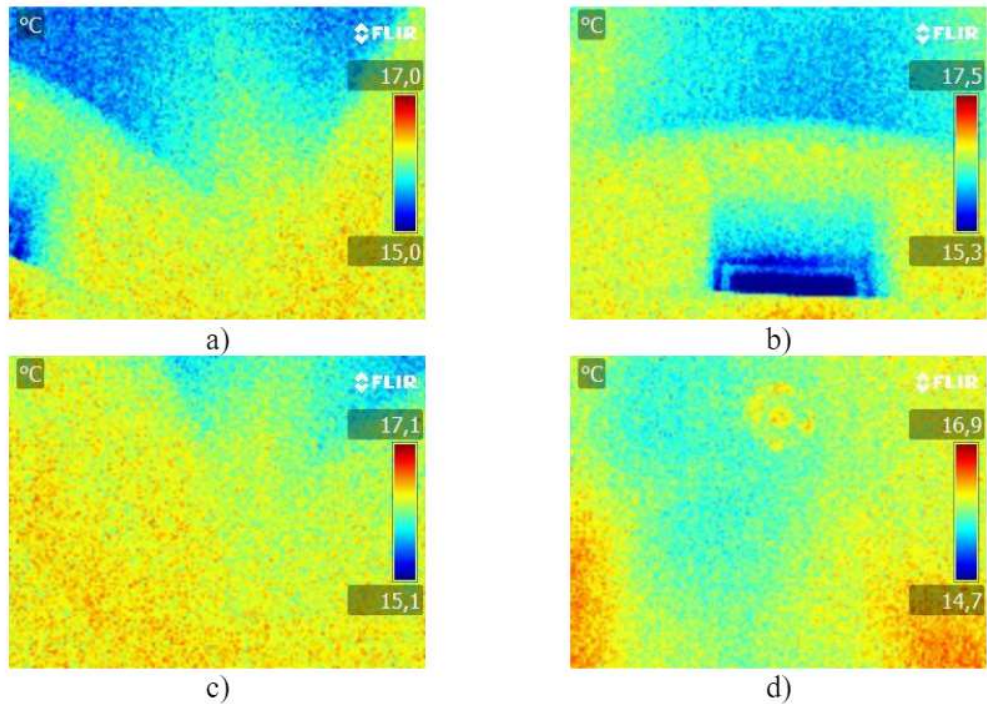
Analyzing the thermal behavior of the room under the lower area of roof 1, Figure 5, referred to throughout the study as the room adjacent to the Communion Chapel, it can be seen in Figure 5a, corresponding to the corner of connection between the exterior facade and the main arch that gives access to the Communion Chapel and, arranged in the area near the presence of the drain in the roof at the top, that the thermal difference between the part corresponding to the facade and the roof of the vault is clearly defined. However, with the climatic conditions recorded during the test, the presence of specific thermal irregularities in the potentially damaged areas associated with the connection between the facade and the toral arch of the groin vault analyzed were not detected. Also, part of the exterior window is observed, which serves as a reference in order to be able to frame the photo. Figure 5b shows a detail of the window area. In this image, the cold spot effect is clearly visible due to the higher thermal transparency of the glass compared to the high thicknesses of the facade. In addition, the lack of thermal insulation in the connection areas between the facade and the roof can be observed, clearly marking the junction edge between the two, and showing a temperature gradient from the beginning to the central area of the vault. In Figure 5c, the thermography of the other corner of the exterior facade is shown, similar to that described in Figure 5a. As can be seen, in this image there are no relevant signs of pathology, being detected only the thermal gap between the vertical faces and the roof of the vault. Finally, Figure 5d shows a general image of the roof. This image shows the presence of a part of the roof slightly colder than the other, mainly due to the effect of the accumulation of water during the test.

Figure 5. Thermography of rooms under roof 1, adjacent to the Communion Chapel: a) Connection of the main arch with the exterior facade, in the area of access to the Communion Chapel, b) Connection of the facade with the roof in the window area, c) Second corner of the facade wall, equivalent to image (a), d) General view of the roof from below.

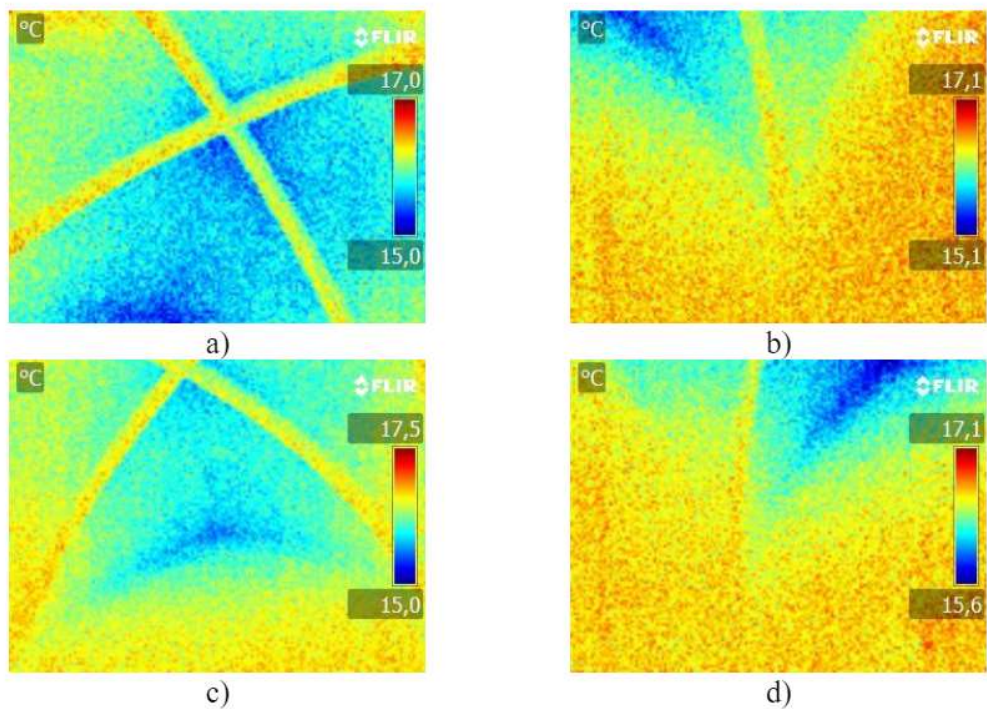
Figure 5. Thermography of rooms under roof 1, adjacent to the side building: a) General view of roof, b) Connection between facade and side corner, c) Connection between facade and roof, d) Connection between facade and opposite side corner.

In relation to the analysis by thermography carried out for the room located in the side nave, adjacent to the central nave of the basilica, Figure 6 shows the distribution of temperatures in the different critical points analyzed in the previous sections. First, Figure 6a shows a lower view of the groin vault roof. It can be observed the difference in temperatures between the perpendicular arches and the rest of the plementery that makes up the vault roof. On the other hand, Figure 6b and 6d show the detailed thermography of the connection corners between the perpendicular arches and the facade walls. A pattern of behavior similar to those described for the previous room is observed, with the difference of the higher temperature of the start of the arches. It should be noted that the analysis of these points was carried out without the presence of nearby light sources before or during the test, so the thermal distribution is due to the hygrothermal equilibrium between the exterior and the interior of the building. Finally, Figure 5c shows the same problem of lack of insulation as in the previous room, due to the connection joint between the vertical facing and the roof.

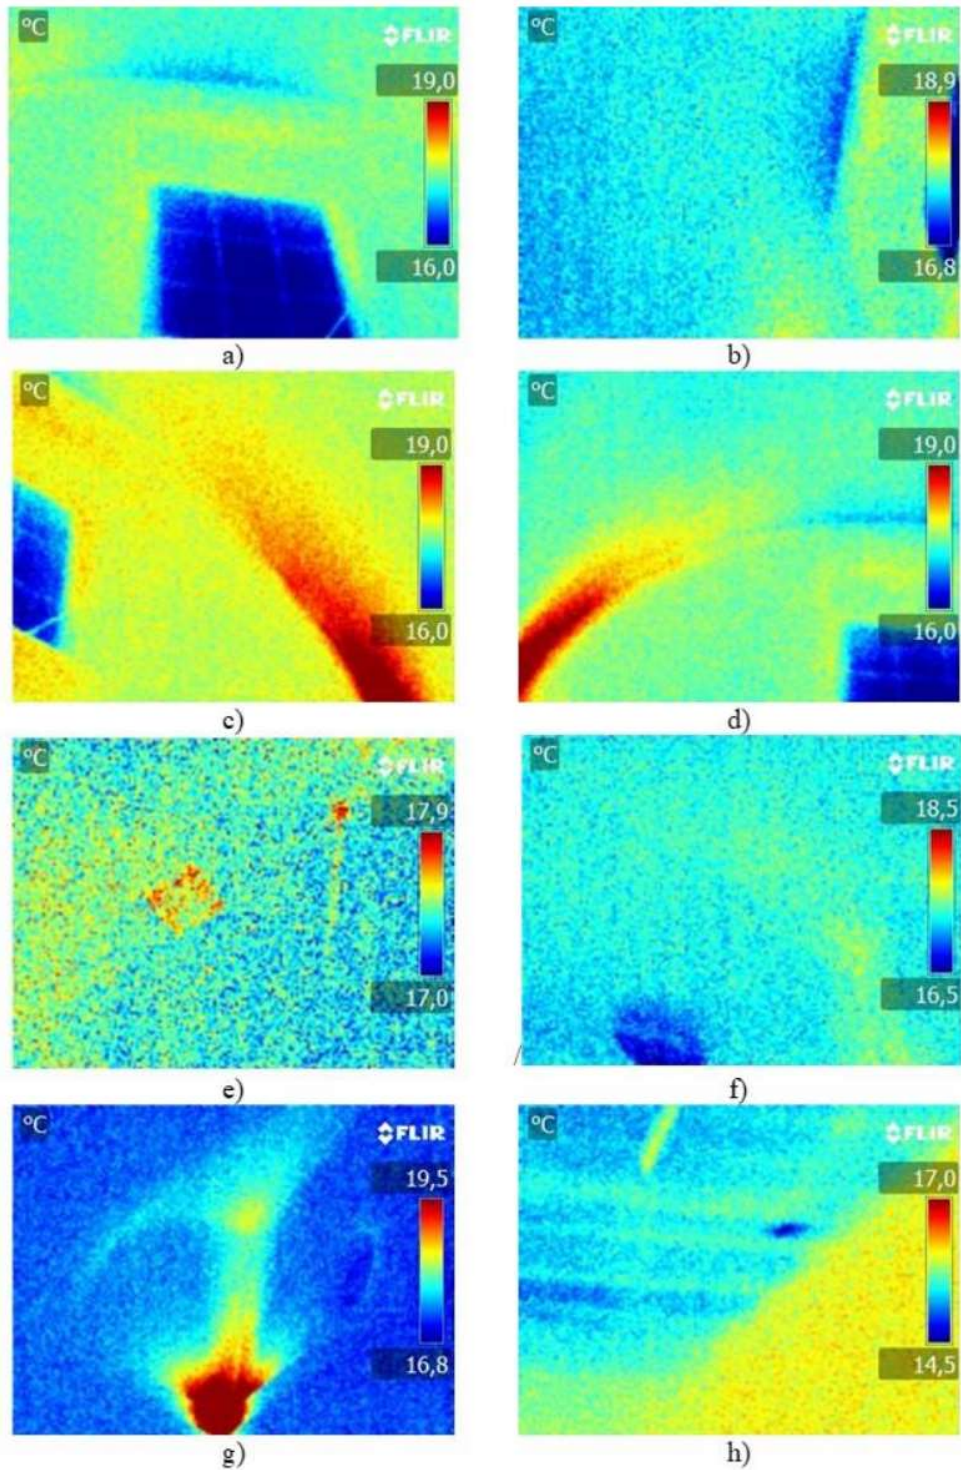
Finally, in relation to the thermography analysis carried out for the room under deck 2, Figure 7 shows the distribution of temperatures in the different critical points analyzed in the previous sections. In general, the thermal behavior is very similar to those detected in the previous rooms, except that in this case a high thermal difference between the points of the interior facade and the roof has not been observed. That is, Figures 7a, 7b, 7c and 7d show the detail of the contact between the facade and the roof, showing the thermal leaks in the upper part of the window area, as well as in the window itself. Figure 7e shows a thermography of the part of the roof corresponding to the anchorage of the chandelier, where a uniform distribution of temperatures is observed without the presence of detected damage. In Figures 7f and 7g, the thermographies associated to Figures 7c and 7d are observed, but in this case, in the facade opposite to the exterior one. In this case, the thermal variations can be observed in the areas affected by the heating of the light sources. This is due to the presence of cold spots in the contact zones between the side wall and the facade. These cold spots, especially those detected in Figure 7g, are related to the detected moisture stains. In these images, the coldest circular hole is shown as a reference to locate the position of the photos. It is important to point out that such humidity stains, besides being related to the presence of a cold zone, are also related to the presence of a water accumulation zone in the upper part of deck 2, close to the dome. In this area the water collected in the dome is discharged, and the lack of lateral sealing at the end of the skirt, together with the low level of ventilation in the room shown, cause the increase in humidity, and thus the appearance of such efflorescence.

Finally, it should be noted the presence of a leak detected in the annex building with access to room 2. This leak is on the roof of the upper floor. It has not been possible to detect whether the presence of moisture is due to an error in the tile roof, or in the roof 2 itself. However, due to its geometric position, it is very close to the position of the roof drain, which could be a sign of a lack of watertightness of the roof.

Figure 7. Thermography of room under roof 2: a) window and slab area, b) lower view of roof, c) connection view of slab side wall, d) connection view of slab side wall, e) central area of roof, f) view of rear dividing wall, g) connection view of side wall and rear wall, h) leak in outbuilding area.
