Non-destructive evaluation of the wooden beams from the Narciso López building in the Historic Center of Havana for reuse in its restoration

Non-destructive evaluation of the wooden beams of the Narciso López building in the Historic Center of Havana for reuse in its restoration

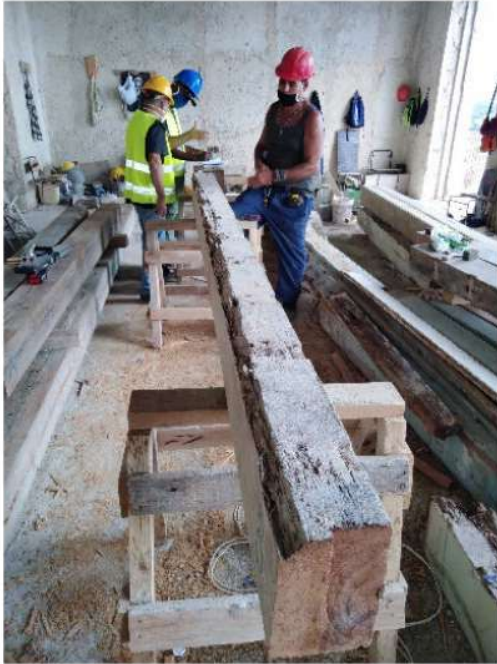
Figure 3. Stage of detailed inspection in beam mounted on wood supports

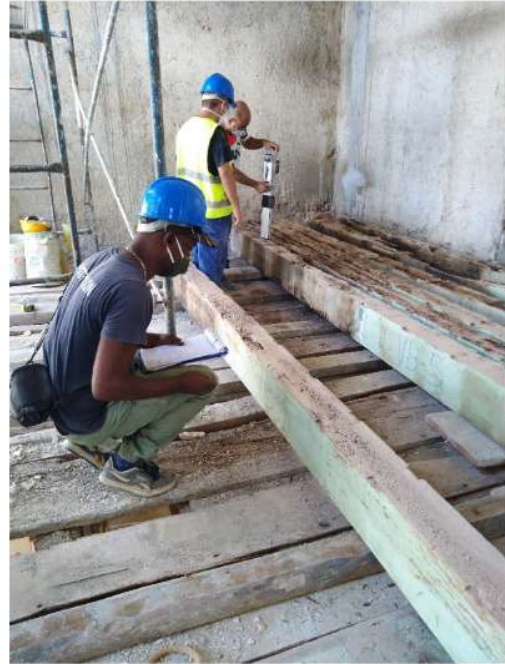
Figure 4. Inspection and visual classification of disassembled beams

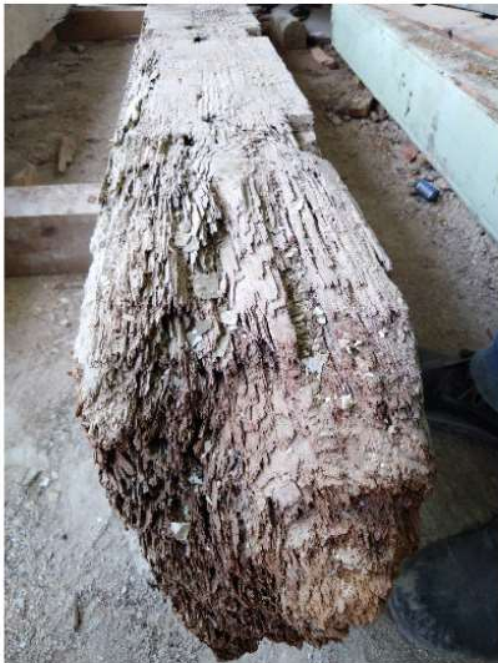
Figure 5. State of the beam heads

The most recurrent injuries found during the visual inspection were the deterioration of the heads due to excess moisture in the joints, by the development of rotting fungi, as well as fissures and discontinuous cracks on the faces and edges. Among the most common restoration and reinforcement techniques for these types of deterioration are the use of metal caps and brackets to guarantee the fastening of the beams at the support points. Pickling or brushing of the faces and edges until reaching a surface with the fewest possible number of injuries. The fissures, on the other hand, can be sealed using resins, or from the preparation of a paste of carpenter's glue mixed with sawdust. Fumigation and treatment with biocide products, and finally the structural recalculation for the new dimensions of the beams.

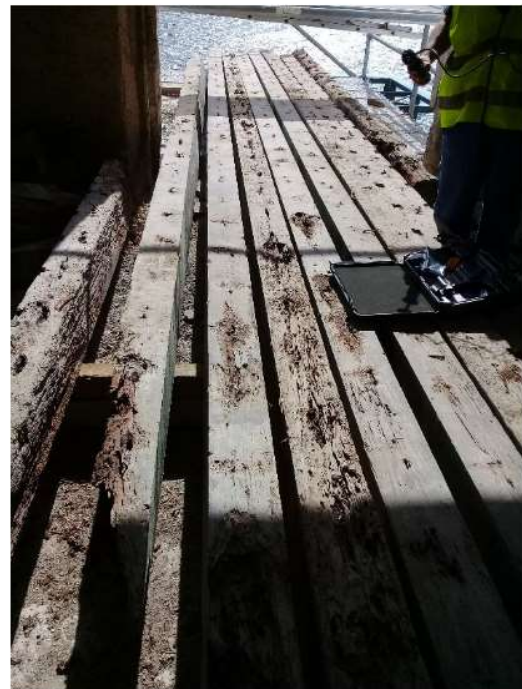
Figure 6. Disassembled beams with different pathological manifestations

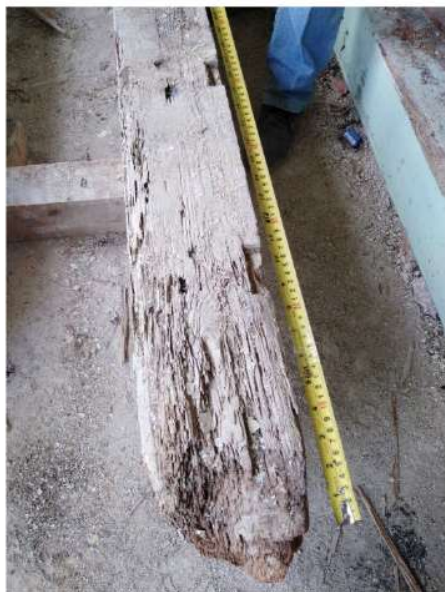
Figure 7. Measure of the affected beam section with Steel tape

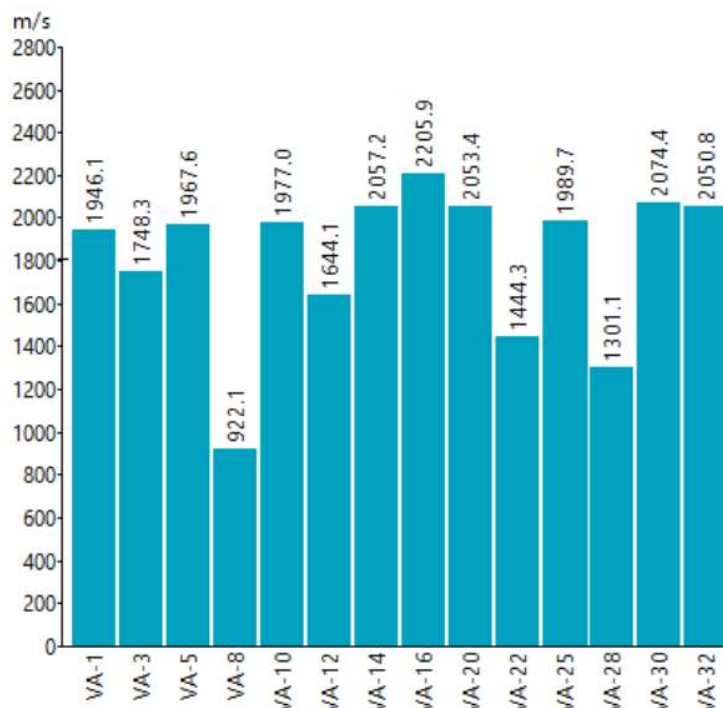
Figure 12. Summary of UPV measurements at a test point for wood beams.
Data extracted from software Proceq PunditLink

In the UPV results obtained, only two beams (VA-8 and VA-28) show values below the established limit of 1400 m/s, being classified as "deteriorated wood". This may be due to fungal infestation from rotting, softening and spalling in the wood having spread into the beams, which is reflected in the wave transmission velocity output between the transducers. With the years of exploitation of the building it is not possible to determine the causes for which these beams suffered a deterioration considerably higher than the rest. It is possible that its location coincided with that of humid areas such as bathrooms or kitchens, although the registered humidity contents do not show extreme values that support this hypothesis. The statistical analysis of the data (Table 4), in which beams VA-8 and VA-28 were excluded, show a dispersion for UPV of less than 10%, with a reliability of 95%, so that for the rest of the values the population of data obtained is accepted.

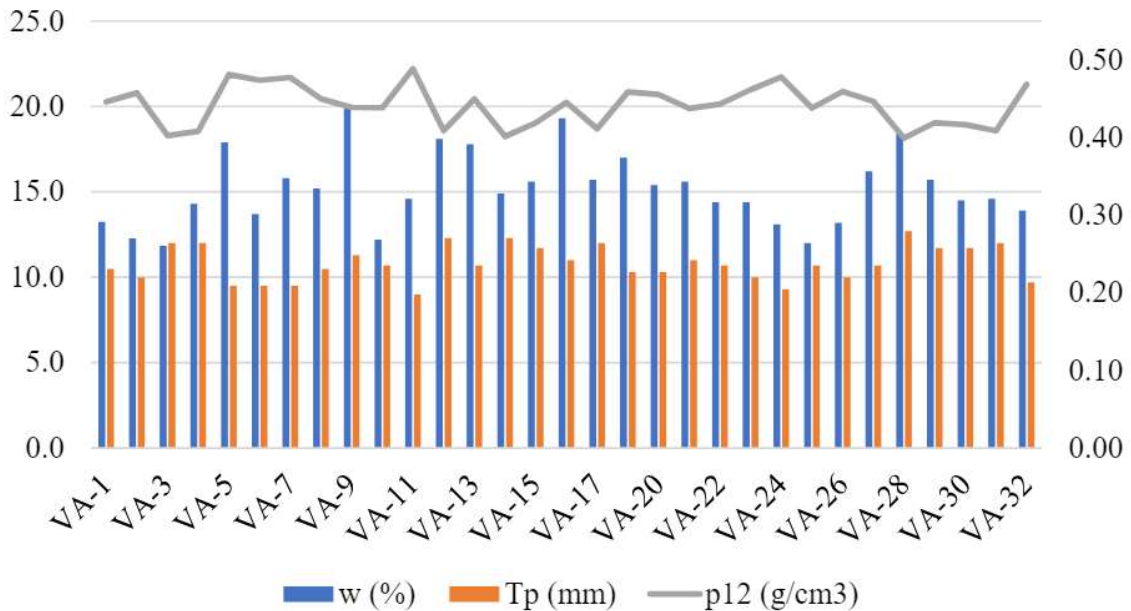
This shows that the estimation of the state of conservation of wood based on the density calculated by penetrometer, can lead to false positives if it is not combined with other measurement techniques. The hardness of the wood at the point of impact of the needle can result in a high value that does not reflect the deterioration inside the material. Figure 13 shows the general analysis of results that correlate the moisture content/penetration/calculated density. In the cases of VA-9 and

VA-16, it is identified how they reach a penetration value ≥ 11.0 mm for humidity close to 20%, in which a softening of the wood would be expected that result in greater penetration, as happens with the VA-28. The moisture content comparison between these beams is very similar but with opposite results. In the case of VA-9 and VA-16 they do not present any lesions and they maintained a UPV higher than 2000 m/s, while in VA-28 the progression of the damages towards the interior of the beam was confirmed with UPV results less than 1400m/s.

Figure 13. Relationship of results of moisture content, penetrometer and density calculated at 12% for all the wooden beams studied

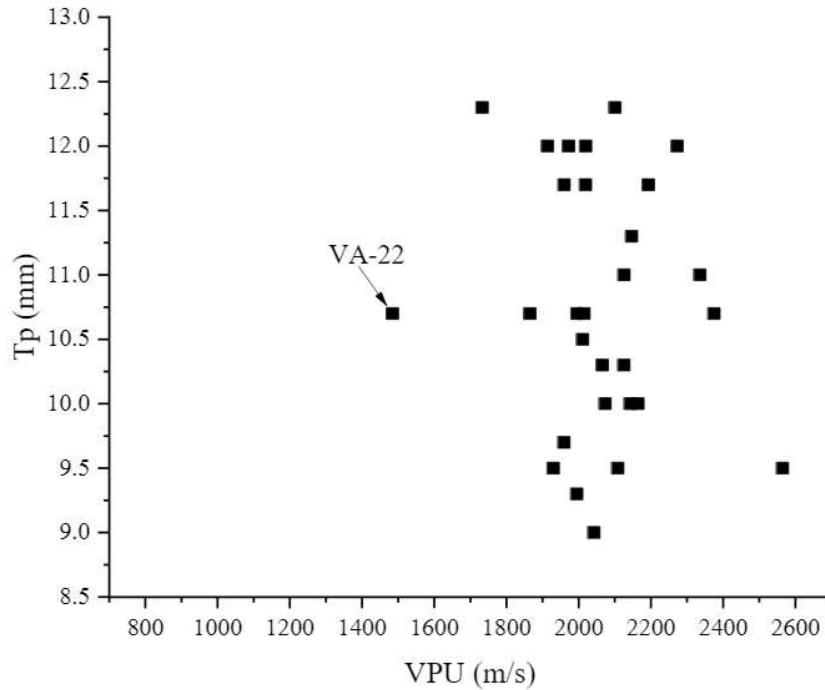
Of the total UPV measurements made, 82% fluctuated in a penetration depth between 9.0 mm and 12.0 mm. In the graphical analysis (Figure 14) it can be seen how the majority set of results occupies the range between 1800 m/s and 2400 m/s for the aforementioned interval. The graph allowed to identify beam VA-22 as a variable distant from the population mean with a result of UPV= 1485.10 m/s. If the calculated standard deviation and the damages present in the beam are taken into account, it would be reasonable for structural safety reasons to replace it with a new one. The values obtained from the proposed equations for estimating the f_k and the MOE show a high correlation between them (Figure 15), characterizing the beams in structural class ME-2 (UNE 56544, 2011), on which they must apply all the restoration and consolidation actions necessary for its reuse.

Figure 14. Relationship of results of UPV vs Tp for the beams evaluated as Sound Wood
