Diagnosis and solutions proposal to the damages present in the ceiling of the Convent of Santa Clara de Asís

DOI: <https://doi.org/10.21041/ra.v12i2.584>

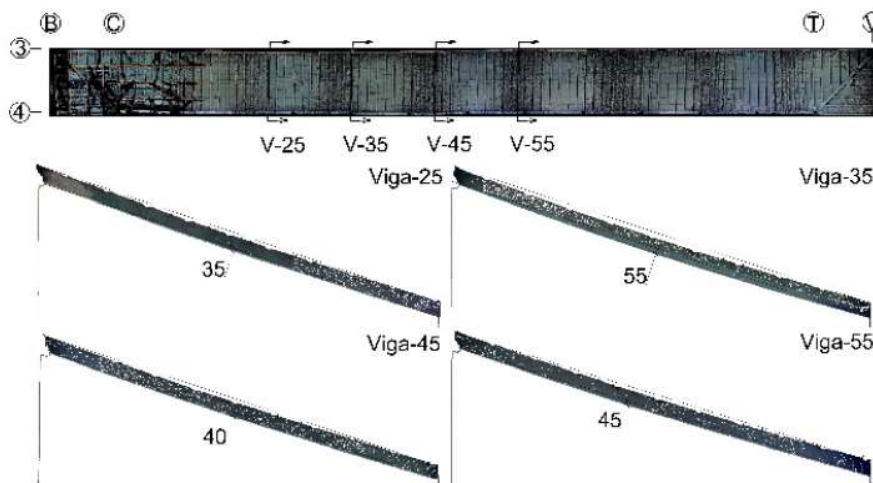
For the structural analysis of the slab beams, orthoimages were extracted using the Reconstructor software, and cuts were made using the Autodesk Recap software from beam number 17 to 98. All the beams that make up the slab present deformations to a greater or lesser extent, and some show flexural failures due to a decrease in their bearing capacity. The Cuban standard (NC 53-179:88, 1988), establishes that the maximum admissible deflection is $1/240$ of length for full load. This indicates that the admissible deflection for the wood beams is approximately 1.5 cm, but the values obtained on site are 2 cm to 4 cm higher than those acceptable by calculation. The standard establishes that the deflection of the beams will increase for load periods of more than 10 years by 50% for dry wood, and 100% for wet wood. Considering this, the allowable deflection would increase by 2.25 cm and 3.0 cm, respectively, for which there are still differences between allowable and actual values (Figure 4). It is important to note that not all the maximum deformations found are located in the center of the span, for the reason that there are areas where the element is more deteriorated than others; that is why the beams deform and fail in the most vulnerable area. It was identified that not all the beams are of the same wood species, which is why their hardness and resistance to bending also vary. In the right feet 1 and 7, the deterioration in the joints has caused the displacement of the same and of all the elements that adjoin it. These vertical movements that the right feet have suffered vary between 3.5 cm - 20 cm approximately, and the separation in the scarf joint between the beams that make up the sliding beam ranges between 1 cm to 2 cm, which represents considerable displacements.

Figure 4. Deformations (in mm) of some wood beams

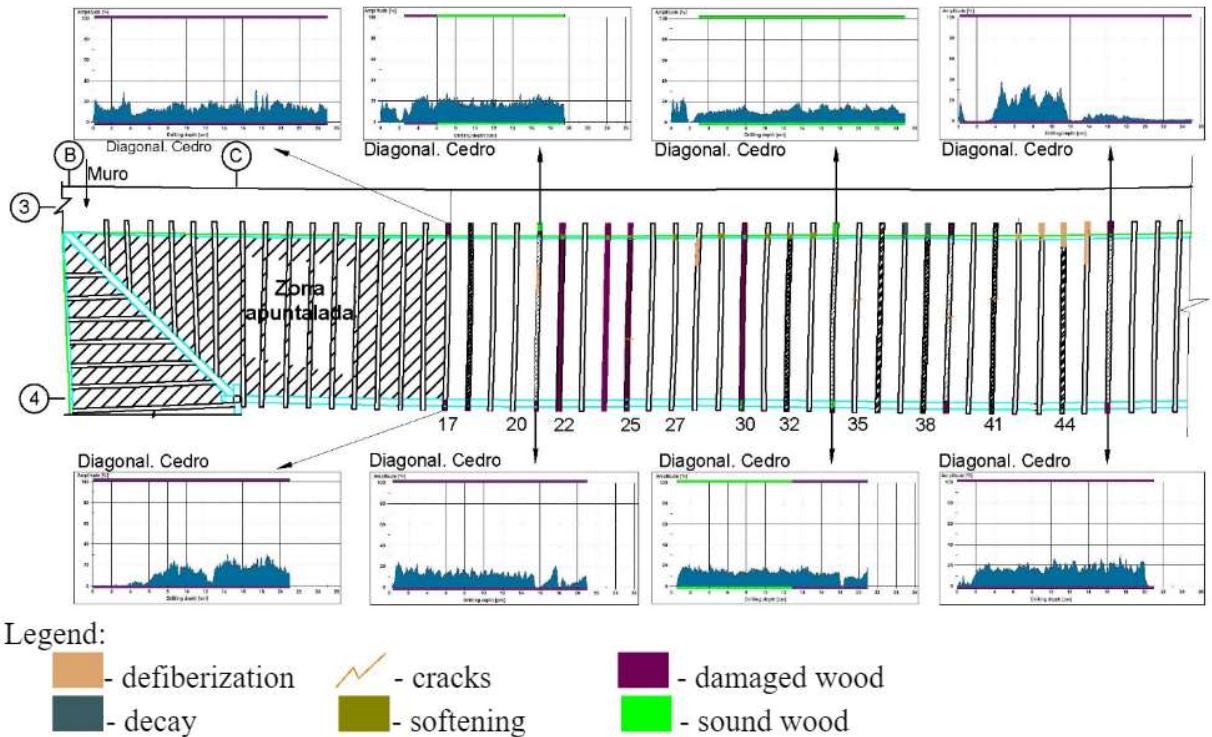
The analysis carried out with the resistograph allowed us to identify that of the 98 beams that make up the roof, 64 of them present different pathological manifestations associated with decay due to exposure to wetting and drying cycles. The resistography began in the area of the junction because it is the most vulnerable area, and depending on the damage detected, measurements were also made in the center of the span or near the supports (Figures 6 and 7).

Figure 6. Results of resistography tests and damages in wooden elements between beams 1-49

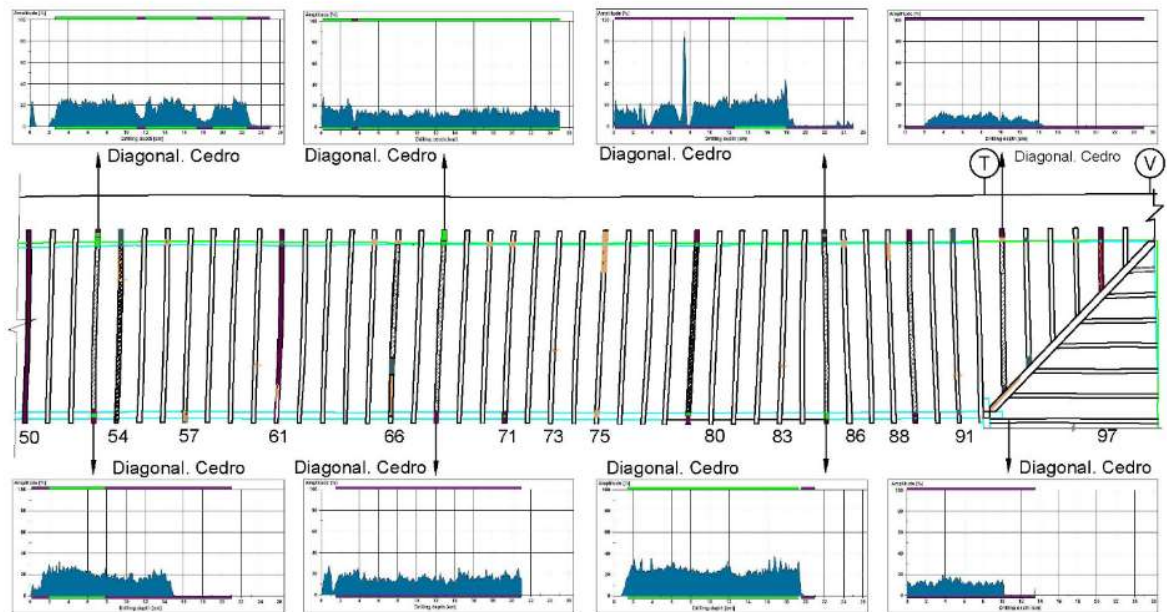
Figure 7. Results of resistography tests and damages in wooden elements between beams 50-98

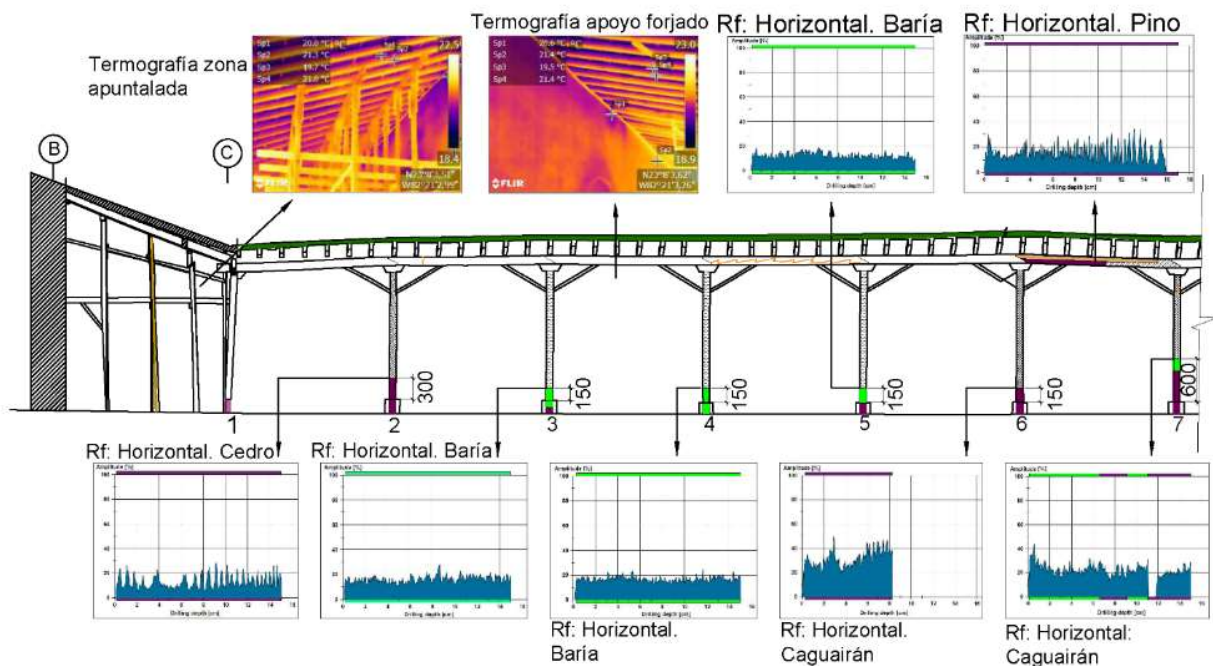
Figure 8. Results of tests on elements of the slab between wood studs 1-7, where the thermography reflects the humidity present in the wall of axis 3 in the support area of the beams, and the resistography in the wood stud and sliding beam of the axis 4

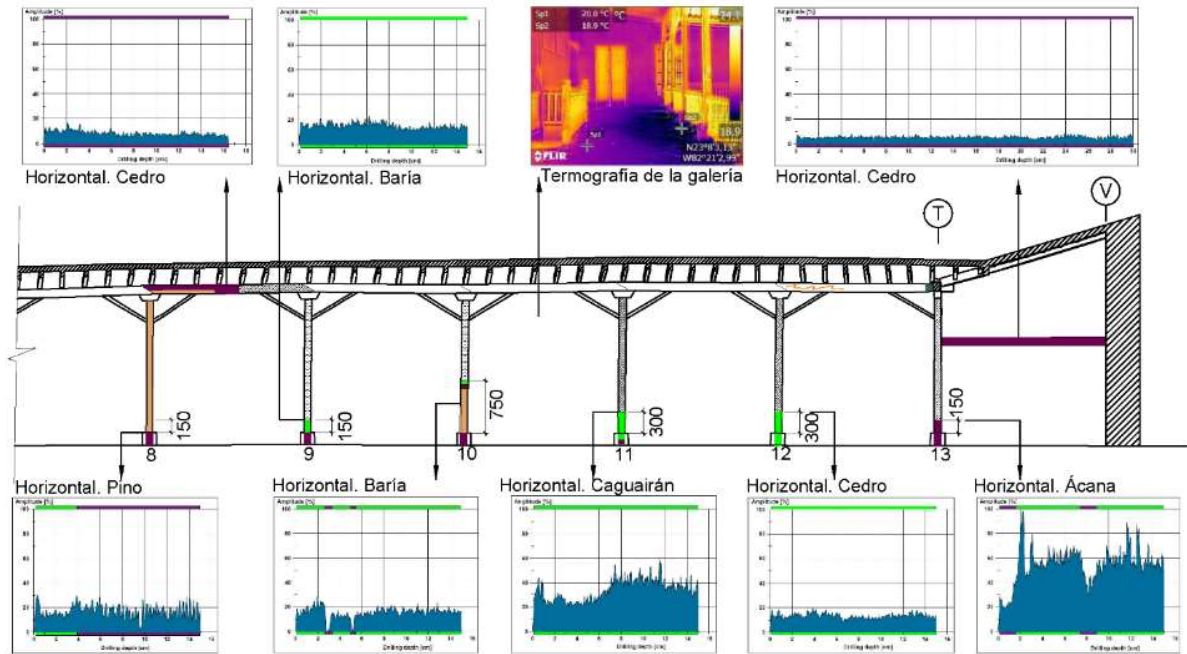
Figure 9. Results of tests on elements of the slab between wood stud 8-13, showing the thermography of the gallery with a high level of humidity in the supports of the wood stud, and the resistography in the wood stud and slide beam at axis 4.
