Evaluation of the pathological manifestations of the Rio Negro Building in Anápolis-Goiás

This paper shows the application of the methodologies GDE (Degree of Structure Deterioration) and GUT (Severity, Urgency, and Tendency) quantifying the pathological manifestations and determining the points of greatest need for maintenance. Thus, a quantitative perspective was used with the application of the previously mentioned methodologies and after building inspections and visual analysis with a photographic record, notes and mappings the methodologies were applied and it was obtained that most of the pathological manifestations that occur in the structure of the building have humidity as origin, resulting in efflorescence, spots or infiltration. Thus, this work defined the points that need priority, directing measures that can later be taken. The methodologies proved to be efficient and important for decision-making.

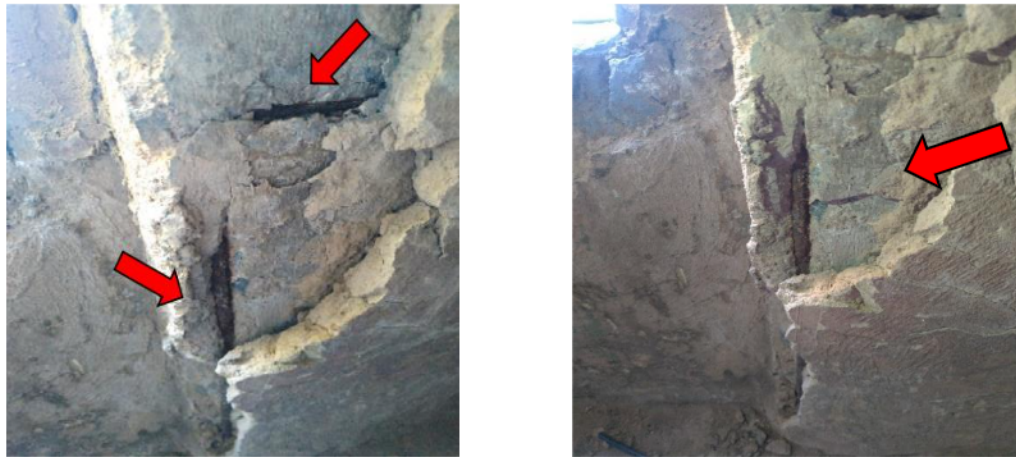
In the column family, only one element, P01, was identified, and it was possible to notice a great exposure of the reinforcements in the process of corrosion, identifying stains along the reinforcements and detachment of the concrete due to the expansion of the reinforcement, as can be seen in Figure 1.

Figure 1. Detachment of concrete and corrosion of reinforcement in element P01

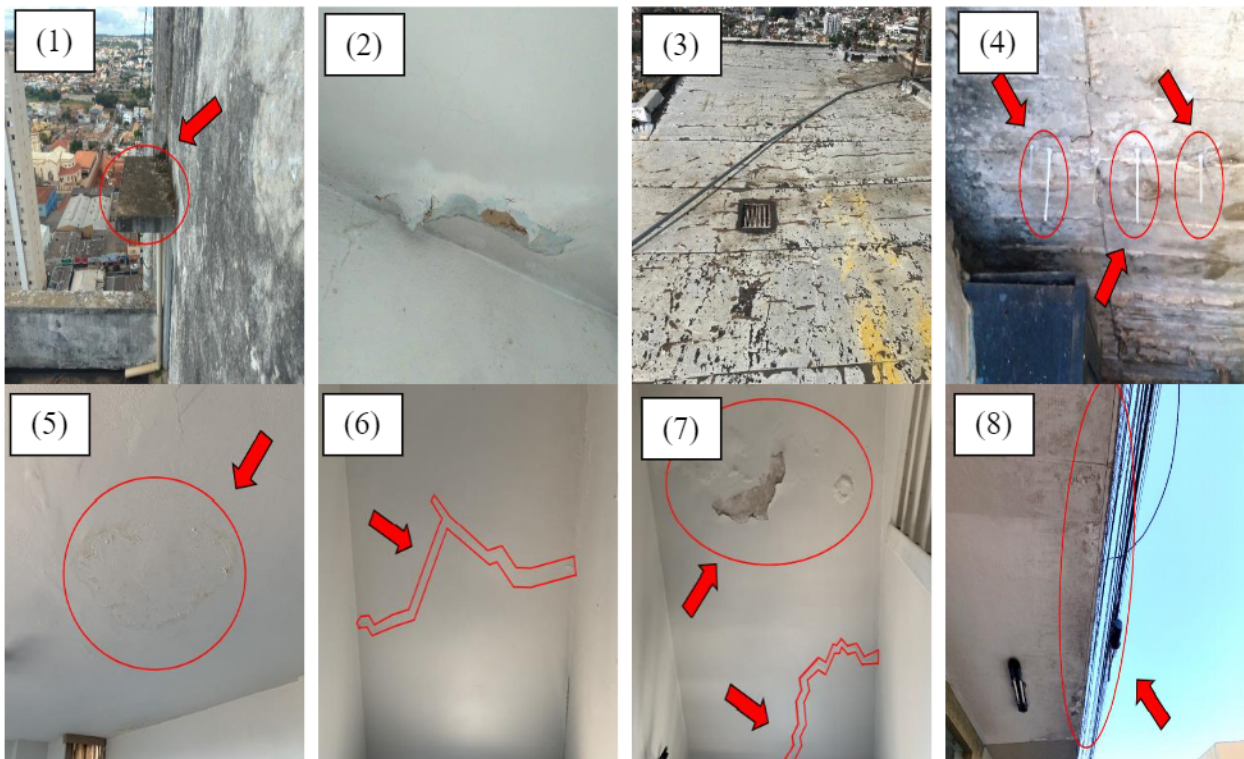
In the slabs family, elements L01 to L08 were identified, as shown in Figure 2, in which stands out the constant presence of moisture, generating dark spots in element L01, detachment of the paint in element L02, formation of calcium carbonate stalactites, due to efflorescence in element L04, small stains and cracks in elements L05 and L08 and wear of waterproofing in element L03. There are also cracks in elements L06 and L07 due to additional loads applied by a telephone antenna over the roof.

Figure 2. Pathological manifestations identified in the slabs. (1) Dark spots on element L01. (2) Detachment of the ping in element L02. (3) Wear of waterproofing on element L03. (4) Efflorescence with formation of stalactites in element L04. (5) Small moisture spots on the L05 element. (6) and (7) Cracks due to additional loading on the cover, on elements L06 and L07. (8) Dark spots of moisture on element L08.

So, in summary, the building's maintenance priorities are the L07 and L06 slabs, which need an in-depth investigation, to identify if there is a need for reinforcement to resist the additional loading and in addition to the recovery of their cracks in order not to the situation worsens.

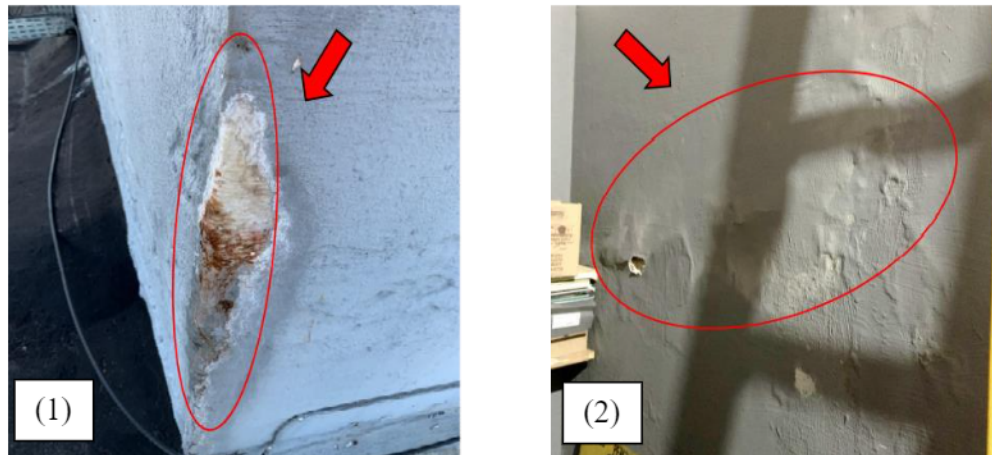
The upper reservoir family and the lower reservoir family showed possible flaws in their waterproofing, identified by the characteristic appearance of light efflorescence stains on elements R01 and R02.

Figure 3. Efflorescence spots in the reservoir. (1) R01. (2) R02.

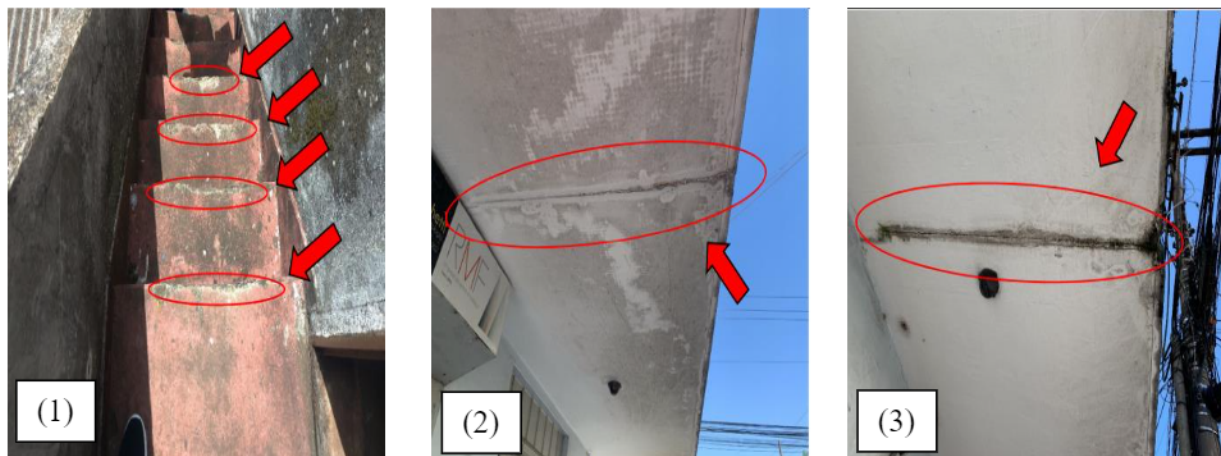
The elements of the family of stairs and expansion joints were E01 for the stairs and J01 and J02 for the expansion joints, as can be seen in Figure 4. In it, it is noted that the element E01 showed only wear on its steps due to the weather over the years and in elements J01 and J02, the constant presence of humidity resulted in the dark spots identified.

Figure 4. Efflorescence spots in the reservoir. (1) Wear of stair treads on element E01. (2) and (3) Stains due to humidity in elements J01 and J02.
