Journal of the Latin-American Association of Quality Control, Pathology and Recovery of Construction

Structural strengthening of a historical building in Rio Branco city – Acre.

D. C. S. Amorim¹, D. R. C. Oliveira²

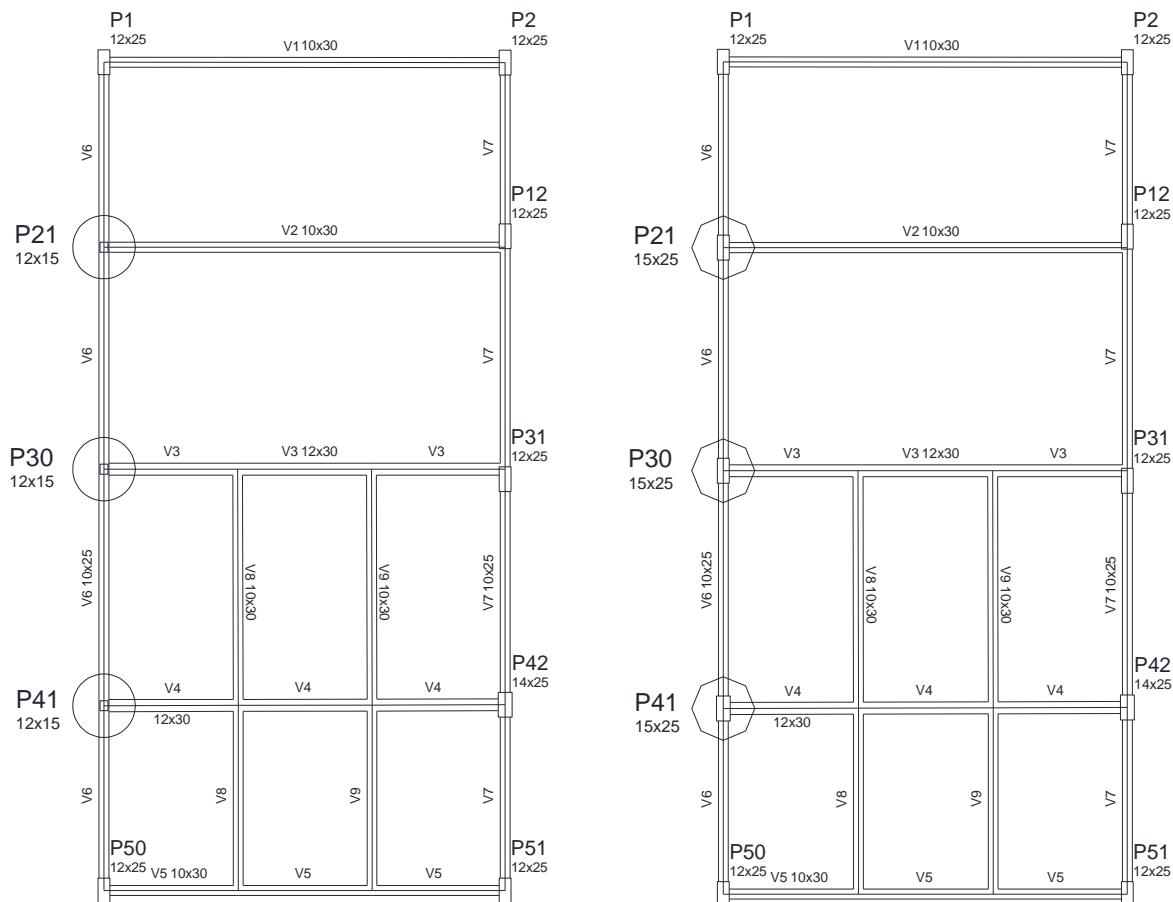
Figure 2. Location and dimensions of columns P21, P30 and P41 before and after structural strengthening (right).

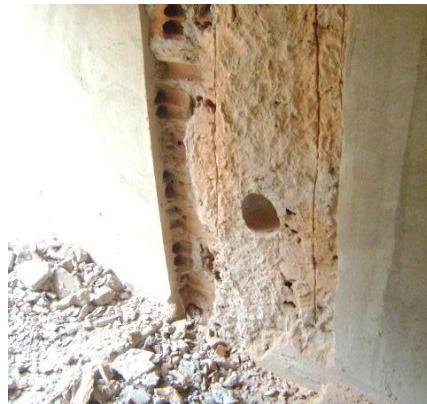
To check the existing structural safety, inspection visits and monitoring of the construction site during the execution of the revitalization work were carried out, where the procedures, techniques and equipment used in operations were identified and the photographic record being held at all stages of the executive process in 2009 and 2010. Before performing any procedure on the structure, the technical team highlighted the importance of axial compression tests on concrete testimonies to enable identification of any eventual problems related to concrete strength, since the old concrete was originally made with ceramic pieces of bricks and roof tiles. The test results indicated that, in general, the structural concrete has low compressive strength and contained coarse aggregate larger than 50 mm, which contributed to the formation of voids inside of some columns. It notes that the use of coarse aggregates derived from reducing of ceramic elements such as bricks and tiles is still a common practice in the city of Rio Branco, where there is shortage of gravel and rolled pebble. Figure 4 shows the location of extraction of the concrete testimonies in a column and Table 1 shows the results for concrete compressive strength of concrete testimonies from columns P21, P30 and P41, which further analysis indicated the need for structural strengthening in the basement level columns.

Figure 4. Testimonies' extraction hole in a column.

Pilar	Testemunhos (MPa)	Projeto de reforço (MPa)
P21	13.7	25.0
P30	20.1	
P41	14.7	
Average	16.2

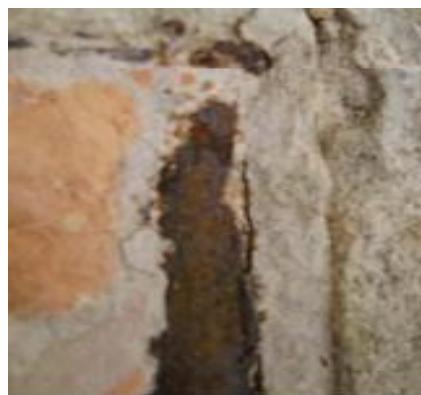
Besides the low compressive strength, it was also found that the reinforcements of some columns had advanced corrosion and severe weight loss, compromising bearing capacity to service loadings and even to permanent ones, once some bars were completely sectioned by corrosion. Figure 5 shows the appearance of the corroded reinforcement bars of the columns. It was concluded that the damage was characteristic of deterioration processes with systemic nature, i.e. related to the quality of the concrete used in the manufacturing of the structural system and especially the thickness of reinforcements coatings that showed values between 10 mm and 15

mm, considered inadequate to provide the required service life of a structure made of concrete containing such porous aggregates.

Figure 5. Columns' longitudinal reinforcement eroded (corrosion).

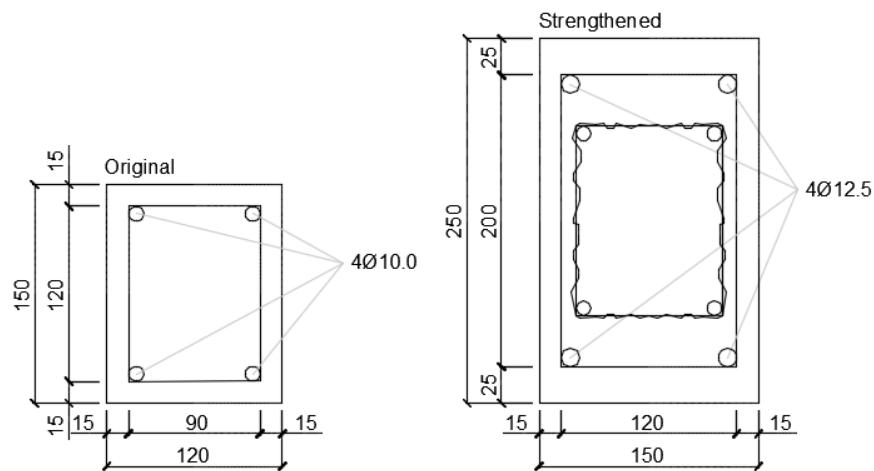
Figure 6. Columns' cross section before and after the structural strengthening.

2.3.2 Reinforcements. The longitudinal and transverse reinforcement (stirrups) before and after the structural strengthening of the columns were composed of steel bars with diameters, numbers and spacing presented in Table 2. The concrete cover for the columns was 25 mm and 15 mm at the short and long sides' dimensions, respectively. Figure 6 shows details of the cross sections of the columns before and after the structural strengthening with reinforced concrete jacketing, and Figure 7 shows details of the transverse and longitudinal bars. The columns P21, P30 and P41 were only strengthened in the basement floor length because these columns presented safety factors below the recommended by the Brazilian standard for reinforced concrete structures design for the future loadings. Figure 8 shows the placement of the reinforcements, where it is possible to see that, despite efforts to preserve as much original architecture, the smaller final dimensions of the columns, plus the 20 mm thick coating mortar layer, would be greater than the wall thickness.

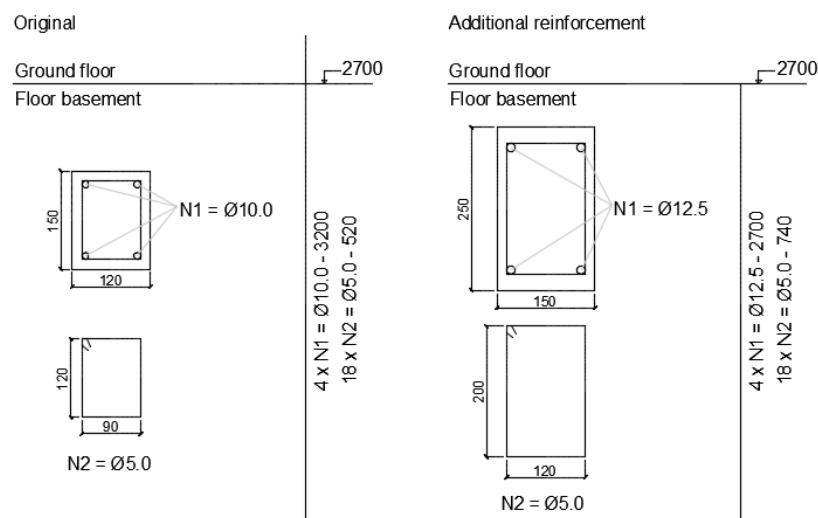
Figure 7. Original and additional reinforcement.

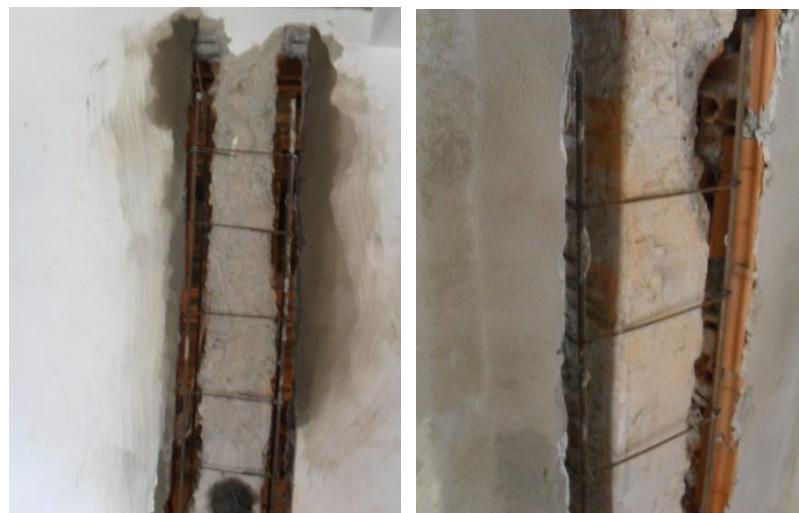
Figure 8. Longitudinal reinforcement and stirrups of the structural strengthening.

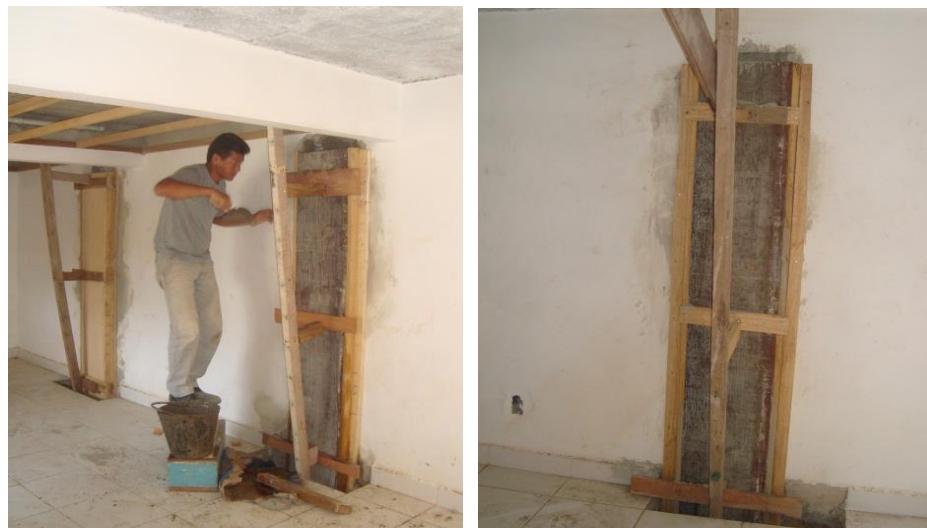
Figure 9. Concrete casting of the structural strengthening.

2.3.3 Concrete casting. So that there was greater adherence between the old and new concrete its surfaces of the columns were wet before the concrete casting. The concrete was carefully released (Figure 9) and the density was achieved with immersion vibrator with a head diameter of 20 mm, first in 50% of the volume of concrete cast in each column and then the remaining volume. After removal of the wooden mold the columns received a mortar coating layer to allow the finishing, or painting. Figure 10 shows the final appearance of the columns with smaller dimensions exceeding in 35 mm the wall thickness.

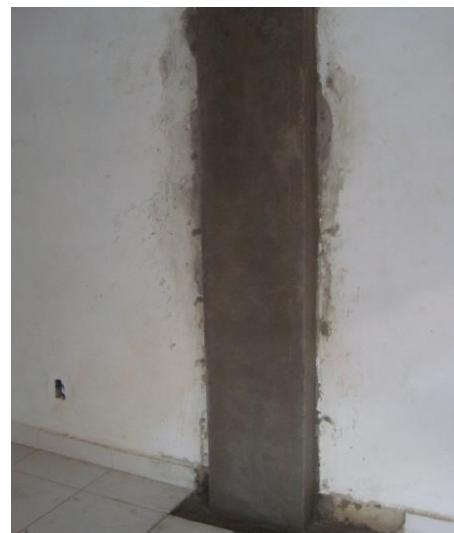
Figure 10. Final aspect of the strengthened columns.

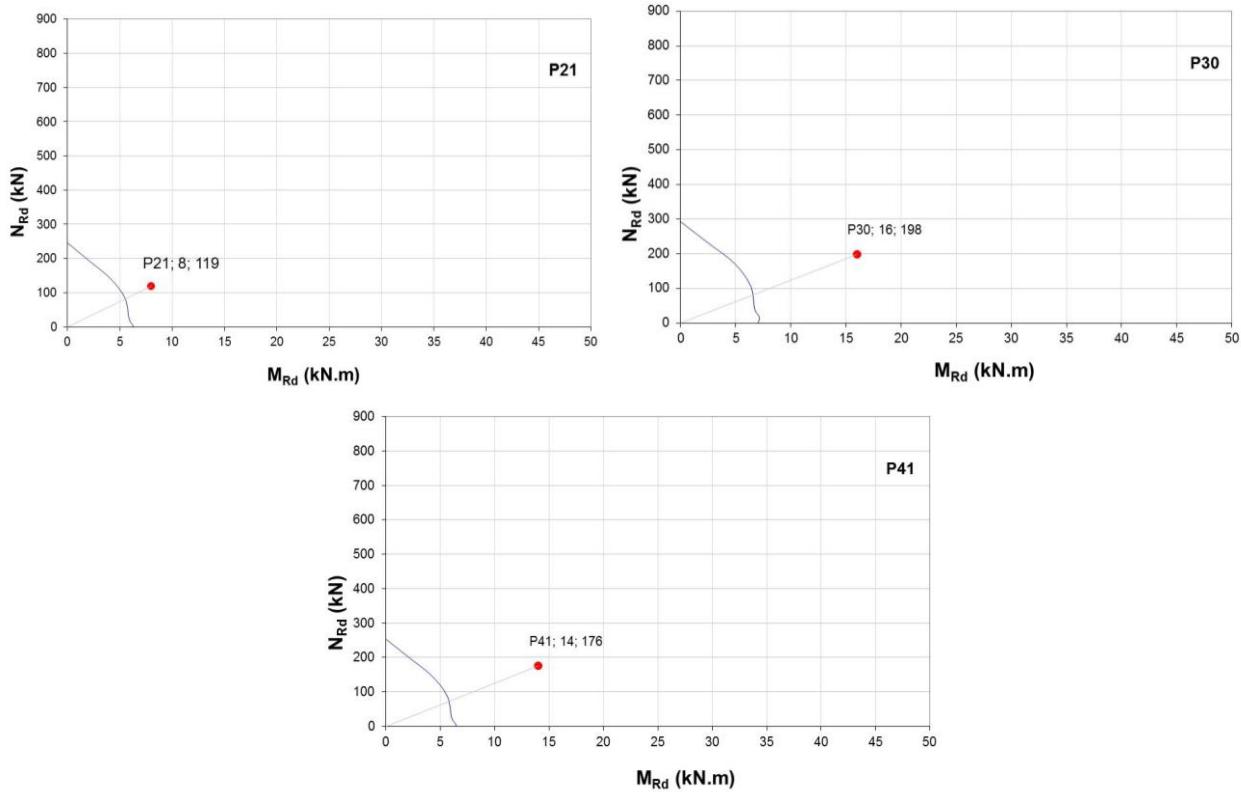
Normal acting force (N_{sk}) was obtained from Altoqi Eberick 2002 software and the results found with the preliminary analysis for the safety factors of the columns P21, P30 and P41 before strengthening not meet the normative safety requirements, as shown in Table 4. Figure 11 shows the interaction envelopes of resistant forces of these columns, i.e. the consideration of acting and resistant characteristic bending moments without any coefficient of increase or decrease in these actions. In this case, it is observed that the bending moments are more important and destabilize

the columns (Marí & Hellesland, 2005), which did not occur because the current actions were lower than those considered in the structural design up to now. It is also possible to conclude with more refined analysis that the progress of corrosion on the flexural reinforcement could significantly reduce the resistant capacity of the columns to flexure and even if the maximum designed loads did not occur, small additions could cause the loss of stability of these columns (Tang & Yang 2011), evidencing the need to strength these structural elements.

Column	f_{ck} (MPa)	f_{cd} (MPa)	f_{yd} (MPa)	A_c (mm ²)	A_s (mm ²)	γ_u	γ_n	N_{Sk} (kN)	$N_{Sd,Eq}$ (kN)	N_{Rd} (kN)	γ_f
P21	13.7	9.9	435	18000	482	1.5	1.35	119	240	155	0.65
P30	20.1	14.4						198	400	215	0.54
P41	14.7	10.5						176	356	164	0.46

Figure 11. Envelopes for columns P21, P30 e P41 before the structural strengthening.

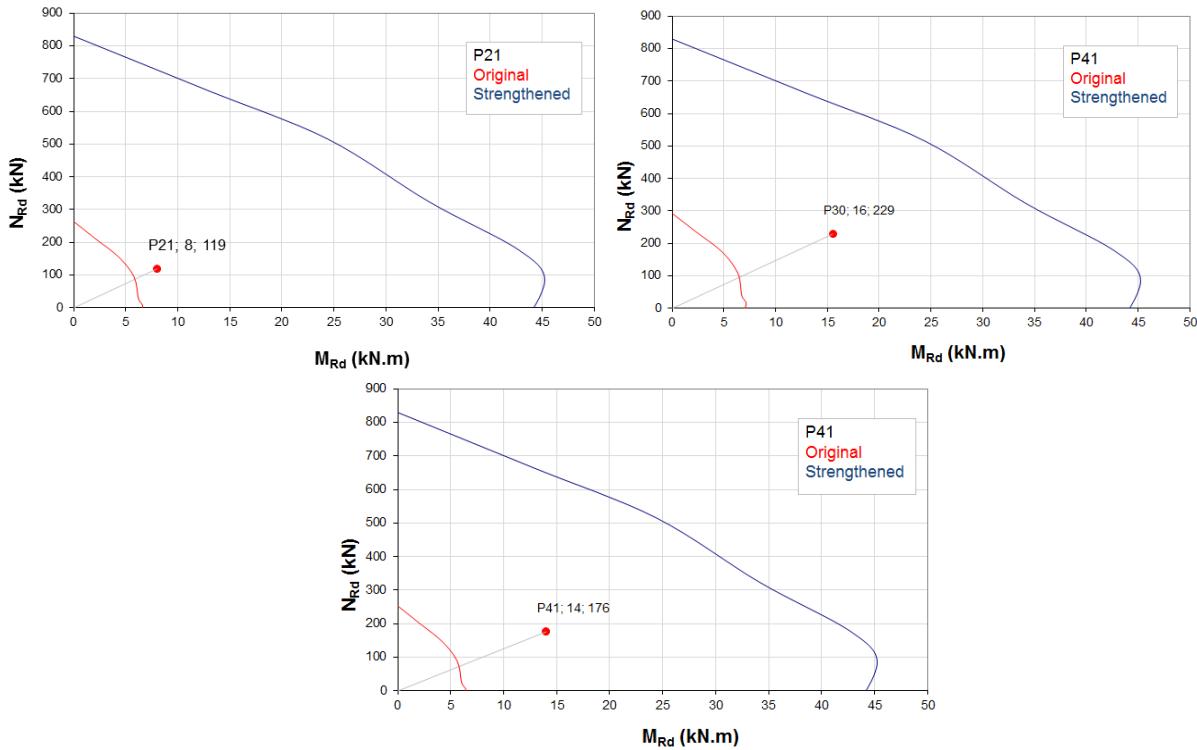
Columns' design safety factors for P21, P30 and P41 strengthened columns was based on the prescriptions of NBR 6118 (ABNT, 2014) following the same criteria used for the original columns without strengthening. The results are presented through the interaction envelopes of Figure 12. The safety factors of each column were determined by the ratio between the length of the straight line from the origin to the outer envelope, passing through the acting loads point, and the distance from this point to the origin, and results are presented in Table 5.

Figure 12. Envelopes' for strengthened columns P21, P30 and P41.

Column	Safety factor
P21	3.5
P30	1.8
P42	2.1
