Evaluation of pathological manifestations in buildings in terms of geographical orientation

W. Mazer¹, L. M. R. Silva², E. Lucas³, F. C. M. Santos⁴.

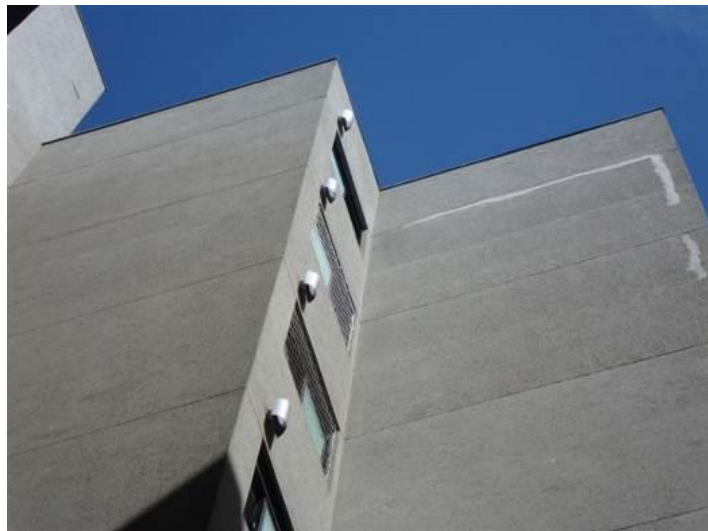
In Table 1 we can appreciate that in all buildings that presented pathological manifestations on their facades, the incidence of fissures was also present; it was seen that the largest portion of the fissures, as indicated in Table 2, happen on the facades that face North, which, in Curitiba, receives the most solar incidence, and which can suffer a variation in temperature of up to 10°C in the same day, as indicated in Figure 7. Some examples of these incidences are shown in Figure 6. Most of the time, splintering also occurs in the same facades as the variation in temperature, in addition to failures in the execution of the building, also have an influence on this type of damage.

a) Thermal variation fissures.

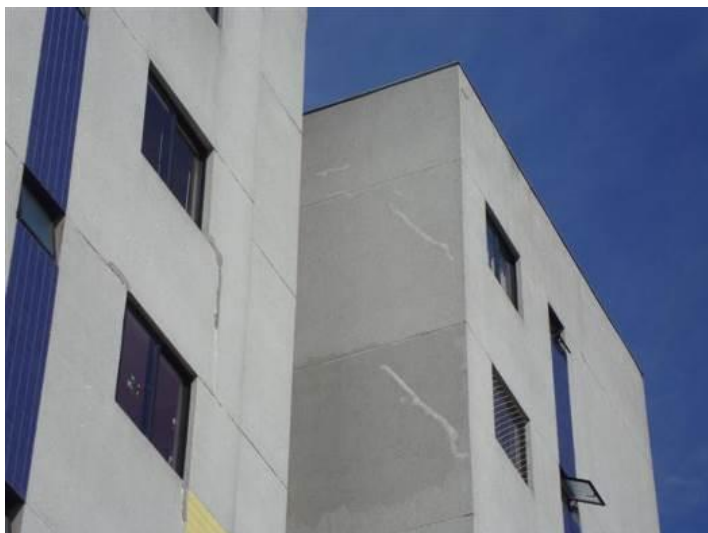
b) Structure movement fissures.
