Building facade cladding detachment: A case study

A. C. Lordsleem Jr.^{1*}, H. Batista Faro¹

Citation: A. C. Lordsleem Jr., H. Batista Faro (2017). “*Building facade cladding detachment: A case study*”, Revista ALCONPAT, 7 (2), pp. 148-159, DOI: <http://dx.doi.org/10.21041/ra.v7i1.126>

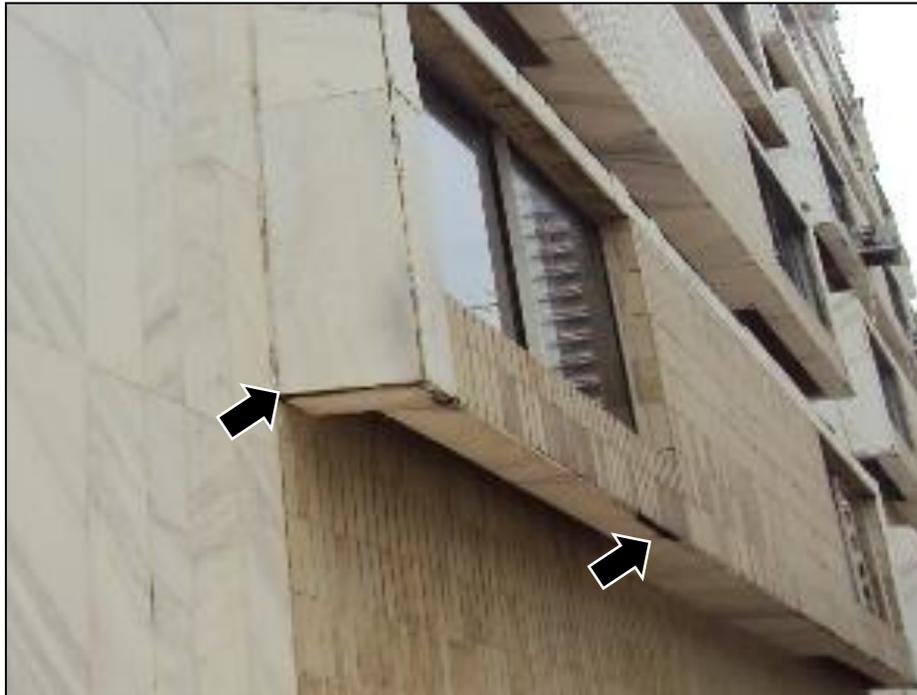
Figure 2. Northern facade (sections T5, T6, and T7).

The north facade (Figure 2) contains details designed to contribute to interior ventilation, where airflow enters indirectly below the aluminum frames, controlled by a "guillotine" mechanism attached to the marble windowsill (Figure 6).

This detail is important in the analysis of facade pathologies, since most of the occurrences of detachment of the marble slabs were found in this area at the bottom of the beam.

During the inspections, a high incidence of detachment of marble slabs was noted on the north facade, where the structure suffered greater exposure to aggressive environmental agents (Figure 2).

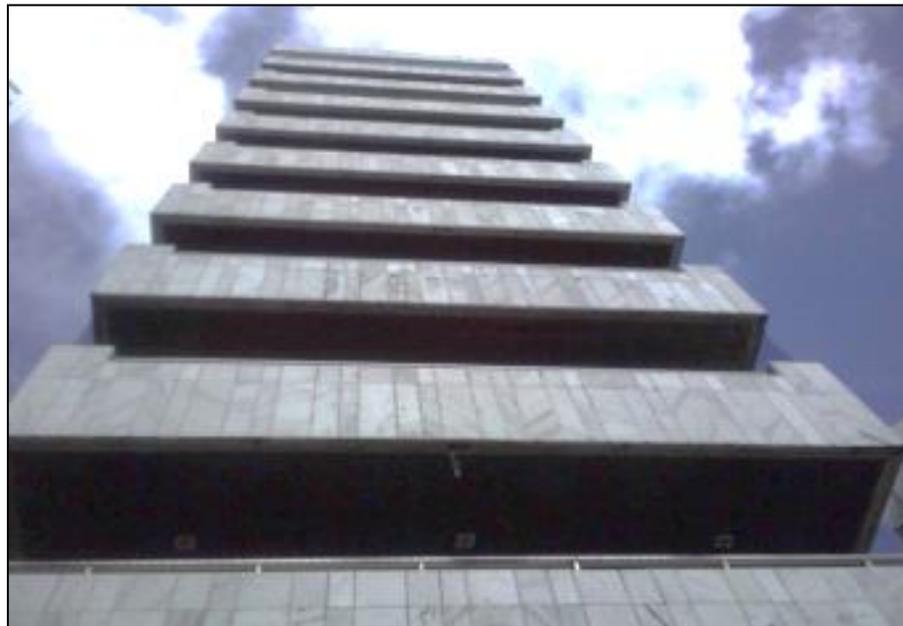
Figure 3. Eastern facade (section T1).

In general, the marble slabs and building facade joints showed signs of moisture condensation, highlighted by the presence of molds. The front facade of the building faces towards the sea (east), thus having its cladding exposed to continuous direct sea breezes. This cladding is entirely composed of striped white marble and has spots of black coloration at various points, characterized by the formation of mold caused by the constant moisture in the grout and the marble slabs due to the water absorption and porosity (grout), as well as the favorable environment for the proliferation of fungi (Figure 3).

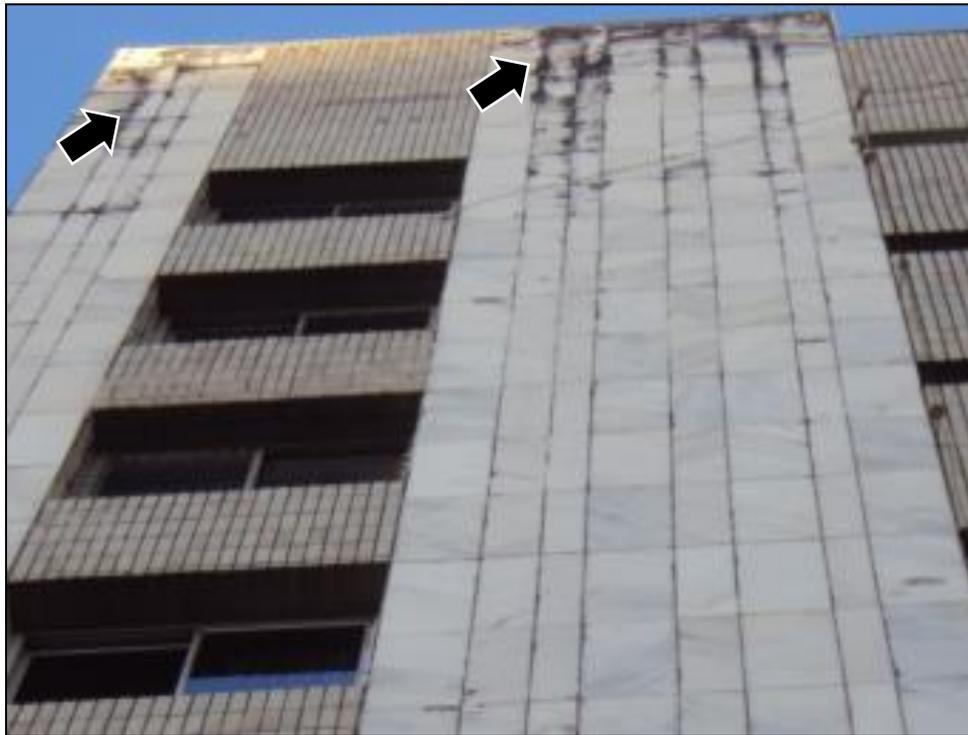
Figure 4. Southern facade (sections T2, T3, and T4).

The southern facade is composed of semi-stoneware ceramic tiles of beige color and rectangular plates of white striped marble, with dimensions of 95x20 cm and 95x30 cm (Figure 4). On the south facade, grout and plates with black spots were observed at roof level, characteristic of mold. There is also a history of detachments occurring in the cladding applied horizontally from below the bottom of the edge beam of the roof balcony.

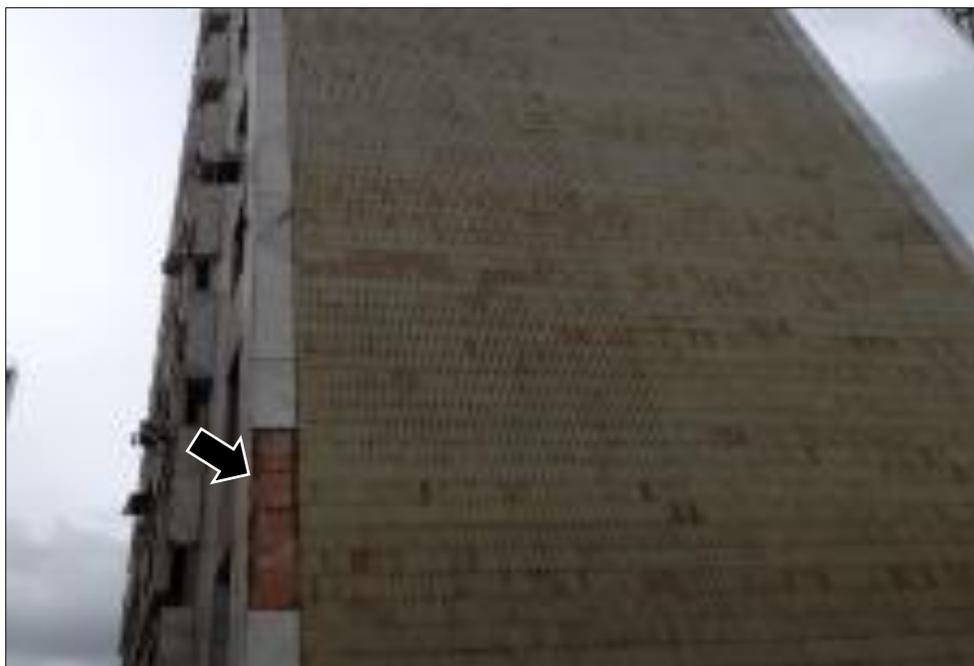
Figure 5. Western facade (section T8).

The west facade is covered mostly by the same ceramic as the other facades, in a closed sheet, having only at the edges a single finishing row of white striped marble. On this facade, the detachment of two slabs can be seen in the finishing marble, while the ceramic remains intact without showing signs of adherence failures (Figure 5).

Another occurrence reported with respect to the west facade was the recurring appearance of infiltrations on the 8th floor, according to a resident. In addition, the condominium contracted for 15 years a company to perform maintenance services on the facade, recovering the grouting of each facade and replacing some tiles that showed signs of adherence failure.

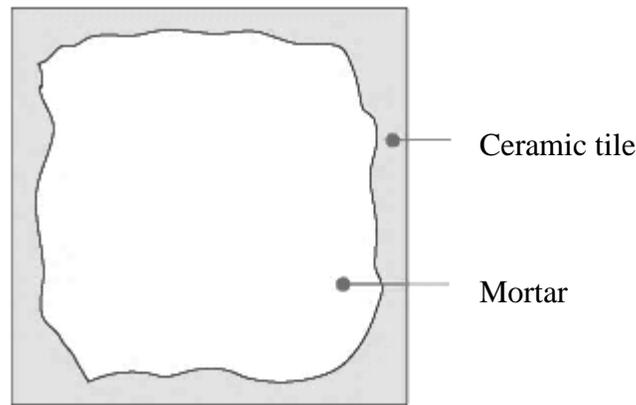
Figure 7. Example of plaster mortar spreading and fixing on the back of the tile – *bolão* method

The cement paste was spread on the back of the tile. In this type of application, the previous wetting of the cladding material (ceramic tile and natural rock - marble) is an important condition to avoid the loss of part of the water needed to cure the mortar.

No joints were observed that would act as movement joints. Most of the occurrences of detachment happened with tiles set in the horizontal, but there was also detachment of some marble slabs set in the vertical panels, confirming the existence of failures in marble slab adherence of the facade cladding. After the removal of a piece of concrete from the bottom of the periphery beam, the corrosion of the reinforcement and the separation of the covering from the reinforcement became evident.

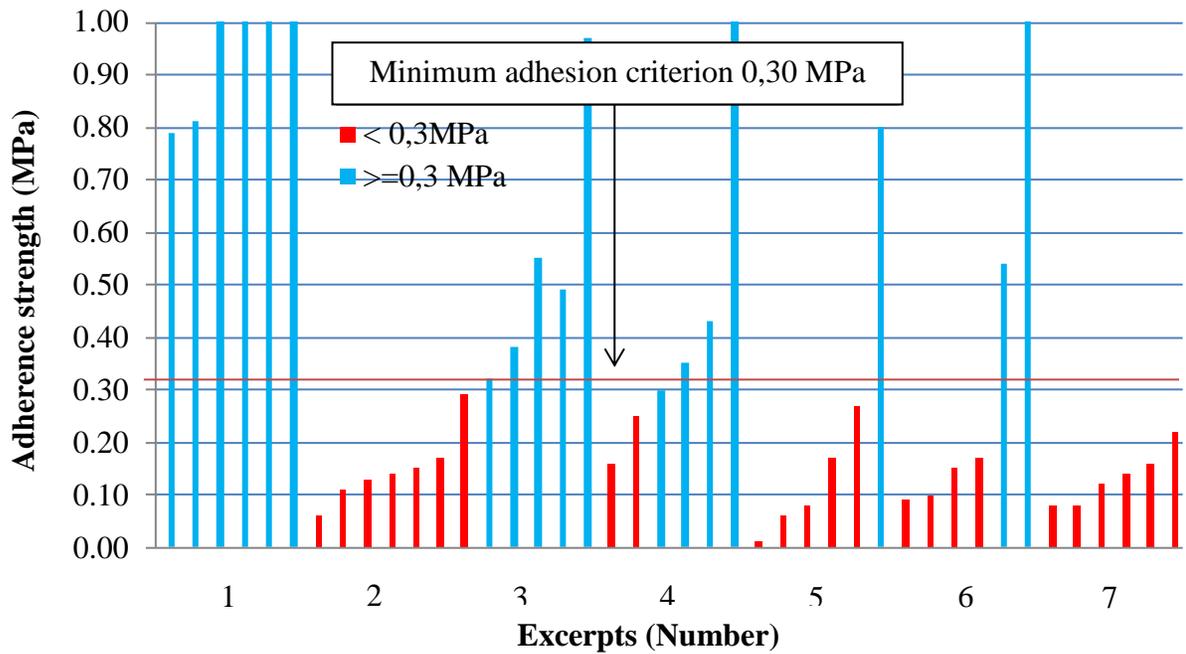
Figure 8. Results of the tensile adherence strength tests (Tecomat, 2011).

The test results can be verified in Figures 8 and 9. According to Brazilian norm NBR 13755 (ABNT, 1996), for every six points verified in the same section, at least four of them must have a rupture tension (traction adherence) value points greater than 0.30MPa.

It should be noted, initially, that the sections tested (T) were clad with marble slabs, except for section 3, which used ceramic tiles and whose results were satisfactory. Judging by the standardized criteria, the values obtained show clear defects in adherence resistance in sections 2, 5, 6, and 7.

In the case of section 1, contrary to expectations, results were found to be far better than the criteria mentioned above. It is reasonable to suppose that what could justify such a large difference in performance may have been either the use of different procedures for this section, or greater ability on the part of the professional who executed the east facade.

The elaboration of a cladding project is recommended to replace the mostly compromised facade marble by other material to be specified in order to reconstruct facade and provide greater efficiency in its functions.

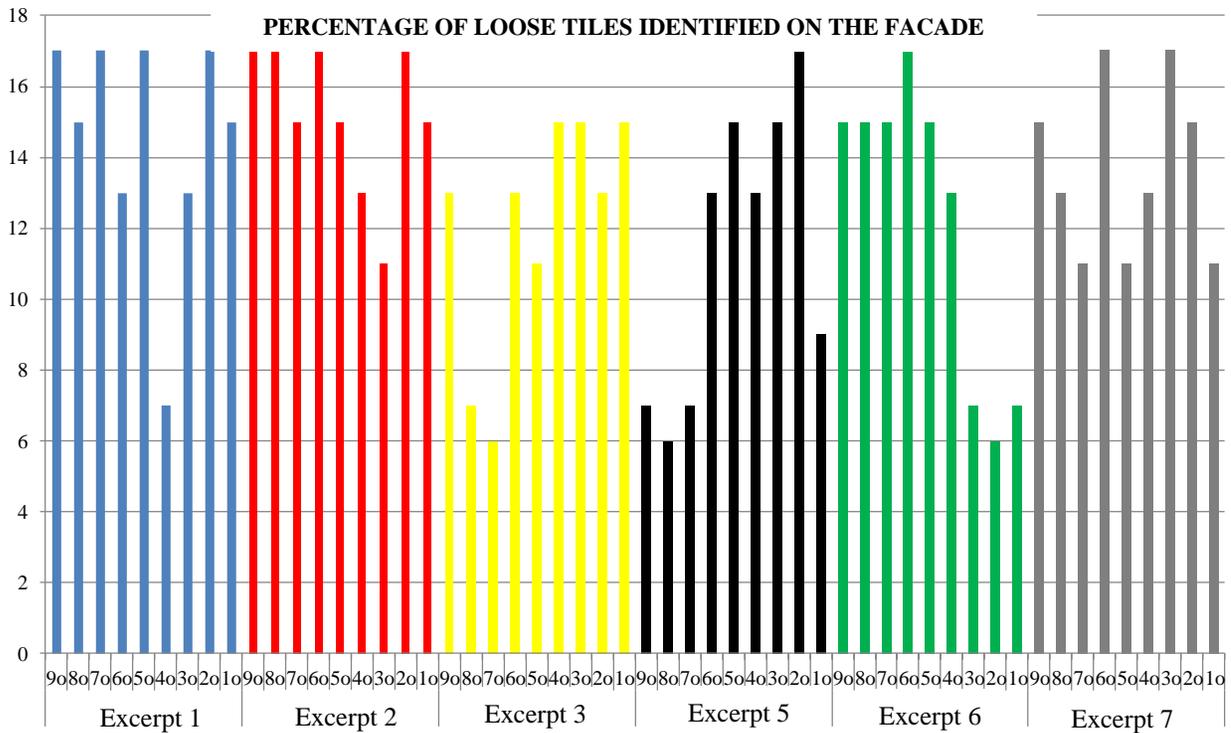
Figure 9. Results of the percussion tests (Tecomat, 2011).

Percussion tests were also performed, where a hollow sound obtained by means of striking the cladding with a rubber hammer indicates a flaw and suggests the possibility of detachment of the tile. It should be clarified that there is no normative criterion that indicates acceptable levels for this test and it should not be adopted in isolation (Table 1).

In general, the results of the direct tensile strength and percussion tests indicate that most of the marble cladding area is found to have compromised adhesion in some stretches with imminent risk of detachment. The perspective is that with movement, whether due to rain, wind, or the various stresses to which they are subjected, other cladding tiles will eventually detach, producing a hazardous situation with the potential for material and personal damages.
