Potential of thermographic analysis to evaluate pathological manifestations in façade cladding systems

O. T. Takeda¹, W. Mazer*¹

First, an exploratory study was conducted on the façades of blocks B and C at Campus Curitiba, Ecoville headquarters of UTFPR for the purpose of investigating the anomalies occurrence and the existent types of pathological manifestations through qualitative visual and thermographic inspections to define the study areas.

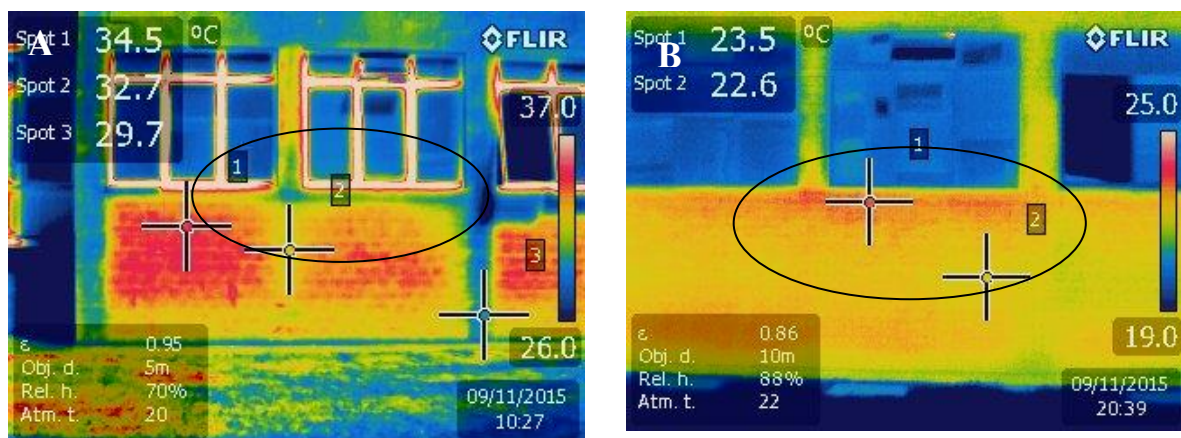
Figure 5. A) Exploratory study thermogram.
B) Confirmatory study thermogram.

In the confirmatory study of study area 1, presented in Figure 5B, it is possible to identify a thermal anomaly that may be associated to a possible detachment with presence of moisture below the ceramic cladding in the window framing region, since the presence of moisture in the region has the characteristic of maintaining higher temperatures in the thermograms during the negative heat flow period in comparison to the unaffected region. This hypothesis is reinforced by the identification of points with damaged grout between the ceramic tiles in the window region. It is also possible to observe in the exploratory study thermogram, shown in Figure 5A, that during the positive heat flow period the temperatures in the window framing regions are smaller due to water evaporation.
