Evaluation of pathological problems associated with carbonation and sulfates in a concrete tower with more than 50 years in service

E. E. Maldonado-Bandala^{1*}, D. Nieves-Mendoza¹, J. L. Vela-Jiménez², P. Castro-Borges³.

DOI: <http://dx.doi.org/10.21041/ra.v8i1.284>

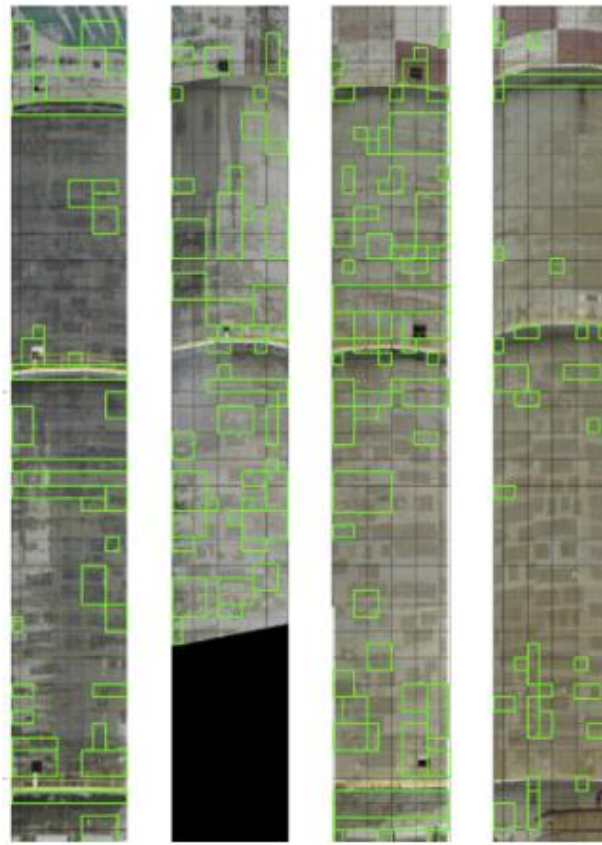
An aerial drone was used to facilitate damage survey due to structural complexity, limited access to high areas and time concerns. An autonomous mission was designed using a flight plan based on sequential GPS points along the tower’s four vertical surfaces (north, east, south and west). Drone cruise speed was controlled such that high quality images were taken in areas with visible structural damage. These were converted into two-dimensional maps and areas with the greatest visible damage marked (Figure 2).

Figure 2. Two-dimensional map of drone images. Areas of major visible damage delimited by green lines.

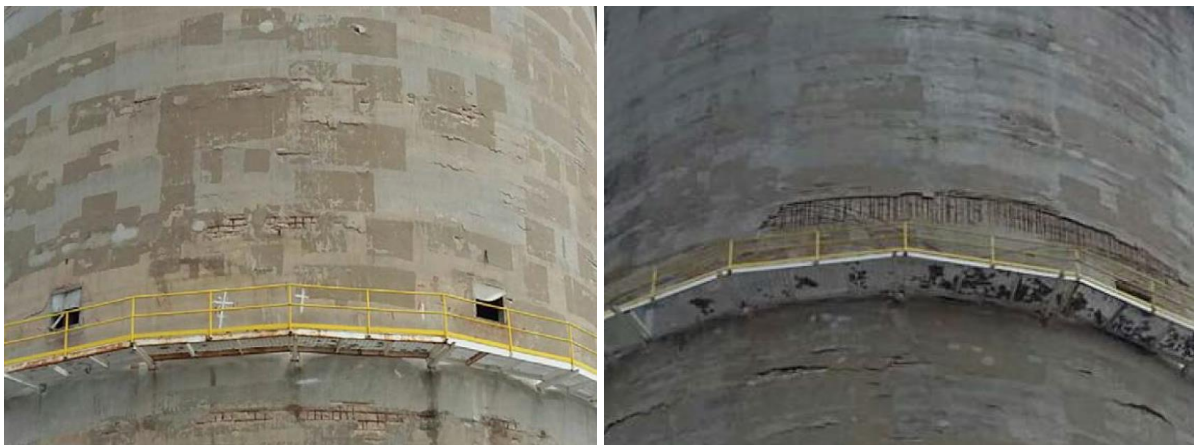
Previous, localized repairs are clearly visible in the images. Since these were probably not done adequately, they may have accelerated deterioration processes in the concrete-steel system (Figure 3 and 4). There are also areas of concrete detachment and spalling, exposed steel reinforcement, diminished section of the reinforcement and cracks ranging in length from approximately 0.50 m to 5.00 m and in width from 3 mm and up.

Figure 3. Exposed steel reinforcement, corrosion, concrete spalling and multiple rectangles indicating the sites of previous localized repairs.

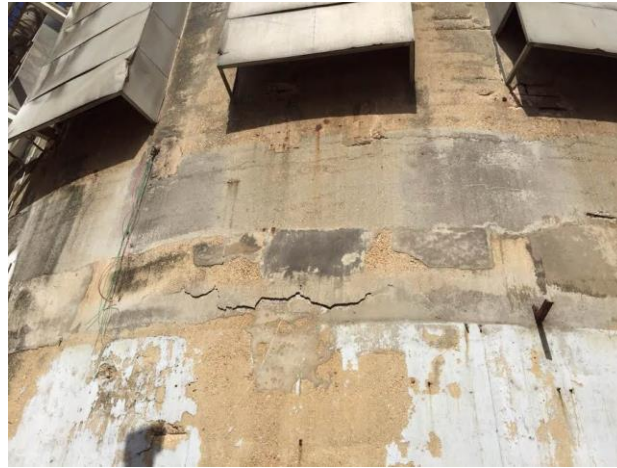
Figure 4. Detail of localized repairs in which the more recent concrete has separated from the original concrete, causing occasional spalling and anodic zones favoring formation of corrosion cells.

Previous localized repairs accelerated corrosion damage in adjacent zones by creating galvanic cells.

Deteriorated and/or contaminated concrete should only be removed from anodic zones. Steel rebar needs to be cleaned and the substrate prepared following official guidelines (NMX-C-518-ONNCCE-2016, 2016). If deemed necessary after evaluation, rebar should be replaced.

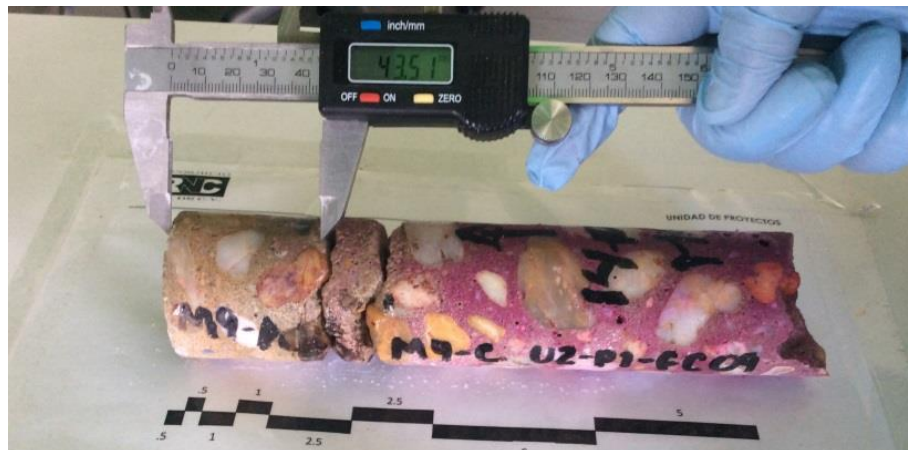
In some samples the depth of carbonation was notable. For example, in U2-P1-P04 a clear colorless zone was visible after phenolphthalein application (Figure 5). This indicates a considerable drop in concrete pH that extends to the depth of the rebar (Table 2). Severe damage is also present from cracks running parallel to the wall surface.

Figure 5. Depth of carbonation in U2-P1-P04. Note depth of damage and cracks parallel to the surface.

Carbonation is the primary mechanism of corrosion in the studied structure. The high CO₂ concentration and high relative humidity in the surrounding environment have reduced concrete pH and generated depassivation of the steel reinforcement.

A chloride-impermeable anti-carbonation covering will need to be applied with the capacity to bridge cracks and including chemical components complying with ASTM C494 / C494M-17 (2017). If cracks appear they should be covered since these are the primary point of contaminant ingress.

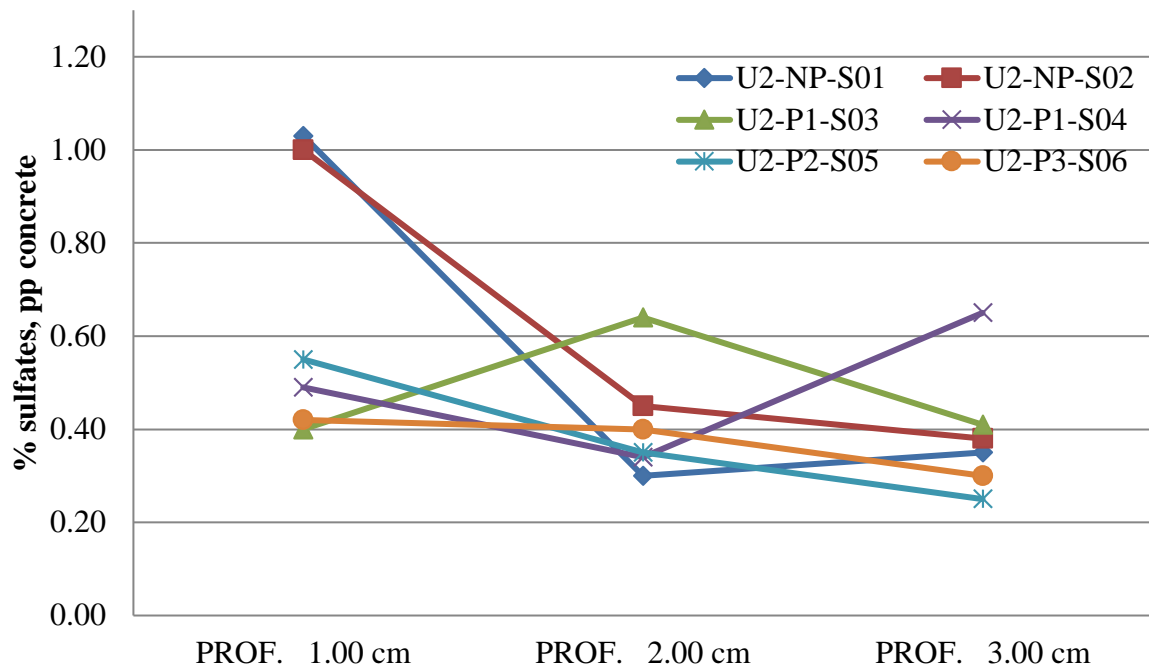
At the concrete surface, this parameter varied from 0.25 to 1.0% pp concrete content, and at 3 cm depth it varied from 0.50 to 0.80% pp concrete content (Figure 6). These are considered high values since the limit is 0.40% pp concrete content. Nearby sources of high sulfate levels include marine waters, industrial gases and the water in adjacent cooling towers. Sulfate attack of concrete components can cause formation of ettringite and plaster.

Figure 6. Sulfate concentration in concrete samples by depth. All tested areas exceeded the 0.40% pp concrete threshold, indicating sulfates damage. (PROF = DEPTH)

Sulfate ion ingress and low compression resistance values are two important conditions that can induce degradation of structural properties in the studied structure. Sulfate attack is known to be quite complicated (E.F. Irassar, 2009), although there are some principal factors that affect the evolution of concrete properties, such as sulfate solution concentration, exposure to high temperatures and low concrete pH (J. Skalny, 2002). All three of these factors were present in the studied structure. Indeed, the sulfates concentration considerably exceeded the proposed maximum concentration (C. Andrade, 1998), possibly leading to formation of ettringite and plaster. This could have accelerated concrete degradation as the products of concrete hydration

and the sulfate ion solution caused expansion and cracking (C. Yu et al., 2015; F. Bellmann et al., 2006). After exposure to soluble sulfates a concrete matrix can soften or its overall porosity increase, thus reducing structure durability.

Due to the structure's geometrical condition and the difficulty of building centering and applying spray concrete at high altitudes, section recovery is best done using prepared structural repair mortar containing sulfate resistant (RS) Portland cement complying with applicable regulations (NMX-C-414-ONNCCE-2014, 2014; NMX-C-418-ONNCCE-2015, 2015). It will need to be sufficiently fluid to allow for manual application.

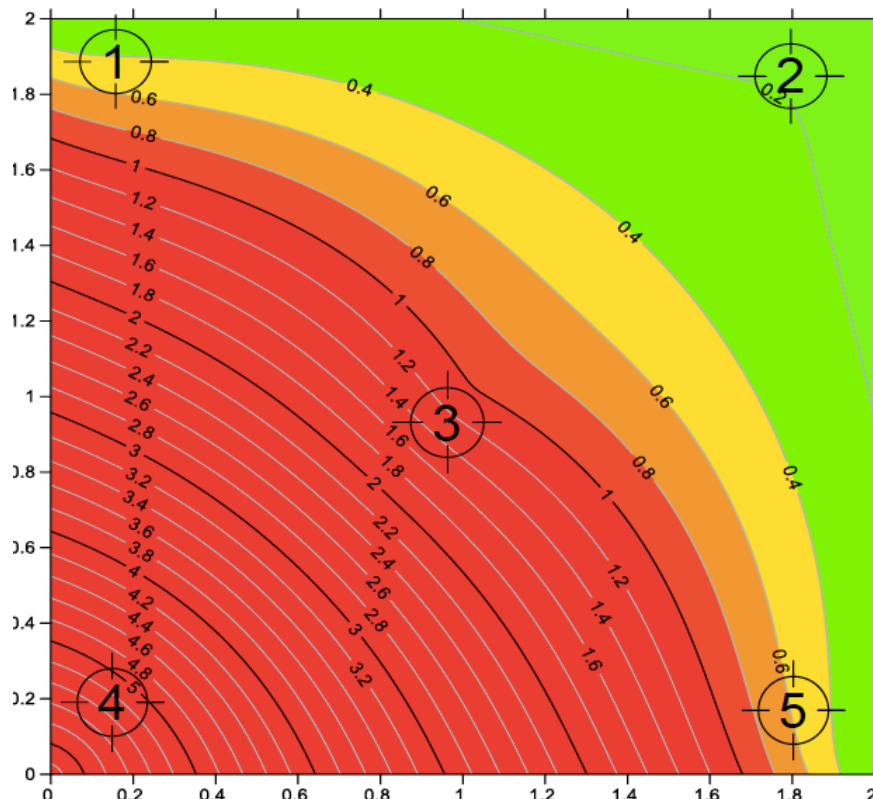
Non-destructive tests of corrosion rate were run even though areas of exposed steel were quite evident and rebar corrosion was obvious. Values for this parameter were moderate to very high in most cases (Table 2), with values near $5 \mu\text{A}/\text{cm}^2$ (Figure 7).

Figure 7. Corrosion rate isovalues for study zone U2-P1-P04; most values are very high.

The very high corrosion rate values may have been caused by localized repairs done with uncompacted materials, which cause cracks and spalling between the new and pre-existing concrete. This is a very common effect at the concrete-steel interface in real structures. It arises from the “top-bar” effect in which adherence to the steel reinforcement decreases in the cover, particularly in thick concrete with inadequate compaction (P.R. Jeanty et al., 1988; A. Castel, 2006). It can also result from corrosion caused by galvanic current within the macrocell. This is caused by an electric connection between rebar exposed to different electrochemical surroundings, that is, passive steel in recently repaired zones and active steel in carbonated zones (J. Gulikers and M. Raupach, 2006; J. Warkus and M. Raupach, 2006). High galvanic currents result which lead to high corrosion levels according to RILEM recommended levels (A. Nasser et al., 2010).

The high corrosion rate results suggest the presence of zones in which loss of steel reinforcement section is advanced. In places where the decrease in original nominal diameter exceeds 10% the structure needs to be reinforced through substitution of the damaged rebar with rebar of the original diameter and with the same yield point (f_y) to meet applicable regulations (NMX-B-457-CANACERO-2013, 2013). Repair sequence and geometry must meet the guidelines in the Rehabilitar network manual (Helene, 2003).
