Application of GUT Matrix in the assessment of pathological manifestations in heritage constructions

The present paper presents the application of GUT (Gravity, Urgency, Tendency) Matrix methodology as a tool in the assessment of pathological manifestations in buildings. Three heritage constructions of the historic center of Sobral, Ceará, Brazil were studied through *in situ* inspections, photographic records and elaboration of the damage map. The GUT Matrix was used as a tool to rank, in each building, priority levels for each damage in order to define their order of treatment. Thus, it was possible to conclude that the applied method can be used as a useful tool to manage the maintenance of buildings through prioritization of the most significant problems and, to contribute directly to the preservation and safety of the built historical heritage.

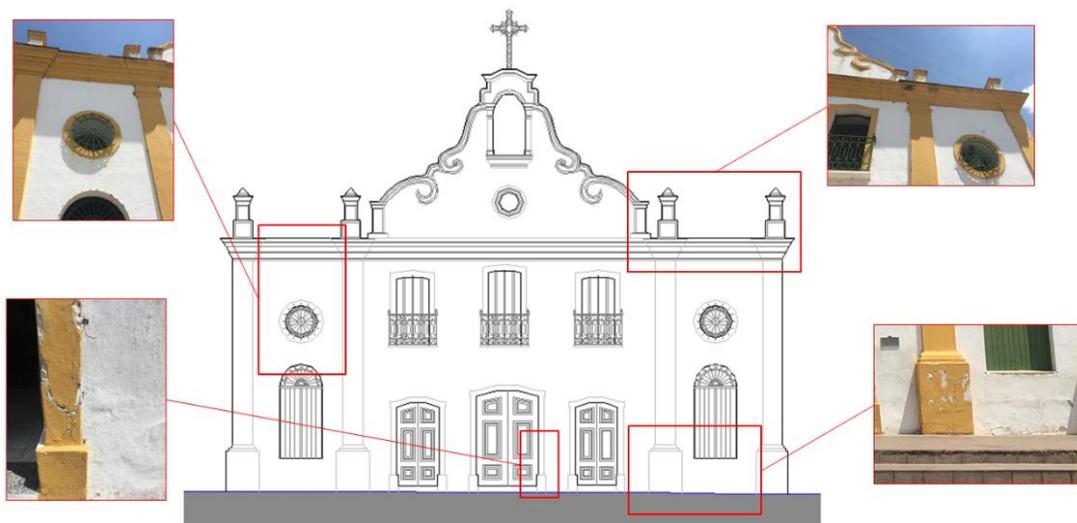
identification of the damage of the structures. Moreover, combining the visual inspection with other control tools, as presented in this work through the GUT Matrix, enriches the results and contributes to their reliability. The inspection of this first church was carried out from the outside to the inside, where firstly the four facades and later the interior were inspected. During inspection the following pathological manifestations were identified: fissures and cracks, disintegration of lining elements, detachment of coating, humidity stains, atmospheric stains, mold/mildew. The main facade presented the biggest number of damages and it is represented by the damage map shown in Figure 4, where detachments are observed in the lower parts of the structure, in the openings and in the central door column some cracks are also visualized, and atmospheric stains can be seen on the top of the church.

The main reason for cracking may be associated with the vibrations existing in the place, because it is located in a central region of the Sobral city and there is a large flow of people and vehicles nearby, that can induce vibrations causing changes in the structure dynamic behavior, which often lead to fissures.

Figure 4. Damage map of the main facade of Nossa Senhora do Rosário Church.

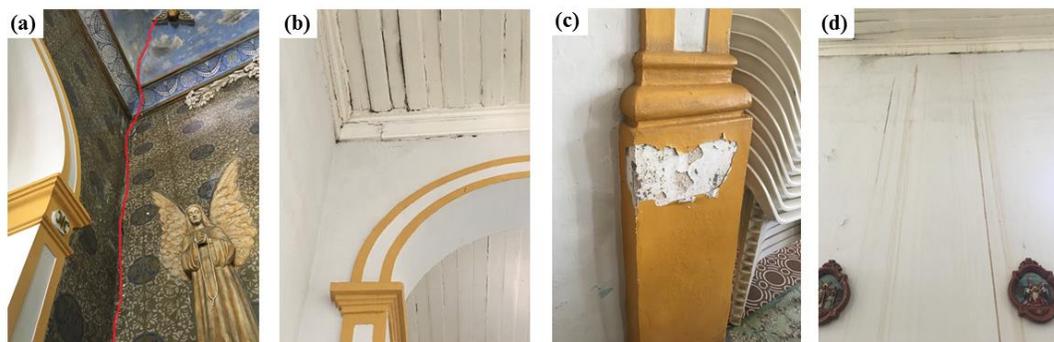
Figure 5. Internal pathological manifestations of the Nossa Senhora do Rosário Church: (a) crack, (b) disintegration of lining elements, (c) detachment and (d) humidity stains.

In the internal part of the church the main, the following pathological manifestations were observed: crack, disintegration of lining elements, detachments and humidity stains, as illustrated by the Figure 5. The most serious situation was the crack located near the altar (Figure 5 (a)), because its presence may be associated with the movements adjacent to the building and new constructions in the vicinity of the sanctuary. These movements occasionally cause sinking of the soil and cracks and fissures in

For the Gravity in the application of the GUT methodology a score 8 was attributed to the crack located near the altar due its large opening. For the Urgency, a score 8 was also inserted due large area of commitment of this damage that requires urgent intervention. Regarding Tendency, a score 6 is attributed knowing that the problem is in a situation of average progression.

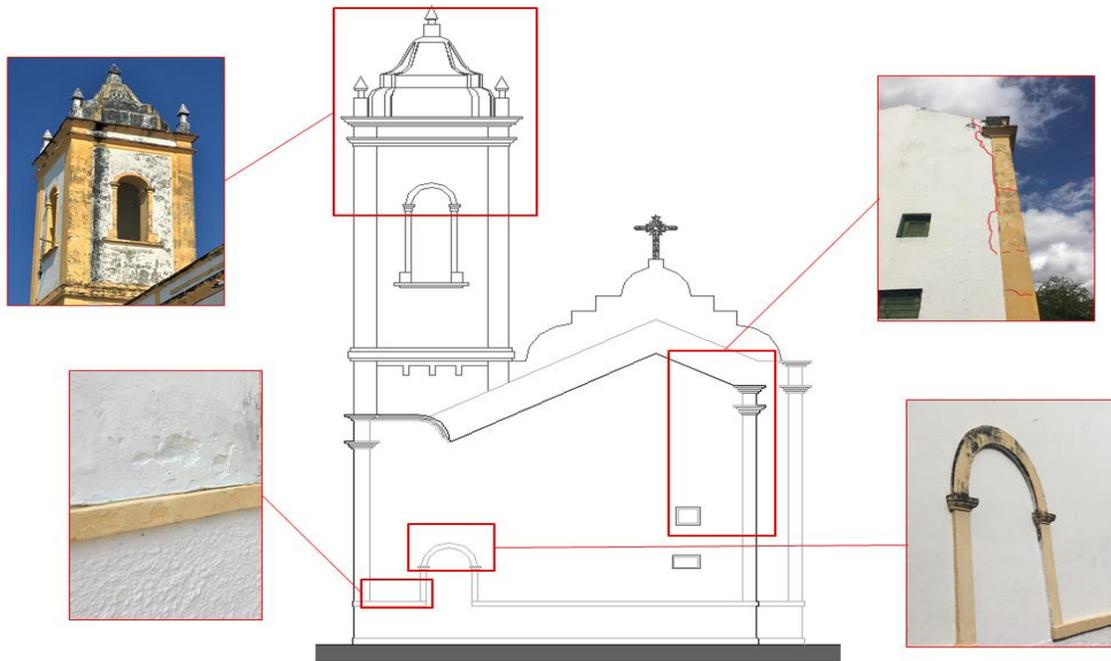
Figure 7. Damage map of the Nossa Senhora das Dores Church.

Figure 7 shows the incidence of a large amount of atmospheric stains in the lateral tower and also in the upper parts of the church. This type of damage was also evident in all other facades. A large crack in the right part of this figure, that starts from the mid height of the wall to the top, was observed. This anomaly is closely linked to a possible sinking of the soil, considering that the structure is located near of the Acaraú River and that over time was impacted by numerous new constructions in the vicinity. Besides this region, in the circular openings of the other facades, this type of damage is also evidenced. There are also detachments of coating in the lower part of this facade, which are also found in the other facades.

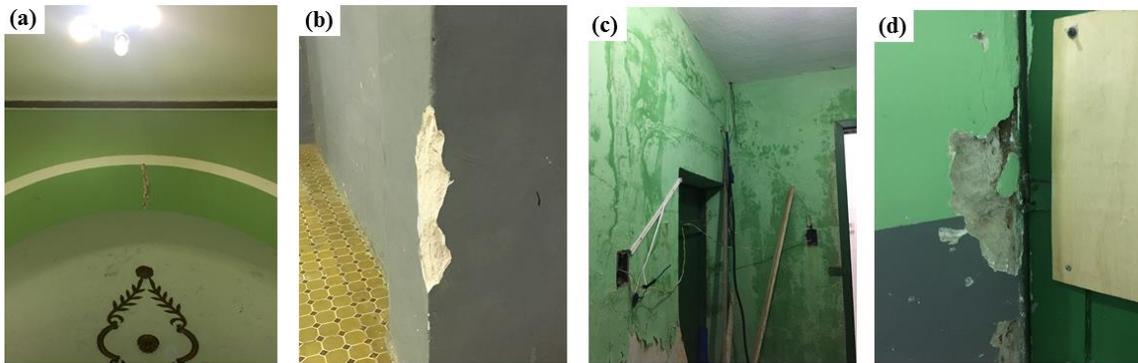
The main pathological manifestations observed in the internal part of the structure were: fissures and cracks, detachment of coating, humidity stains and detachment of coating with exposure of parts of the frame, which are illustrated in Figure 8. In Figure 8 (a), there is the most severe pathological manifestation for this building: a crack located in the central arch of the main nave. This anomaly is in a very aggravated situation, being its occurrence related to the incidence of soil movement of the foundation and to a possible overload in the arch, since many interventions with an increase of load were executed over time, as for example, the exchange of a lining that was previously made of PVC by a slab of reinforced concrete. Thus, to Gravity, a score 10 was attributed, that is, the maximum score of the method here used, which causes a high impairment of the performance of the building. Regarding Urgency, a score 10 was also inserted, due to the large area of commitment of this manifestation, requiring urgent intervention. And for Tendency it was also chosen a score 10, corresponding to the large possibility of evolution of the situation.

Figure 8. Internal pathological manifestations of the Nossa Senhora das Dores Church: (a) crack in the central arch, (b) detachment of coating, (c) humidity stains and (d) detachment of coating with exposure of the frame parts.

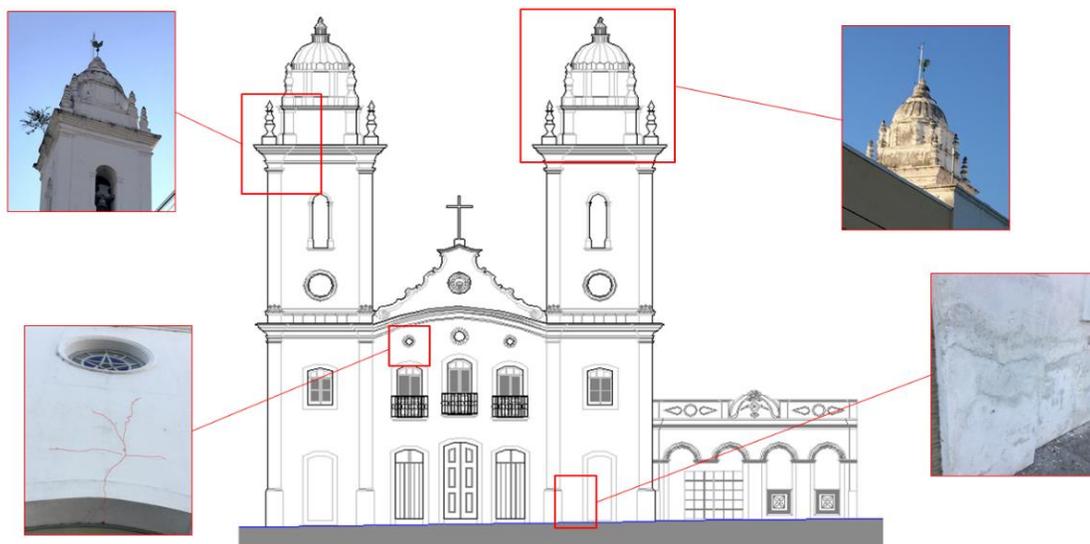
The right lateral facade (connected to the lateral courtyard) and the back facade of the Menino Deus Church were not analyzed because these two facades are linked to the adjacent buildings. However, the other facades as well the internal area were thoroughly inspected, and the main facade presented the most severe damages, which can be observed in Figure 10, where the most evident were: atmospheric stains, located in many regions of the structure mainly on top of the two towers; fissures in the vicinity of circular openings of all doors and windows and in the lower part the columns of a tower, which is accompanied by detachment of coating; and rooting of shrubs, located at the top of the left lateral tower.

Figure 10. Pathological manifestations of the Menino Deus Church.

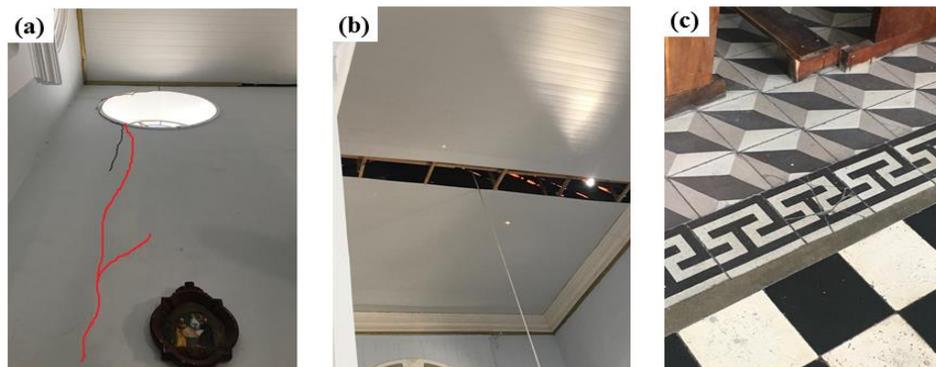
In the internal part of the church the main damages observed were fissures and cracks, disintegration of lining elements and disintegration of floor elements, as shown in Figure 11. Disintegration of lining elements was observed in many parts of the roof, as well as fissures.

Figure 11. Pathological manifestations in the internal part of the Menino Deus Church: (a) Fissures, (b) disintegration of lining elements and (c) disaggregation of floor elements.
