## Diagnostic of damage in a building of the early twentieth century in Havana. Case study

A. H. Oroza<sup>1\*</sup>

This paper aims to discuss the results of the diagnosis made to a reinforced concrete building erected between 1900 and 1906 for the firm Casteleiro & Vizoso (Figure 1). Eclectic style and seven levels high, it was projected so that all levels had 4 m high struts, except for the ground floor with 6.3 m. The building was erected on a steel structure, covered in hydraulic concrete with foundations and reinforced concrete roof. The foundations consisted of support rafts calculated to support an average load of 3 Kg/cm<sup>2</sup>. The concrete prepared to form all the midlevel and stairs was dosed in proportion to 1 volume of cement, 3 of sand and 5 of gravel. The calculation of the accidental load of the floors was estimated for 366 Kg/m<sup>2</sup> and a safety factor of 4 was applied to the metal structure.

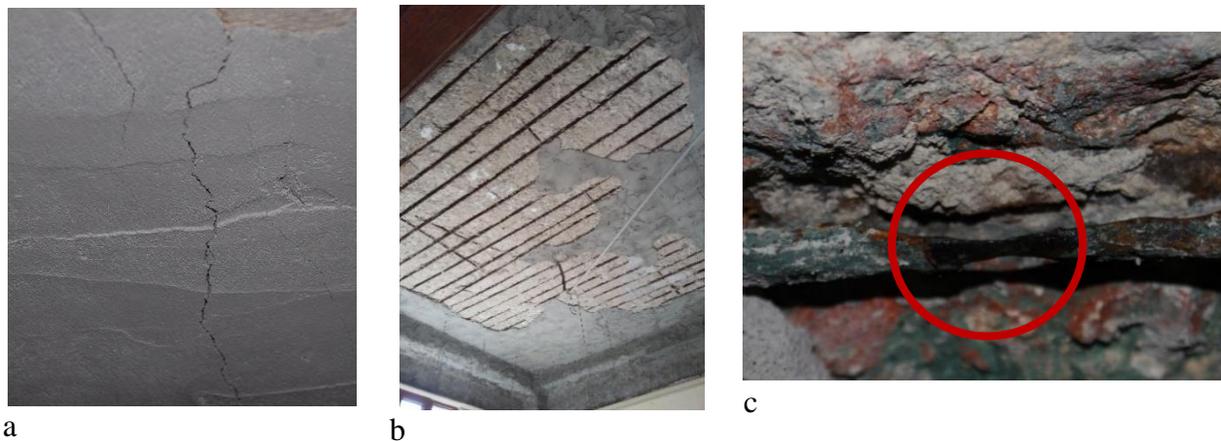
Slabs with loss of concrete coating, exposed steels and longitudinal cracks in the direction of reinforcement bars were identified (Figure 2a). The roof slab of the seventh level, in addition to

On the ceiling of all the apartments it was observed that the slabs had been previously repaired. The material used for the restoration was a cement-based structural mortar. During the inspection it was possible to verify that in these previous repairs, the original slab thickness was never recovered. Also, no anticorrosive treatment was applied to the reinforcing steel bars and as a consequence, most of the applied restoration mortar already showed cracks, slapping and loosening in various areas (Figure 2b)

The most affected spaces were those destined for cooking and bathing due to the steam generated by to the use of hot water. The reinforcement steels in the slabs of these areas had severe atmospheric corrosion effects. Some of the existing bars were found fractured or with a very advanced localized section loss (Figure 2c), jeopardizing the structural stability of the element due to possible flexural failure. The measured carbonation depth ranged between 5-6 cm, with a calculated  $K_{CO_2}$  of 5.2 mm/year. The coating thicknesses ( $e_c$ ) were within 1-2 cm.

Figure 2. Damages identified in the roof slabs. a) Longitudinal cracks in the direction of the steel bars resulting from corrosion. b) Loss of repair mortar on the ceiling slabs in large areas of the living room. c) Localized corrosion at reinforcement bar

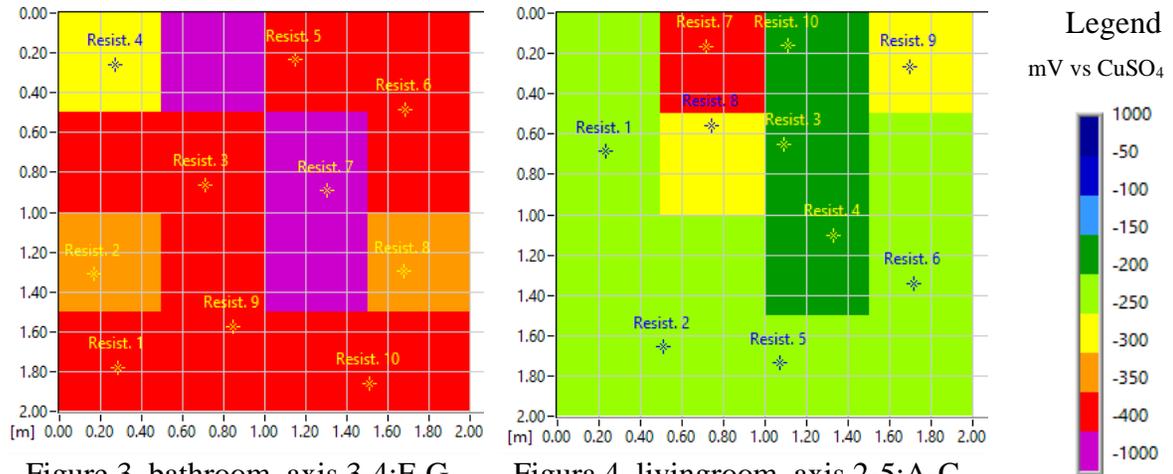
The results between both techniques demonstrate that there is a correspondence between the values of  $E_{corr}$  and  $\rho$ . In areas with hot water use, the diffusion of oxygen is increased, as well as its availability at the level of reinforcements. In reinforced concrete elements where there is no primary protection due to the advance of carbonation and the presence of chloride salts, the established corrosion rate ( $i_{corr}$ ) becomes the main parameter that determines the reason for deterioration of the structure. In the drier areas, more positive  $E_{corr}$  values are recorded with resistivity levels greater than 80  $K\Omega$ -cm.

Figure 3. bathroom, axis 3-4:F-G

Figura 4. livingroom, axis 2-5:A-C

Figure 3 and figure 4. Mapping of Ecorr on the reinforced concrete slabs of the third level

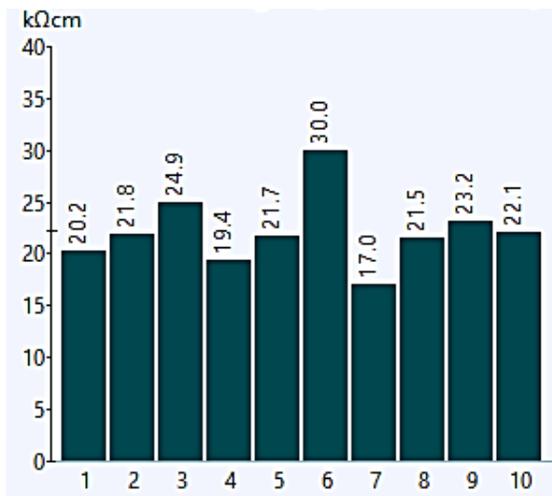
Figure 5. bathroom, axis 3-4:F-G

Figure 5 and figure 6. Results of the apparent resistivity on the reinforced concrete slabs of the third level

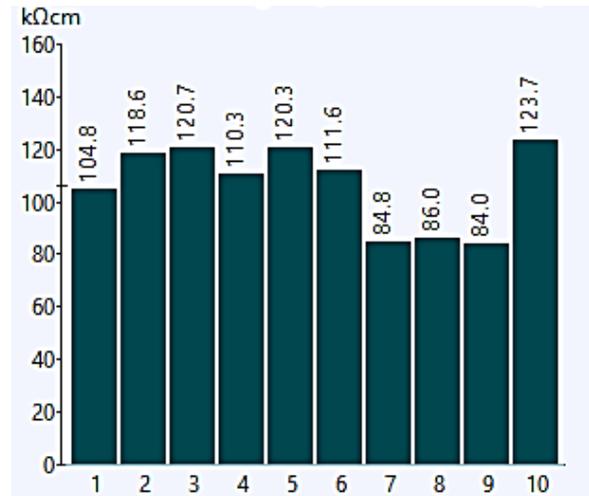
Figure 6. livingroom, axis 2-5:A-C

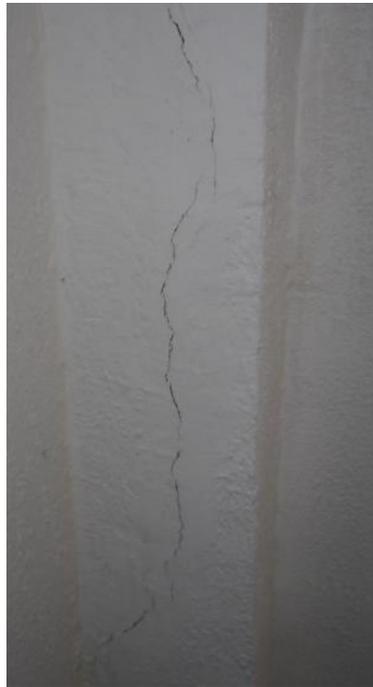
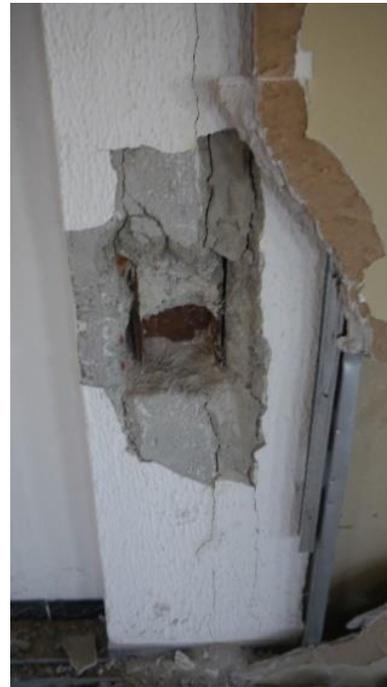
The visual inspection was carried out in the columns located in the last, penultimate and intermediate corridor. For the construction of the columns, I-sections and  $\varnothing 16$  steel bars were used interchangeably. It was identified that the vast majority of these had been previously intervened and still have a state of deterioration marked mainly by longitudinal cracks (Figures 8 and 9), as a consequence of the corrosion of the reinforcements. In general, both the I-sections and the bars that make up the columns showed a high level of corrosion with loss of section.

Figure 8 and figure 9. Current deterioration state of columns.

In the particular case of the second level, a high degree of corrosion with loss of section in the different reinforcements of the columns was widely observed. All the elements studied are made up of type I profiles. The coves were made in the columns indicated in Figure 10. Next, in table 5 the numbers of the coves made, and the measured wing thicknesses are presented.

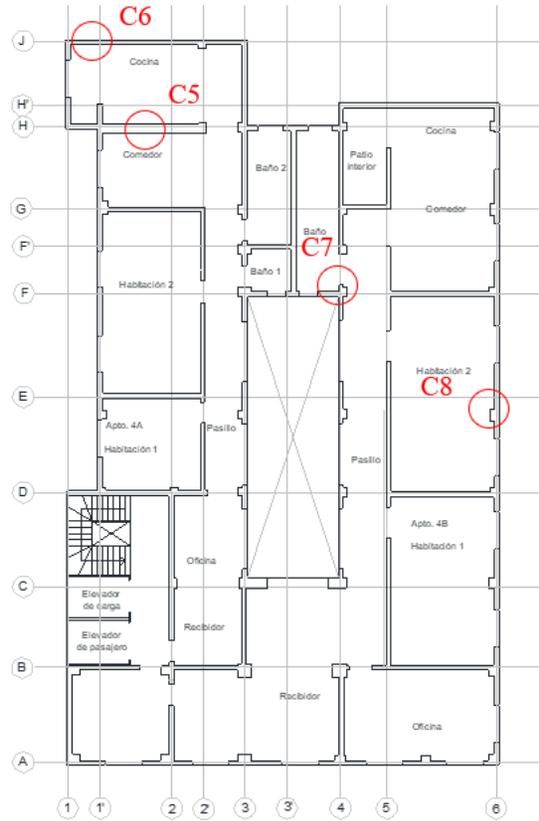
In the case of cove C1, the profile is accompanied by a ladder type reinforcement with 10 mm diameter bars that also presents corrosion. In the fifth level, when executing the coves (Figure 11) it was observed that the reinforcement of the column corresponding to the C6 is an ordinary steel reinforcement that still retains its metallic gray color. In coves C5, C7 and C8, corrosion was observed with loss of section in reinforcements consisting of type I-sections.

Figure 11. Cove's location at the 5th level
