## Electrical Resistivity Tomography for the detection of subsurface cavities and related hazards caused by underground coal mining in Coahuila

José A. Batista Rodríguez\*, Marco A. Pérez Flores, Yuri Almaguer Carmenates and Maximiliano Bautista Hernández

## Abstract

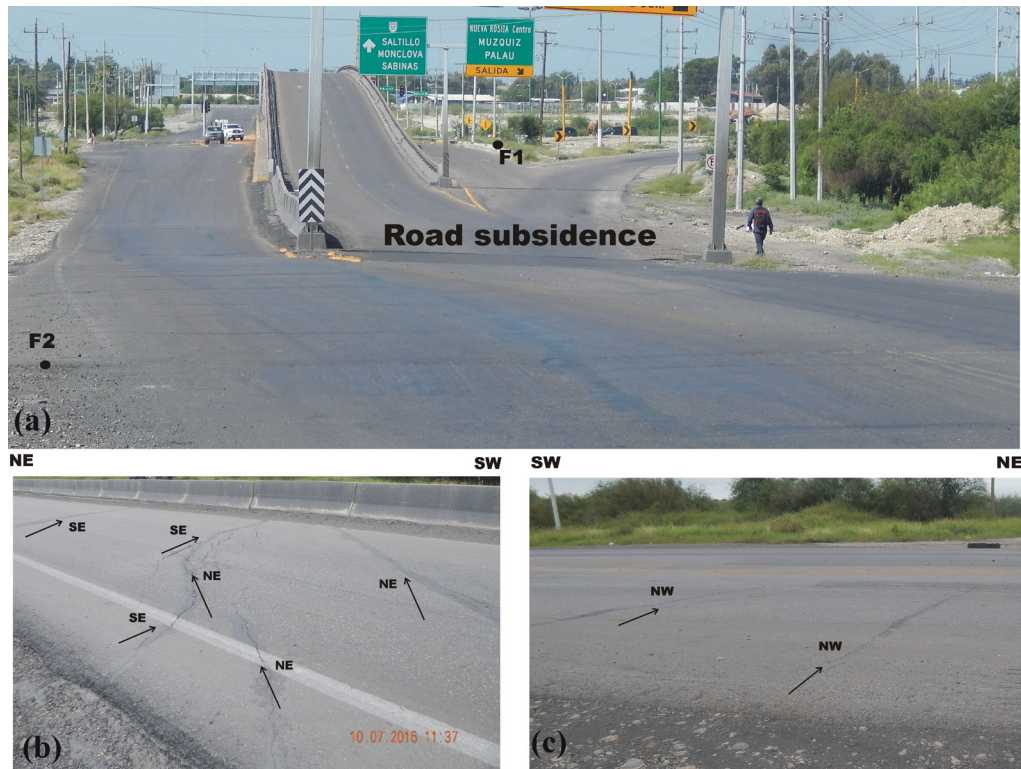
This sector contains both a road and a bridge support (Figure 5), with subsidence found on the road at the northeast end (Figure 9a), which could be related to the underground coal mining (Peng, 2008) due the shallower mining activities in this sector and its surroundings.

The northeastern end of Profile 2 covers the area of the road where subsidence is found (Figure 9a). Two possible cavities are identified with the ERT below the road, at 13 m depth, with both structures presenting different electrical resistivity, size and depth (Figure 10). It can be inferred from the resistivity image that the first cavity is smaller, larger resistivity and partially empty or filled with dry sediments. The second cavity is larger, lower resistivity and filled with either water or water-saturated sediments (Van Schoor, 2002; Zhou *et al.*, 2002; Martínez-López *et al.*, 2007; Putiska *et al.*, 2012).

Above these cavities, around 7 m depth, a small size aquifer is located within the Sabinas Conglomerates (CONAGUA, 2015). Above the area that covers both cavities, the road is highly fractured, with some fractures cutting across the entire road (Figures 9b and 9c). The electrical tomography suggests that some of these fractures penetrate into the subsoil, mainly in the area of the second cavity (see the inferred fracture in Figure 10).

Four small cavities are found in the SW end of Profile 2 (Figure 10), located next to the bridge (Figure 5) with subsidence on the road (Figure 9). Two cavities have very low resistivity, while the other two are more resistive, smaller and shallower (approximately 7 m). The cavity found at the center of the profile is clearly the cause of fracturing on the road surface. Moreover, in this zone, the ERT results show at patterns that suggest subsidence, namely, zones of low resistivity (represented by the light gray color) with a convex form (Figure 10).

**Figure 9.** Sector 1. a) Image showing the subsidence of the road. b) and c) Image showing fractures on the road surface in profile P2. Arrows indicate location and direction of the fractures. Reference points for the photographs shown in b) and c) are indicated as F1 and F2 in Figure 2, respectively. F1 and F2 also are indicated in Figure 9a.

These results suggest that special attention should be paid to both of these areas and to activate a system for monitoring the roads and the bridge integrity in order to avoid damage due the gradual or sudden land collapse.

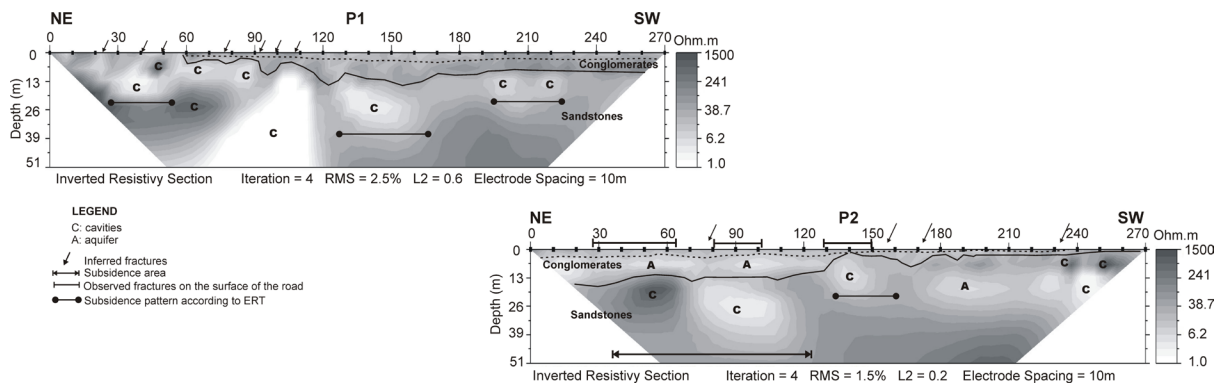
Profile 1 also shows several cavities from a depth of 7 m onwards, most of which present low values of resistivity and are small in size. Above these cavities water table of about 5 m inside the conglomerates is located. According to the ERT, the geometry of these structures shows patterns of probable subsidence, although no visible deformations are observed on the surface of the roads. These patterns were found in the ERT results for zones with low resistivity and convex shapes with respect to the surface (Figure 10). These zones resemble the characteristic descent into a small basin which is caused by the accumulation of sediments. Towards the northeast of the profile, a large cavity with very low resistivity was observed, extending from a depth of 10 to 50 m ( $x=110$  m). Above this cavity, the road presented no subsidence; however, the ERT showed that it is so close to surface that we expect possible fracturing on surface. We found, in some buildings adjacent to the road fractured walls. All fracture systems observed on the road are perpendicular and oblique to the highway (Figures 9b and 9c), following the probable galleries direction (Peng, 2008). The fracture systems follow three different directions: perpendicular to the road on a NW-SE direction; oblique on a NE-SW direction; and, a NW-SE direction.

**Figure 10.** ERT of Sector 1 (profiles P1 and P2). The section of P2 from 170 to 270 m is located next to the bridge. Continuous curved lines indicate boundaries between rocks and discontinuous curved lines indicate water table. The profiles are located graphically according to their position in the field (see Figure 5).

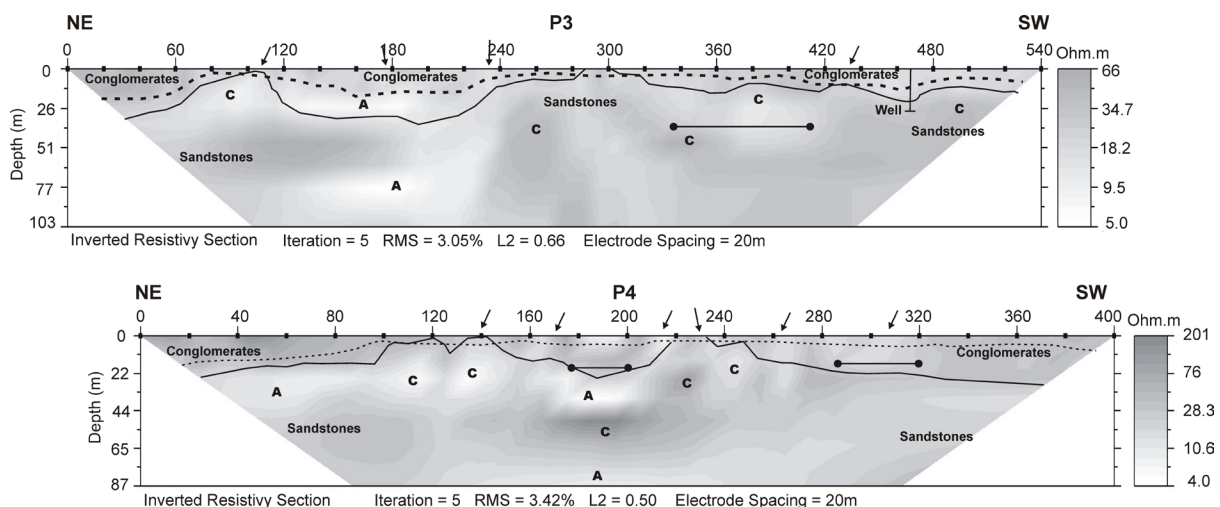
The bridge support is found at the southwest end of the sector, where profiles 3 and 4 were measured (Figure 5) as having lengths of 540 m and 400 m, respectively and their resistivity models are shown in Figure 11. In this zone, the road presented no subsidence and no fractures; however, the ERT results indicate cavities patterns by underground mining activity. These patterns are circular and oval

shape and they are located at two depth levels (approximately 22 m and 50 m). Some of these cavities were observed at both sidewalks, indicating that they are connected and cross under the road. All cavities identified are low resistivity (represented by the light gray color). Values lower than 10 ohm-m suggests that the cavity is water-filled (Van Schoor, 2002; Zhou *et al.*, 2002; Martínez-López *et al.*, 2007;).

Putiska *et al.*, 2012). This water is provided by the aquifers located in conglomerates and the upper level of the Olmos Fm. (Figure 11). The water table was determined with using a well located in the profile P3 ( $x=465$  m) with a water table at 12 m. Their variations are established using resistivity values. Cavities with a resistivity between 30 and 200 ohm-m may be filled with sediments slightly saturated with water (represented by the light gray color; Van Schoor, 2002; Zhou *et al.*, 2002; Martínez-López *et al.*, 2007; Putiska *et al.*, 2012), probably due to cavity collapse. It is possible that some faults or fractures infiltrated water inside the cavities as a first stage and the absence of water as a second stage could cause the collapse itself.

The larger cavities (30 m wide and 25 to 35 m high) identified at a depth larger than 30 m, do not produce visible road deformation; however, this is not a general rule. Some of the zones with probable land subsidence ( $x=360$  m in P3 and  $x=180$  in P4) are related to cavities deeper than the mentioned depth.

It should be noted that, most of the cavities identified are located on both sides of the bridge support. The bridge support itself is located in an area with a large hazard level.

**Figure 11.** ERT of Sector 1 (P3 and P4). The profiles are located graphically according to their position in the field (see Figure 5). Continuous curved lines indicate boundaries between rocks and discontinuous curved lines indicate water table. The section of P3 from 0 to 280 m and the section of P4 from 0 to 230 m are located next to the bridge. Vertical line indicate well.

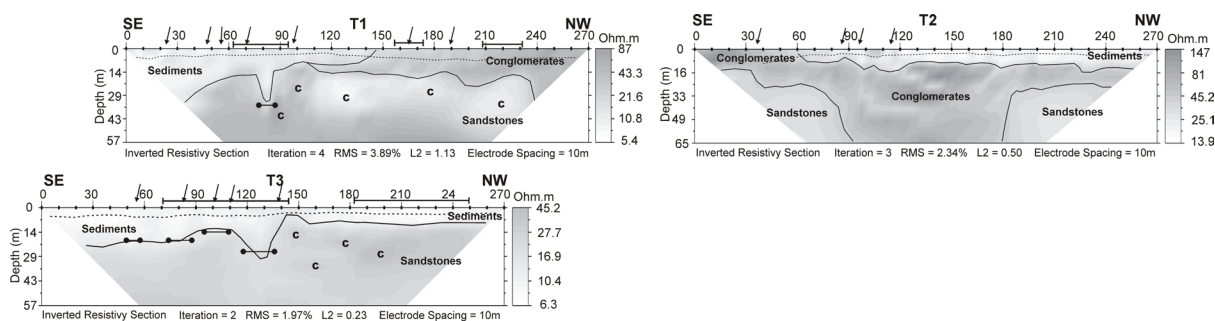
Sediments with a very low resistivity outcrop at the SE end of T1 and they extend to depths larger than 35 m (Figure 12). Electrical resistivity values suggest that these sediments are water saturated, in which the water table oscillates around 5 m, deepening to the NW of the profile T1, according to the resistivity values. Towards the SW end of the profile, conglomerates outcrop and extending to 14 m depth. Several cavities, beginning at a depth of 14 m, are identified in the sandstones underlying the sediments and conglomerates, all of which recorded low resistivity values (Figure 12), indicating that these structures are probably filled with water or water-saturated sediments.

This study identified several fracture systems on the road above the identified cavities (Figure 12), with most of these fractures running perpendicular to the road (Figures

**Figure 12.** ERT of Sector 2. The profiles are located graphically according to their position in the field (see Figure 6). Continuous curved lines indicate boundaries between rocks and discontinuous curved lines indicate water table.

13a and 13b). The ERT models also present patterns that suggest deep extended fracture systems related to the cavities. Similarly, the ERT model for T1 shows a pattern of probable subsidence with low resistivity (represented by the light gray color) and a convex form, while on the road increases the density of fractures and decreases the spacing between them.

Sediments and conglomerates outcrop in the T1 and T2 models (Figure 12), while ten meters depth, conglomerates cover almost the entire Profile 2 (T2) and raise a thickness of 50 m at the center. No cavities in the central part are identified in the ERT model. This explains why no fractures were found on the road.

Profile 3 (T3) is located on the opposite sidewalk (Figure 12). Only sediments outcrop in Profile 3 and the cavities identified in Profile 1 also appear, suggesting that they are located below the road.

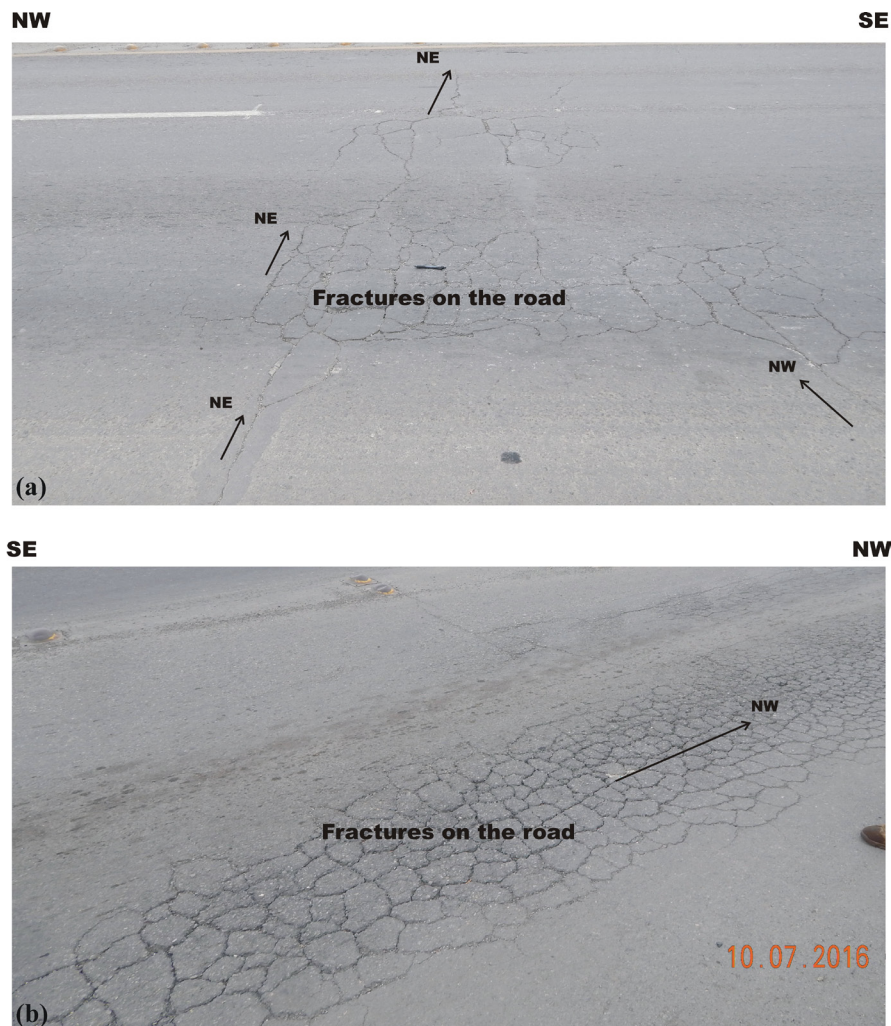
More road fractures were found on the east side than on the west (Figure 13b), which may be related to the outcrop of less competent materials (sediments) on the east side.

**Figure 13.** Images of fractures with signs of subsidence on the road surface in Sector 2. a) Profile T1. b) Profile T3. Arrows indicate location and direction of the fractures. Reference points for the photographs shown in a) and b) are indicated as F1 and F2 in Figure 6, respectively.

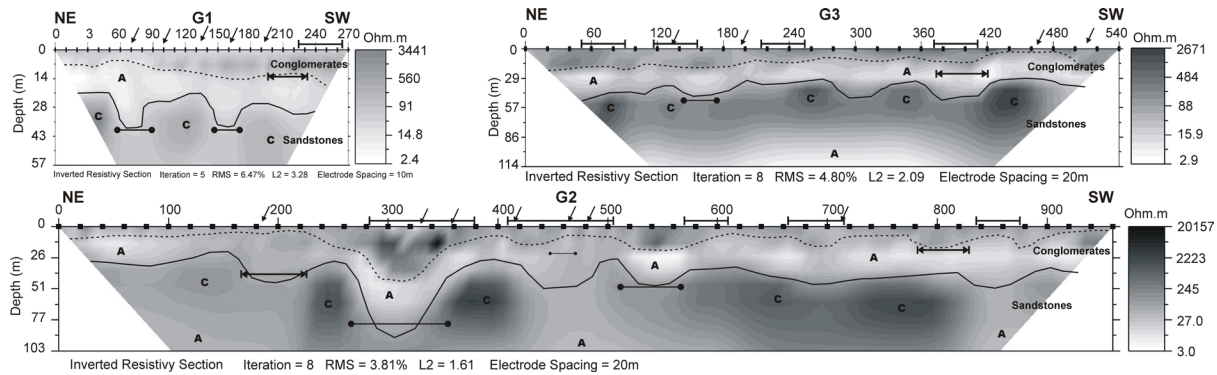
data continuity and, therefore, a 960 m-long continuous resistivity model. Several cavities were also identified in these profiles, most of them larger and deeper than those identified in the previously described sectors (Figure 15). Generally, cavities were identified at a depth of 30 m and reached up to 50 m in diameter.

Conglomerates outcrop the profiles measured in this study, while the ERT results reveal an aquifer (CONAGUA, 2015) attached to the sandstone contact. This aquifer is thicker and wider in lateral extension than those identified in the previous sectors (sectors 1 and 2). Resistivity values indicate that this aquifer has a very variable water table that can exceed 15 of static level reported by CONAGUA (2015). The results of this study permit the inference that cavities can be found at a depth of below 28 m.

Figure 15 shows that, generally, the aquifer level becomes deeper in the zones between the cavities ( $x=60$  m,  $x=150$  m and  $x=200$  m in G1;  $x=200$  m,  $x=290$  m and  $x=440$  m in G2; and,  $x=300$  m in G3). Two of these zones are located just below the subsidence observed on the road (Figure 14a). One zone is located at the SW of G1 and another at around  $x=200$  m in G2, while a third is found at around  $x=800$  m at the SW end of G2 and at 380 m in G3 (Figure 15). In all the zones located between the cavities identified in this study, a high number of fractures were observed on the road (Figures 14b and 15).

Within the sandstones, another aquifer was found at a depth of 100 m below the cavities (Figure 15), in some areas connected to the upper aquifer located at  $x=200$  m,  $x=460$  m, and  $x=860$  m in G2. This finding concurs with the CONAGUA (2015) results, which indicate the connection, through fractures, between the shallow and deep aquifers. These ERT

Most of the cavities identified in this study present high values of electrical resistivity, indicating that they are not water-filled and, instead air-filled or partially filled with sedimentary materials (Martínez-López *et al.*, 2007; Putiska *et al.*, 2012). These materials may be associated with the ceiling collapses that have occurred in the mining structures.

**Figure 15.** ERT of Sector 3. The profiles are located graphically according to their position in the field (see Figure 7). Continuous curved lines indicate boundaries between rocks and discontinuous curved lines indicate water table.
