Recommendations for rehabilitation and corrosion protection of a 100-year-old steel bridge (Durgadee) across heavily polluted river near Mumbai, India

S. S. Bhonge¹, P. Dalwi², J. K. Kulkarni³, S. K. Manjrekar⁴ *Contact author: bhongess@gmail.com

DOI: http://dx.doi.org/10.21041/ra.v10i2.476

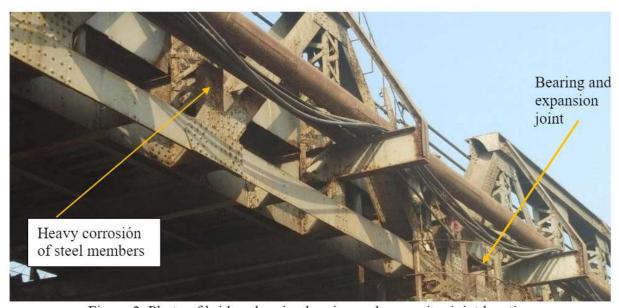
- Bridge consist of 10 spans of 36m each having total length of 360m with through truss
 arrangement Superstructure and Decking arrangement: There is a continuous flooring
 system of Jack arch over the stringer beam for all 10 numbers of spans. Signs of upheaval of
 BT layer shows that there is immediate need of replacement. The expansion joints of the bridge
 are completely damaged and blocked.

Figure 2. Photo of bridge showing bearing and expansion joint location

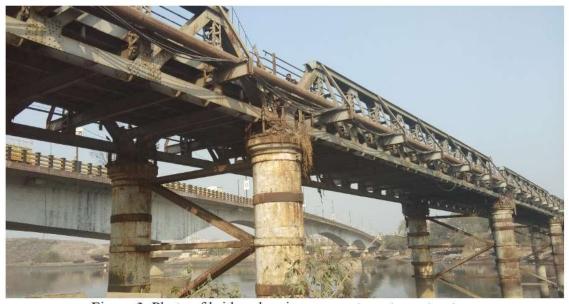
Figure 3. Photo of bridge showing warren truss type structure.

Figure 3 is a photo of the bridge showing the warren truss type structure. The work of repairing built-up steel girders by restoring or replacing damaged or deteriorated elements include, but is not limited to, providing temporary supports for jacking; modifying girders to accept jacking loads; temporarily supporting or reducing loads carried by girders; disconnecting or removing elements from girders by removing bolts or rivets; drilling and reaming holes; grinding to provide required finish or tolerances on steel surfaces; making minor repairs to decks within the work area; erecting repaired or replaced elements and incidental items by welding or high tensile strength bolting; and preparing surfaces damaged or left bare by the work and applying a prime coat of paint.

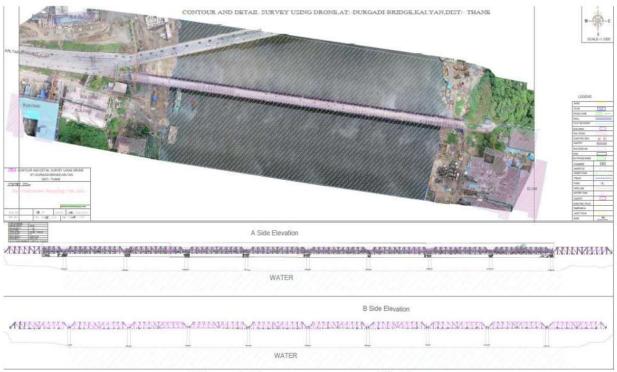
Manufacturing defects as well as design flaws can sometimes be noticed through a drone tour as illustrated in figure 4.

Figure 4. Drone survey map of bridge
