## Effects of the extremely aggressive atmosphere on structures and equipment of offshore platforms undergoing decommissioning.

L. S. Araujo<sup>1\*</sup>

, E. C. Mounzer<sup>1</sup>

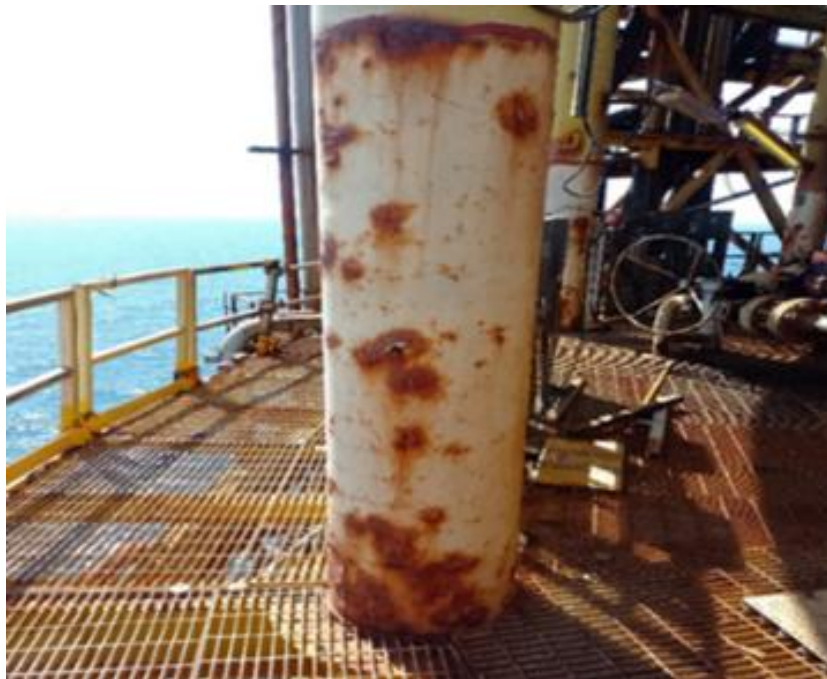
In honeycomb corrosion (Figure 3), the surface is characterized by the formation of cavities with small diameters and great depths, which can lead to holes in the part (Ballesteros et al., 2009).

Figure 3. Alveolar corrosion.

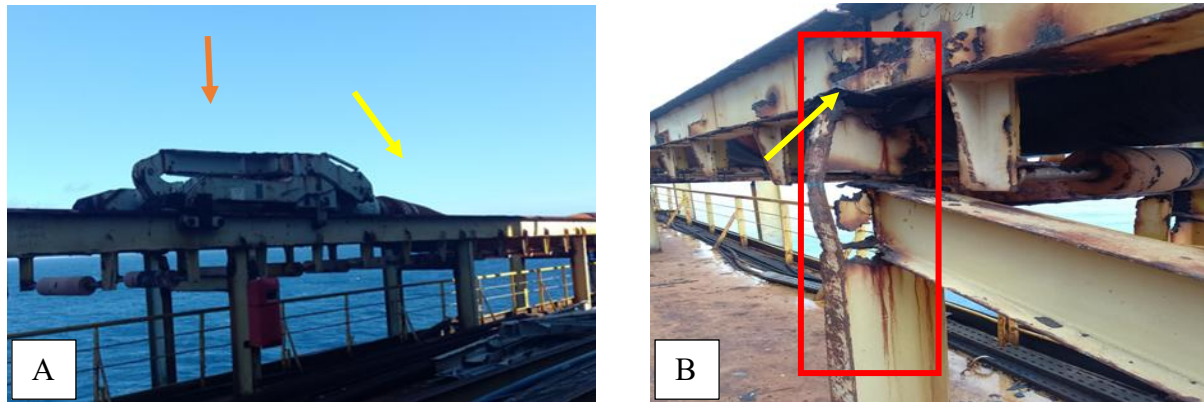
Closing the topic on deformations, Figure 9 shows the conveyor belt of an offloading line, responsible for its accommodation and transfer, loaded with its own weight, the weight of the trolley (A1, orange arrow) and the weight of the offloading hose, indicated by the yellow arrows at ‘A’ and ‘B’. The structure shows signs of corrosion along its entire length, with the section indicated at B showing the most severe damage. This is because the concentrated load, together

with the loss of mass due to excessive proximity to the support region, favoured the phenomenon of crippling of the structure, which can be interpreted as a localised failure caused by the ‘crushing’ of the web.

Figure 9. Crippling in the conveyor belt column of an offloading line.

In this case, the decommissioning of the offshore unit is in the stage of cleaning, inspection and repair of the cargo tanks, when necessary. In view of this, offloading operations have been suspended. Therefore, considering the reduction in available manpower and the expectations for removal of the platform from the location, it is recommended to remove the offloading hose, conveyor rollers and trolley, in order to reduce the load on the structure. As for the clipping of the structure, the section of the conveyor belt from the downstream column to the upstream column can be removed, considering the failed column as a reference, reducing the consumption of man-hours worked for the planning and execution of the activity.
