Adaptation of a damage map to historical buildings with pathological problems: Case study at the Church of Carmo in Olinda, Pernambuco

In view of the above, this article is the result of a Master's research project in progress and presents the processes of drawing a damage map based on the methodologies adopted by IPHAN, seeking to implement them in a real case study on the façades of the Carmo Church in the municipality of Olinda, PE.

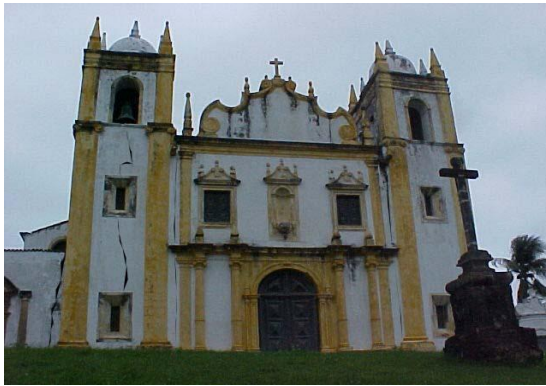
Figure 3. Structural damage to the Carmo Church in the year 2000. Source: Public Collection of Olinda.

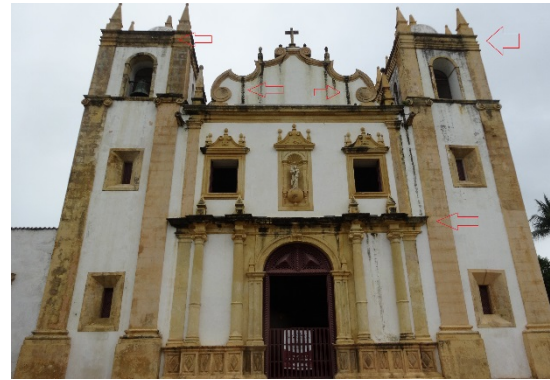
the Church was returned to the population. However, only 4 years following the restoration work, some anomalies in the façades can be observed.

Figure 4. Current damages to the Carmo Church. Source: Authors.

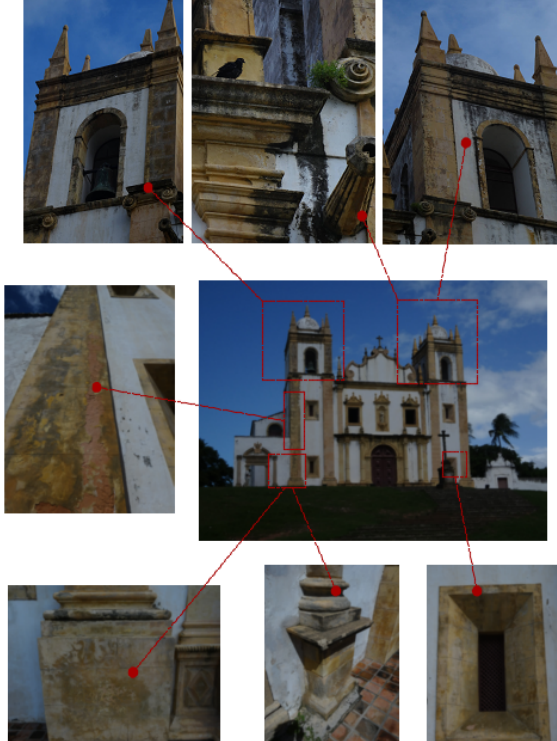
The investigations carried out affirm that the most commonly observed pathological problems in the façades of the Carmo Church were: dirt, vegetation, cracks, and humidity, with recurrences of black crust also being found in the east, west, and north façades. During the inspections, pieces of reinforced concrete with highly corroded steel reinforcement were also found, as well as a rotted wooden door in the north facade. In the following figures, the identification cards for the principal pathological manifestations are presented succinctly.

Figure 6. Damage identification form for the north façade of the Carmo Church. Source: Authors.

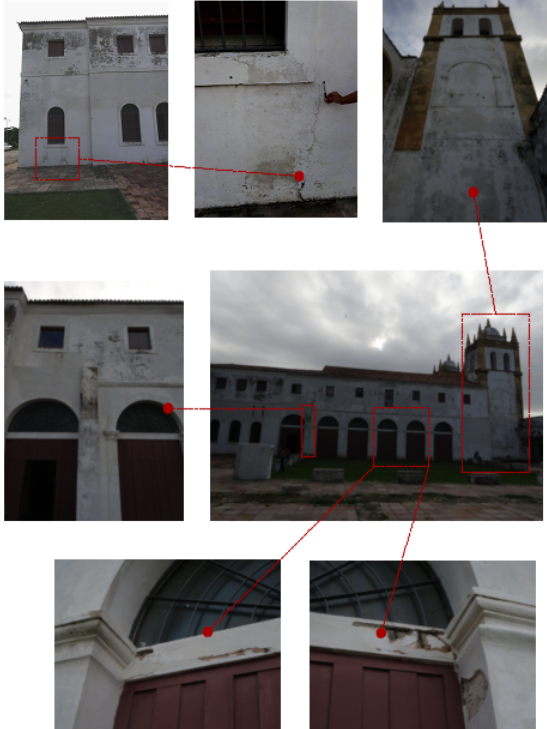
Figure 7 shows the identification form for the east façade, where it was observed that the pathological problems most frequently found were wet stains, dirt, cracks in the plaster, vegetation, and corrosion of reinforcements.

Figure 7. Damage identification form for the east façade of the Carmo Church. Source: Authors.

The use of reinforced concrete, demonstrated by the presence of reinforcement corrosion, indicates an intervention in the structure with the use of construction technologies that did not exist at the time of the original construction of the church. Therefore, the treatment of this pathological manifestation should be done as soon as possible, and in a way that does not interfere with safety, while preserving the architectural features of the façade.

It is important to note that the east façade of the building has a higher incidence of saline mist. The Carmo Church is located in a coastal area, so structures made with reinforced concrete are subject to the degenerative action of chlorides and the cycles of wetting and drying produced by the rains.

In this sense, the correction of the corroded points found during the east façade inspection must be performed as quickly as possible, in order to avoid the loss of steel sections, the breaking of steps, or the displacement of larger areas.

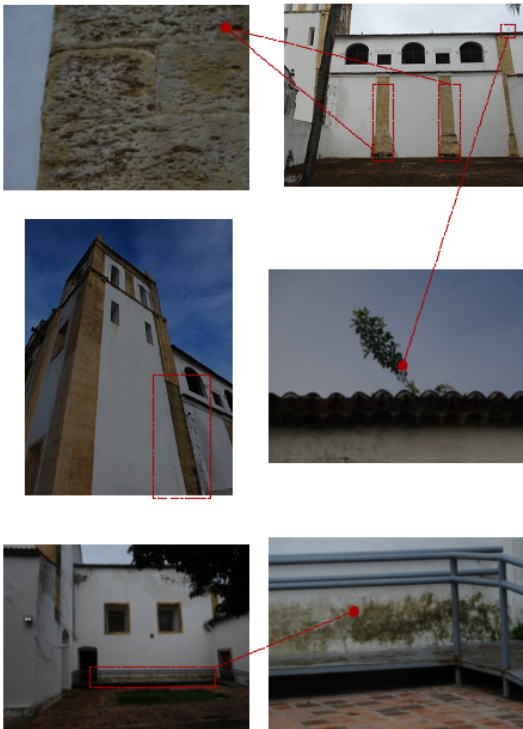
Figure 9 shows the damage identification form for the west façade. The anomalies found were similar to the other façades; however, this façade had more damage to its masonry structures, which presented granular disintegration, pitting, and section losses (gaps).

The DIF for the west façade (Figure 9) also showed that the water penetration process capillarity action in the soil was intensified by the construction of a metallic ramp that causes water to splash onto the façade when it rains. This explains the development of mold and slime at this location.

Figure 9. Damage identification form for the west façade of the Carmo Church. Source: Authors.

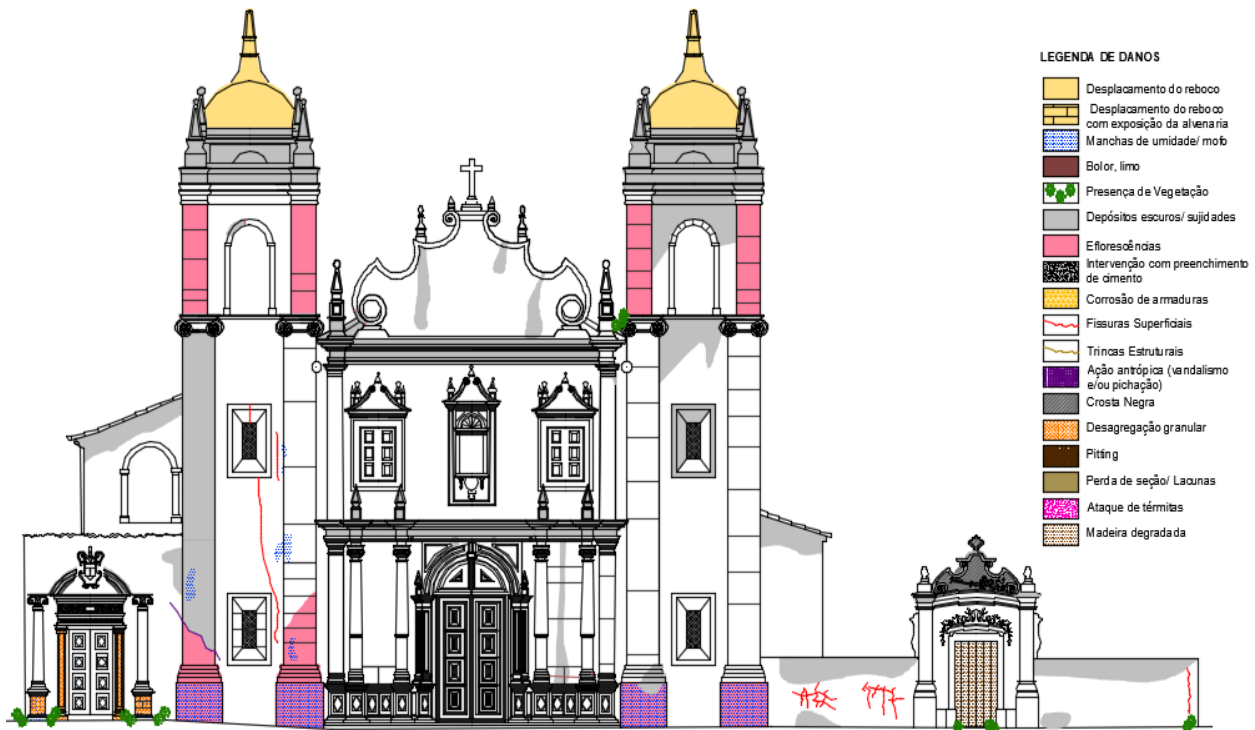
Figure 10. Damage Map of the North Façade of the Carmo Church. Source: Authors.

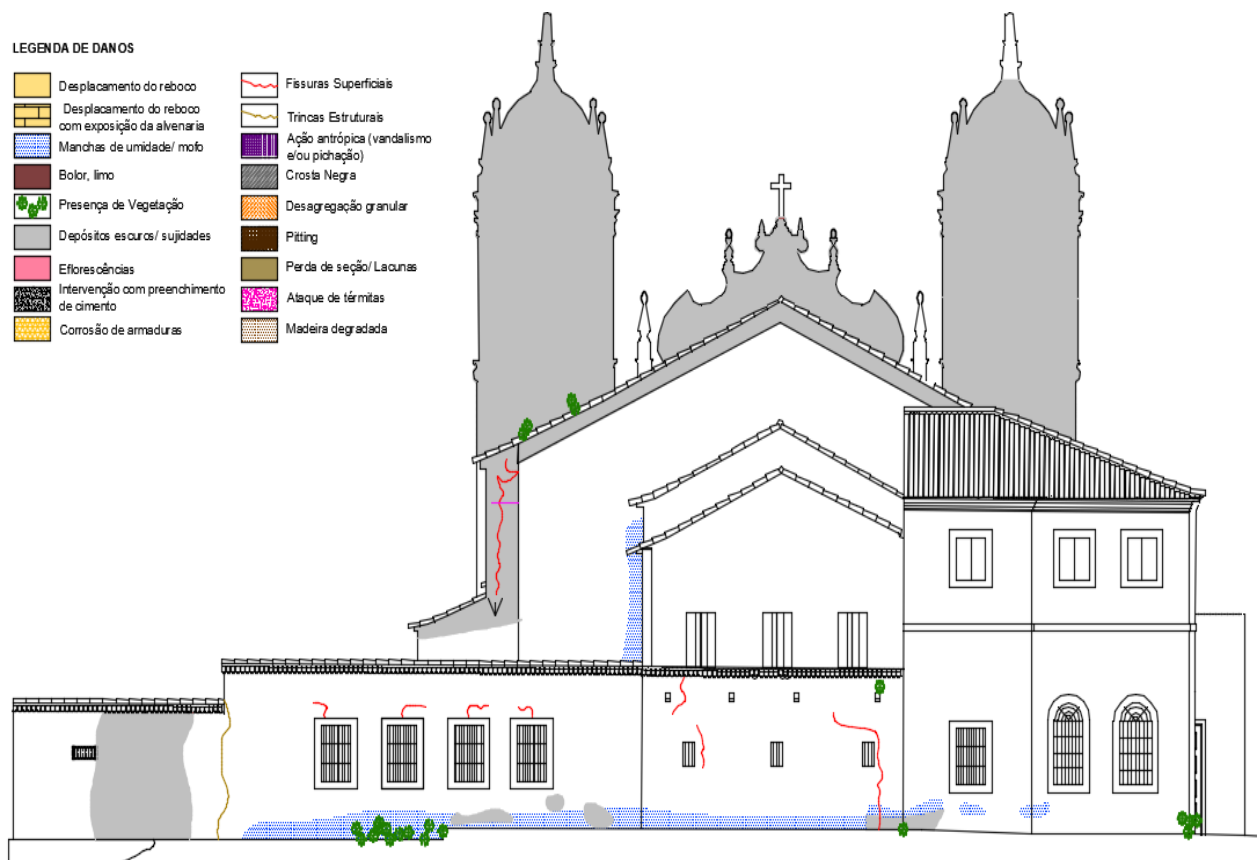
On the southern façade, damp spots with accumulations of dirt were also observed, including ascending moisture stains along the entire length of the façade (see Figure 8).

Some alterations to the initial design of the building were also verified, including former doorways that have been sealed and windows that have been reduced in size. No information was found about these interventions, making it difficult to identify the material that was used to seal these elements.

It is believed that the material used was probably something with high porosity and high permeability, since moisture spots can be observed in the areas where these changes were made.

Another point identified was the appearance of a vertical crack with a gap ranging from 0.5 to 2 mm near the deposit wall (south façade). Because the Carmo Church has a history of structural problems resulting from settling, having undergone foundation reinforcement in 2001, treatment of this problem will require monitoring of the fissure in order to identify its origin.

Figure 11. Damage Map of the South Façade of the Carmo Church. Source: Authors.

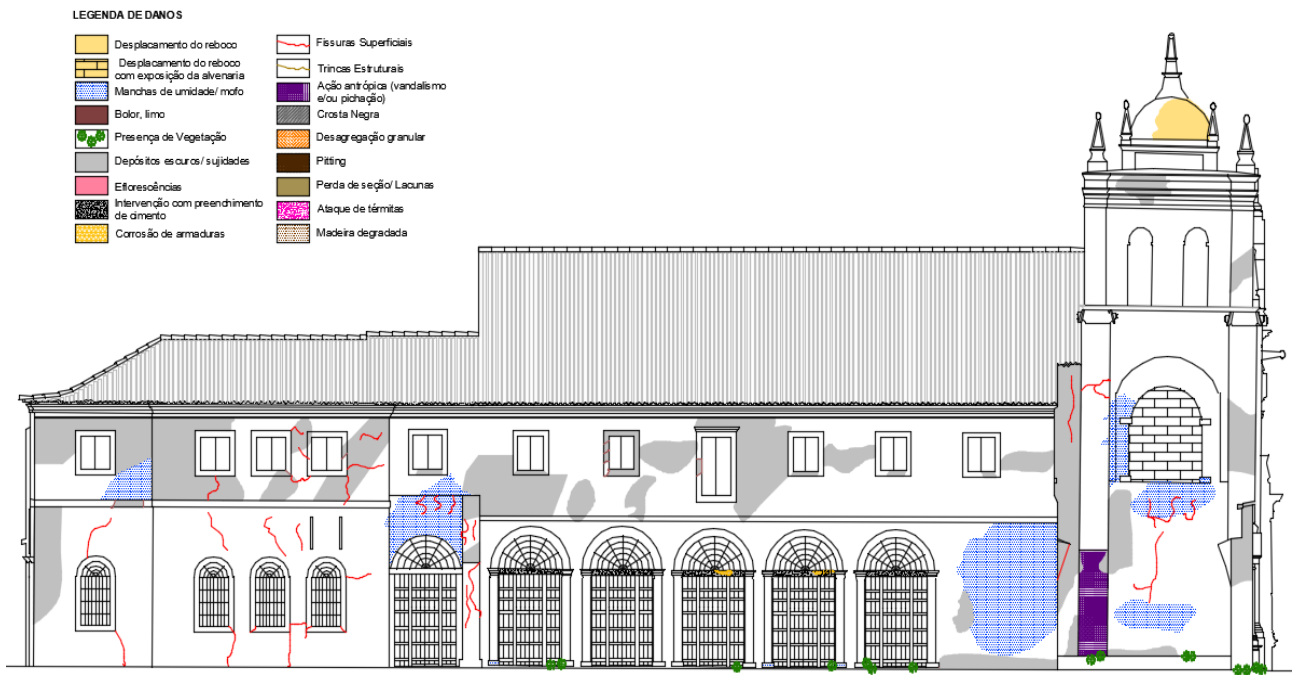
Figure 12. Damage Map of the East Façade of the Carmo Church. Source: Authors.

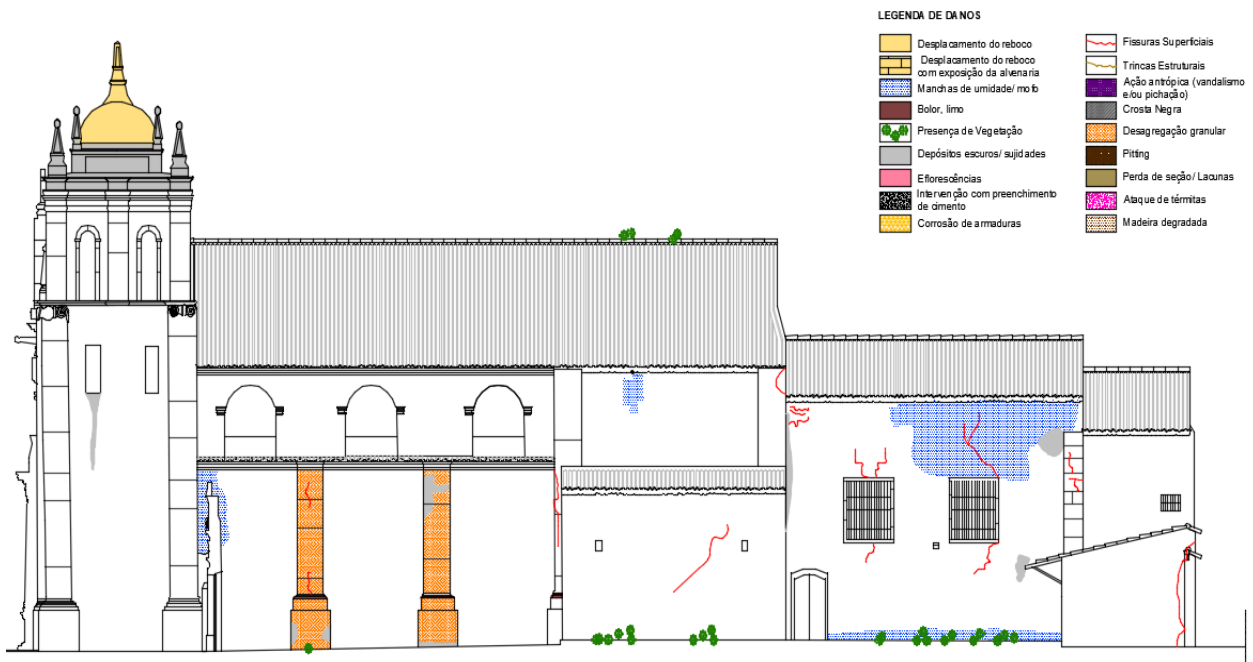
Figure 13. Damage Map of the West Façade of the Carmo Church. Source: Authors.
