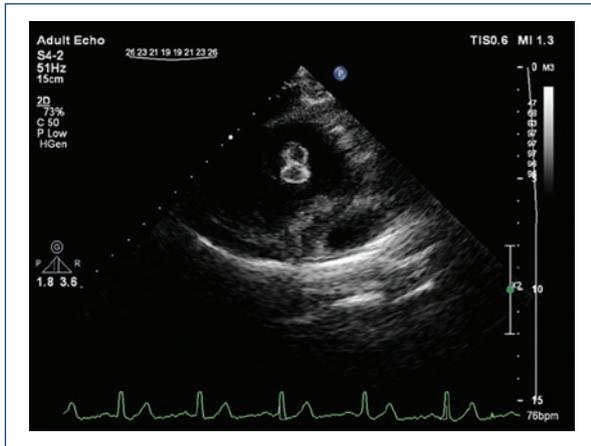
**Figure 2/Video 2.** Off-axis parasternal long-axis view showing the figure of 8 image artifact of the occluder device.

coronal imaging position is necessary to avoid misinterpretations of studies such as malposition or displaced device.

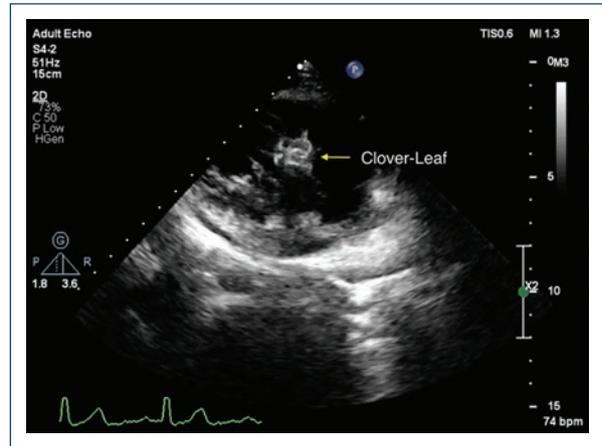
**Figure 3/Video 3.** The occluder device resembles a clover-leaf in this off-axis parasternal long-axis view.
