## Practical use of the safety factor in the column repair strategy of a concrete building with historical value

In this paper the practical use of the safety factor (FS) in the column repair strategy of a reinforced concrete building with historical value (almost 70 years) is presented. 80% of a building located in the historic center of the city of Campeche, Mexico, declared a World Heritage Site by UNESCO, was repaired. Strategies were used for a better use of material resources, equipment, and labor in the repair of walls, columns, slabs, and beams. One of the strategies was to use the theoretical FS to calculate the repair depth without structural consequences but fulfilling the purpose of controlling the carbonation of the concrete and maintaining the desired prediction of service life.

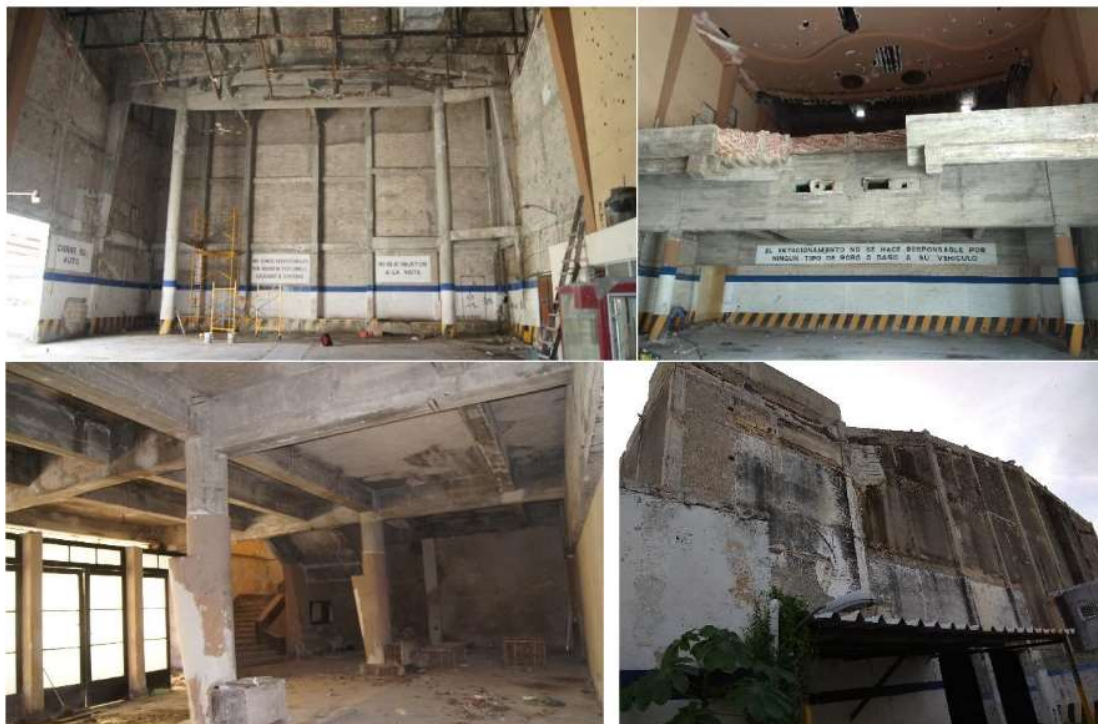
Figure 2. State of the structure before being repaired.

The structure had as its primary function that of being a cinema, later it functioned as a parking lot and was finally abandoned. These changes in use and abandonment were factors that potentiated the damage, as partially observed in the photos of Figure 2.

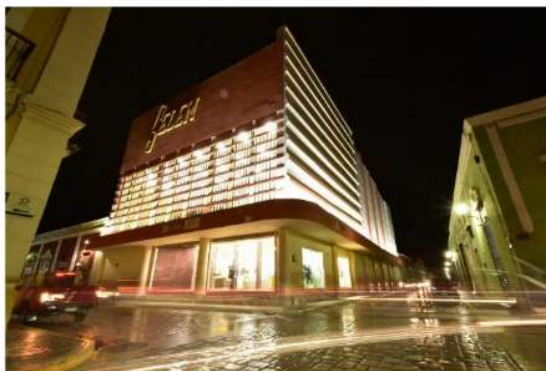
Figure 7. View of the intervention building

With this work, it has been possible to demonstrate in a simple way the ease and confidence with which an UDR in columns can be approached, considering a simple calculation of the SF. Figure 7 shows a night view of the building already recovered.
