## Concrete degradation by the formation of biogenic sulfuric acid in a Sewage Pumping Station

This work presents the study carried out in a Sewage Pumping Station after severe degradation was observed. The attack by biogenic sulfuric acid in sanitary sewage systems is widely studied in the literature, however, data on real work situations are still quite limited. Analyzes of the concentration of H<sub>2</sub>S in the air, carbonation depth, compressive strength, petrography, SEM/EDS, XRD and chemical determinations were carried out in concrete cores extracted above the effluent level. The products identified on the surface were Gypsum, Jarosite, Ferrous Hydroxide, Ferrous Chloride and possibly Hisingerite. The results demonstrate the presence of products on the surface, from the dissolution of cement paste as well as from the 16 mm steel bars located in the attacked region.

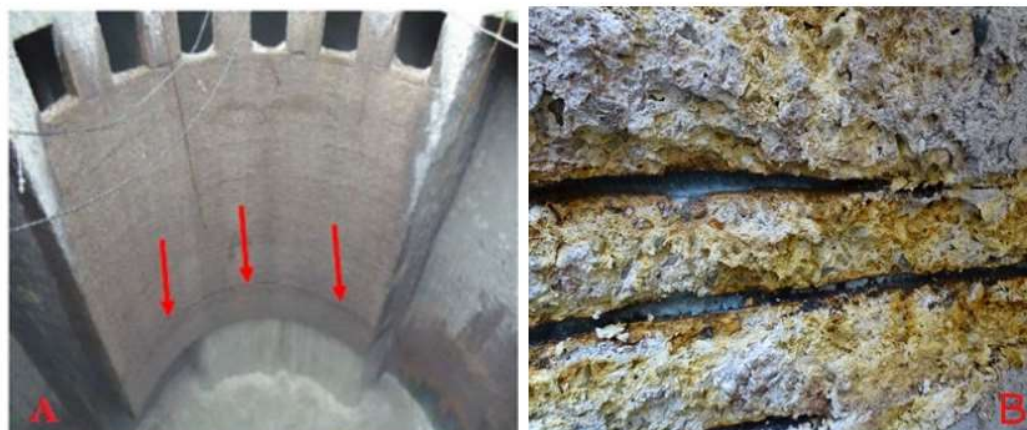
Figure 1. (a) wet-well (b) Degradation of concrete and steel bars observed by site inspection

The inspection of the structure was carried out in the wet well (Figure 1a) and restricted to the gas area (above the waterline). In this region, the concrete surface presented an atypical condition with layers up to 15 cm thick with no cohesive properties, very easy to remove with a spatula (Figure 2a). The wall's thickness specified in the project is 35 cm. The passive reinforcement with 16 mm diameter was oxidized (Figure 2b), with loss of section and sectioned and/or completely dissolved parts.

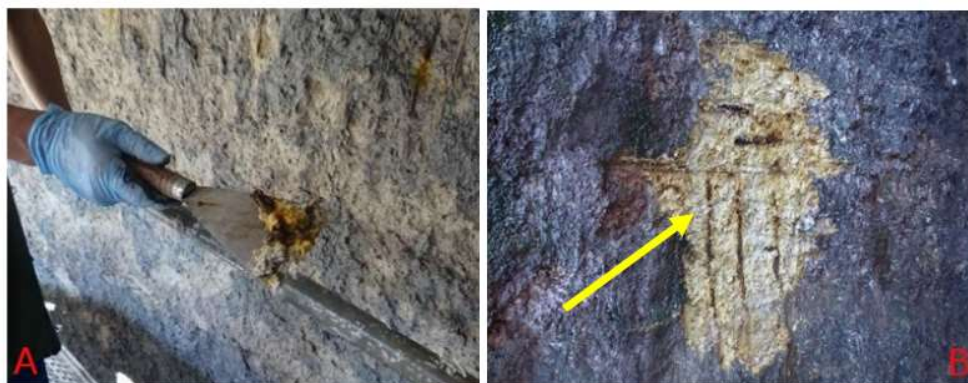
Figure 2. (a) removal of the degraded concrete layer using a spatula and (b) parts of completely reinforcement dissolution

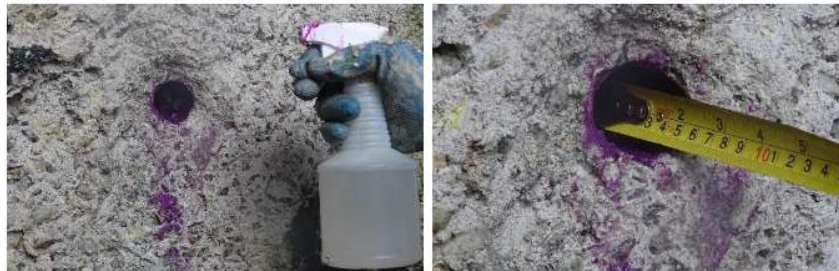
After removing the layer with no cohesive properties of approximately 8 cm from the wet-well's wall, it was observed that the concrete was carbonated as it did not change color with the phenolphthalein's solution application. Then, a 5 cm hole was made, observing that the innermost region of the concrete was still alkaline, as illustrated in Figure 4.

Figure 4: wet-well's wall - alkaline concrete
