Flexural behavior of reinforced concrete beams with electrochemical parameters associated with high level of corrosion

J. A. Moreno Herrera*¹, J. L. Varela Rivera¹, R. Visairo Méndez², P. Castro Borges²

DOI: <https://doi.org/10.21041/ra.v12i3.630>

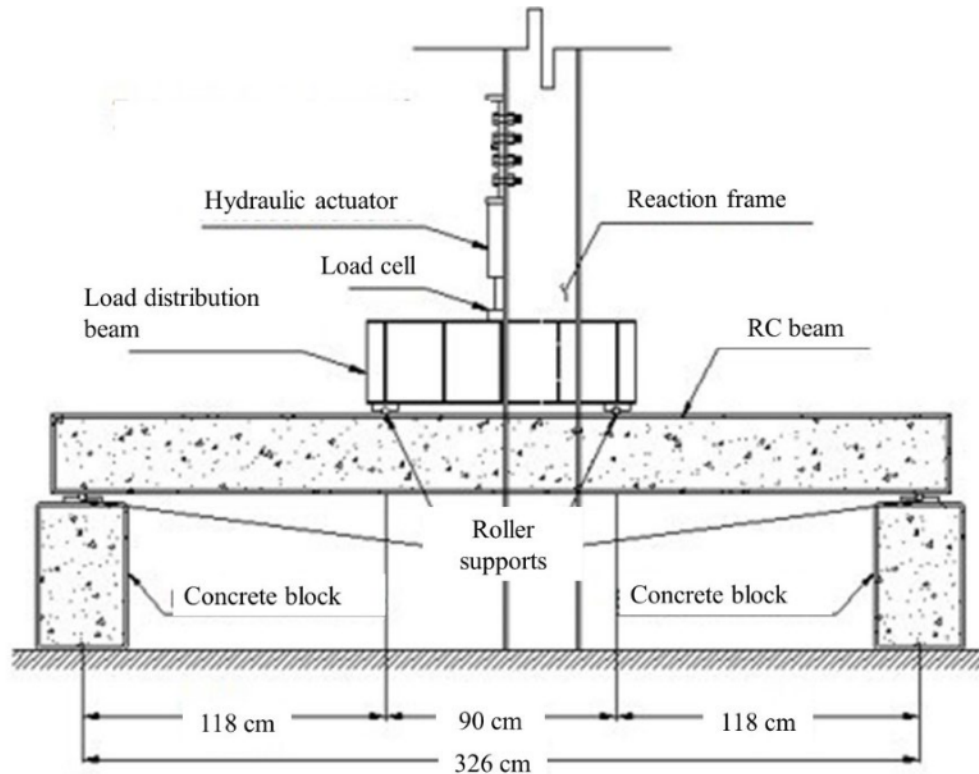
Figure 1. Four-point load system

Beams were subjected to incremental vertical loads until the target tensile stresses in the longitudinal steel reinforcement were reached (Table 1). Loads were applied using a traditional four-point load system (Figure 1). With this loading system, a constant bending moment with no shear force was induced in the central third of the beam length. In Table 1, VC refers to control beams, VCC to beams with corrosion, 0.4 and 0.8 refer to the target tensile stresses in the longitudinal steel reinforcement (40% and 80% of f_y). In Table 1, P_{cr} refers to the cracking load associated with flexural cracking strength and Δ_{cr} refers to the corresponding displacement, P_{m1} refers to the load associated with the target tensile stress and Δ_{m1} refers to the corresponding displacement. In that table, the initial stiffness (K_o) and the post-cracking stiffness (K_{cr}) of beams are included. The initial stiffness was calculated using P_{cr} and Δ_{cr} . The post-cracking stiffness was calculated using both P_{cr} and P_{m1} .

Control beams and beams with corrosion were subjected to incremental vertical loads until failure. Beams were tested after the period of application of the corrosion technique. Loads were applied using the same four-point load system described before (Figure 1). Loads were applied using a hydraulic actuator and were measured with a load cell. Vertical displacements at the mid-length of beams were measured using two linear potentiometers. Strains of the longitudinal steel reinforcement were measured using strain-gages. The strain-gages were attached to the longitudinal steel reinforcement prior to pouring of concrete (Moreno-Herrera et al., 2022).

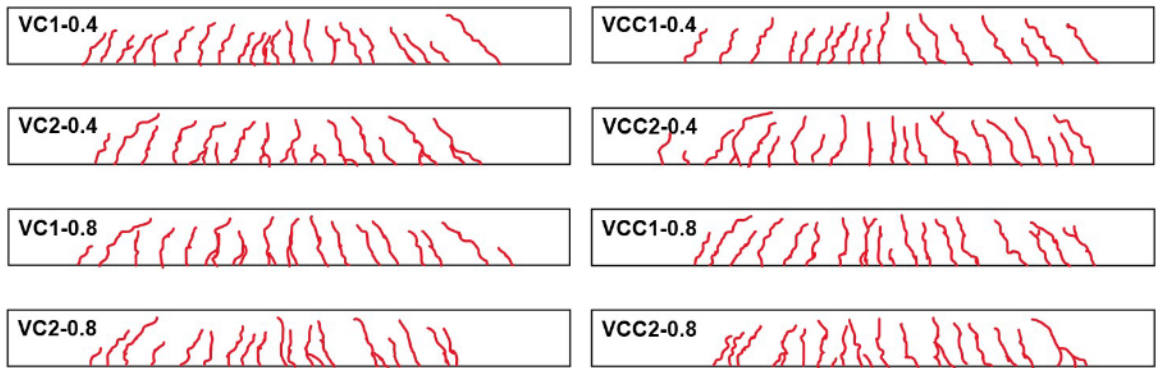
Figure 2. Final cracking pattern of beams

The final cracking pattern of tested beams are presented in Figure 2. The final cracking pattern of control beams and beams with corrosion was similar. This cracking pattern was defined by the formation of vertical flexural cracks at the beam center and diagonal flexure-shear cracks at beams ends.

- The final cracking pattern of control beams and beams with corrosion was similar. This cracking pattern was defined by the formation of vertical flexural cracks at the beam center and diagonal flexure-shear cracks at beams ends.

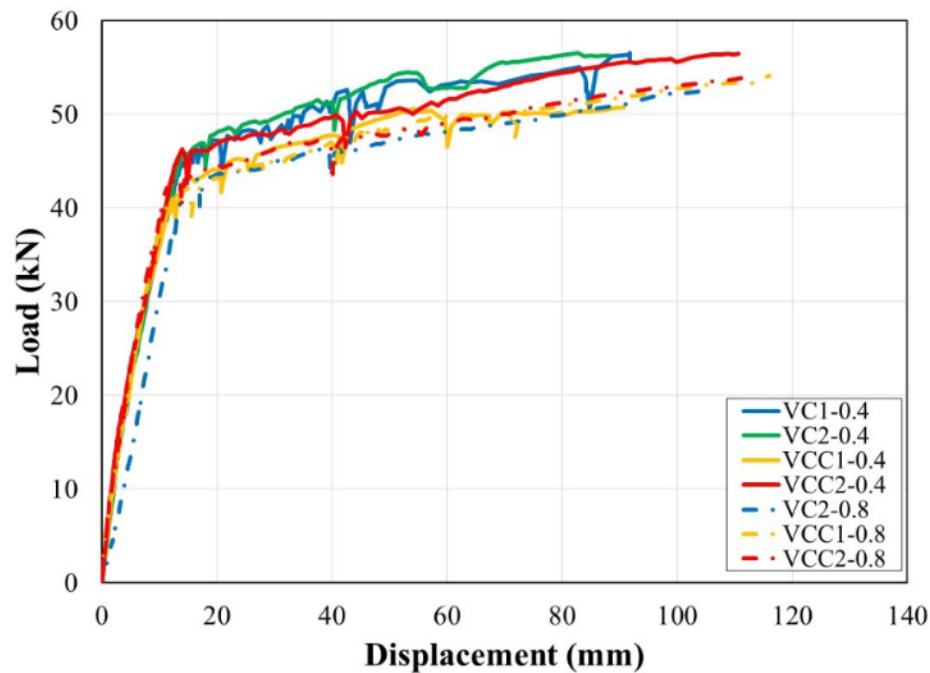
Figure 3. Load – displacement curves

The load – displacement curves of beams are presented in Figure 3. Table 3 shows the yielding load (P_y) and corresponding yielding displacement (Δ_y), the maximum load (P_{m2}) and corresponding displacement (Δ_{m2}) of beams. Yielding loads were determined using the strains measured with the strain-gages. Initial yielding stiffness (K_y) and displacement ductilities (μ) of beam are presented in Table 3. Initial yielding stiffness was calculated using the yielding load. Displacement ductility was calculated as the ratio between the maximum displacement and the yielding displacement of corresponding beams. For beam VCC1-08, only the maximum load and corresponding displacement are presented because of problems with the measurements with the strain-gages.
