## Influence of the thickness of the coating of the elements of reinforced concrete exposed to corrosion processes and subjected to external loads

R. S. Meneses<sup>1</sup>, J. M. Moro<sup>1</sup>, R. R. Aveldaño<sup>1</sup>, N. F. Ortega<sup>1</sup>

<sup>1</sup> Engineering Department, Universidad Nacional del Sur, Bahía Blanca, Argentina.

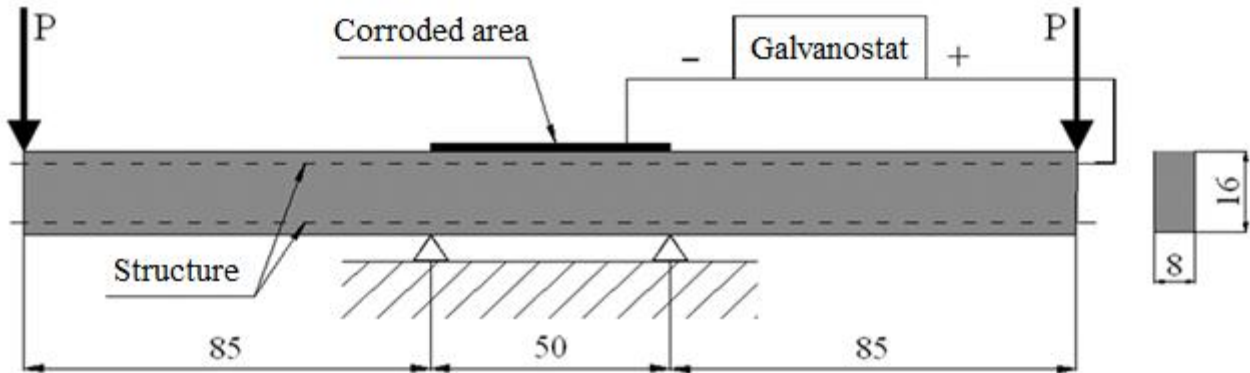
In order to obtain the tensile stress of the superior reinforcement (which would be the one that would have been subsequently subjected to a process of accelerated corrosion), loads were placed at the extremes of the beams, adopting an intermediate area as the area to be corroded, and leaving overhangs on the two lateral sides. Figure 1 shows the adopted structural outline. The area between the supports possesses an almost constant bending stress, therefore, the entire area of the bars affected by the corrosion is subject to a stress that is practically equal in intensity, by being subjected in each case to its own weight plus the effect of various loads that varied from 90 kg to 100 kg.

Figure 1. Outline of the Test

The elements were subjected to accelerated corrosion for approximately 160 days through the application of an external printed current, provided by a galvanostat connected between an exposed end of the upper reinforcement (anode) and a contra-electrode (cathode) comprised of a stainless-steel mesh (of 50 cm in length and of the same width as the beam), located in its upper face. A sponge (of equal dimensions) was placed on it, which was kept moist with a controlled quantity of an aqueous solution with 0.3% (in weight) of sodium chloride (NaCl) (3 g NaCl / litter of water). Prior to connecting the galvanostat, the moistening of the central area began for 2 days in order to ensure that the entire coating had the necessary humidity to allow the circulation of the current. In order to have a controlled moistening (reducing evaporation), an acrylic plate followed by a nylon canvas were placed. The density of the applied current was of  $100 \mu\text{A}/\text{cm}^2$ , which is around ten times the measure in highly corroded reinforced concrete structures (Rodríguez, 1993); it was chosen for having been adopted by various groups for their research in the issue (Acosta, 1998; Alonso, 1994; Alonso, 1998; Aveldaño, 2011) with the purpose that when the process in study was finalized, results of corrosion penetrations greater than 0.30 mm in the bars were obtained within a reasonable time.

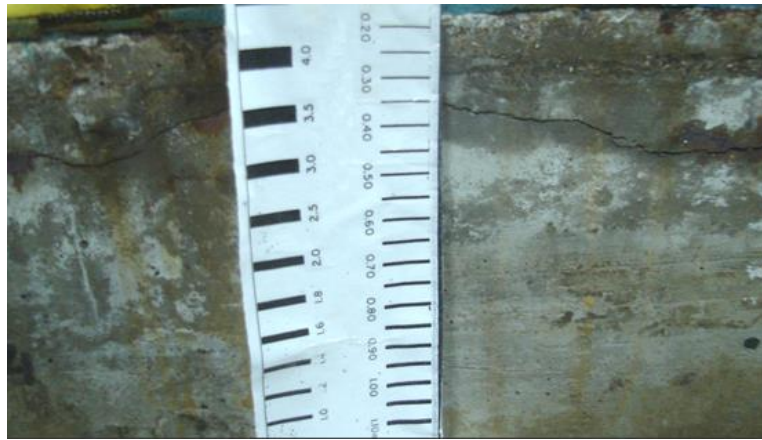
First of all, the beams were loaded and the initial cracking by flexion was measured prior to moistening. The follow-up of the surface of the beams was done by observing them daily and recording the moment the first stains and cracks appeared due to corrosion. From the emergence of these first cracks, the periodical measure of the width (by comparison with a graduated Vernier, with a minimum division of 0.05 mm (see Figure 2)) and length of the same (with a graduated ruler that possess a millimeter precision) was performed. This task was carried out in order to find the maximum crack widths and the cracking areas, which are obtained as the sum of the lengths of each crack, multiplied by their respective width.

Figure 2. Measurement of the width of a crack generated by accelerated corrosion.

Before taking the measurements, it was moistened for 2 days with the aforementioned NaCl 0.3% solution in weight, until reaching constant moisture; subsequently, a constant current density was applied through a galvanostat for the duration of the test. Under these conditions, the evolution of the corrosion potential was followed-up at various characteristic points of the beam (on the dry and humid areas, coinciding or not with the abutments). All the measurements were carried out by previously disconnecting the galvanostat, and the cement was moistened in the areas where the determinations would be subsequently carried out, such that the measurements of the potentials would stabilize quickly. This moistening process normally lasted a couple of hours.

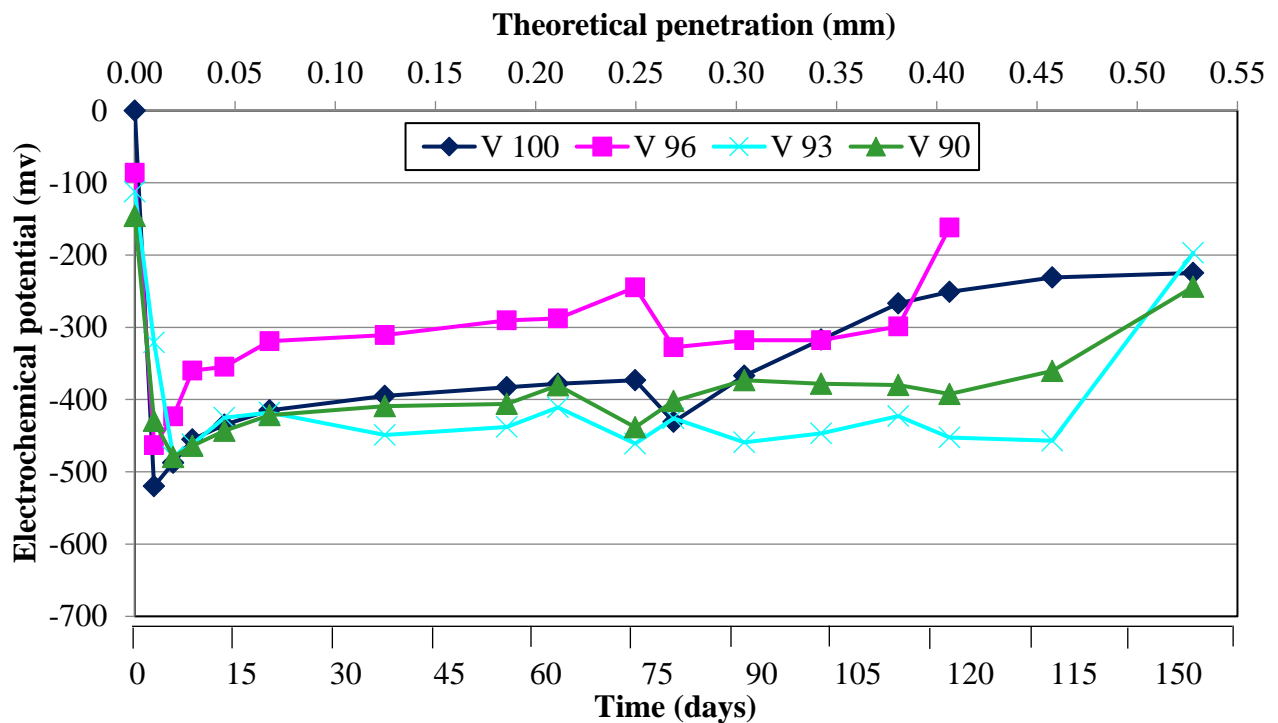
Figure 3 shows the electrochemical behavior of the reinforcement, where the evolution of the corrosion potentials was graphed, representing the average of the measurements obtained on 5 points located in the central area affected by corrosion on each of the 4 tested beams. There are two scales on the abscissa axis, one represented by the time passed since starting the test and, in the upper part of this figure, the theoretical penetration of the attack, which is an average value fixed with the Faraday law (Equation (1)), applied to the material losses in the reinforcement located in the central area of the beams.

Figure 3. Average corrosion potentials (moistened area), in terms of the theoretical penetration and time

At the same time, the corrosion potentials were recorded in order to carry out an electrochemical follow-up of the corrosion processes (Figure 3), in accordance with a standardized procedure (American Society for Testing and Materials, 1980). These were measured with a CANIN (PROCEQ) brand voltmeter, utilizing a Copper – Copper Sulfate (CSC) reference electrode especially built to carry out measures in concrete structures. The corrosion potentials in the central 50 cm of the central area affected by corrosion were determined in 5 equidistance points, averaging the values of the same.

The electrochemical behavior analyzed in the four beams, through the follow-up of their corrosion potentials, showed that in the course of the first 5 days, since connecting the accelerated corrosion process, the minimum potential value was reached; the beams with less coating (V96 and V100) were the ones that completed their activation period first (with minimum potentials between -478 and -531 mV). Subsequently, an increase of these potentials can be observed that could be considered as a pseudo-passivation process that is accompanied by the generalization of cracking (see Figure 5), which was similar on all the beams. Although the potentials of the two beams with lower coating / reinforcement diameter ratio are somewhat higher than the other two, it could be said that these are more passivated due to allowing an easier entry for oxygen from the exterior. This process was also found in previous works carried out in this laboratory (Aveldaño, 2011; Aveldaño, 2013; Schierloh, 2001).

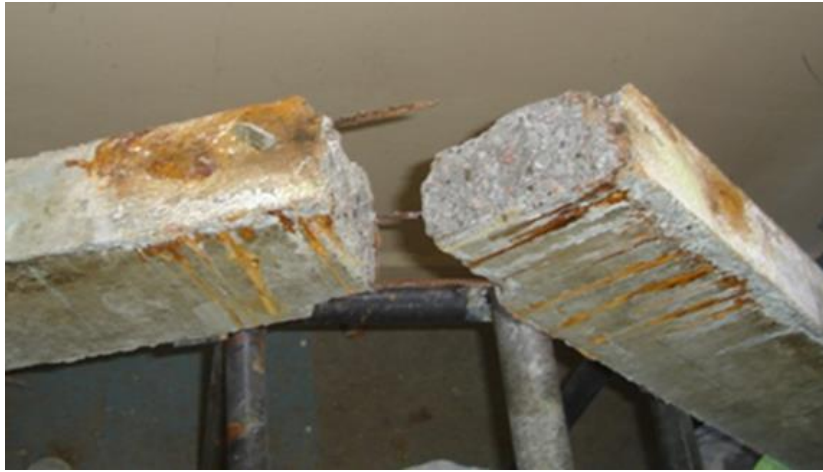
It is worth noting that while the test was prolonged for approximately 160 days, when reaching 140 days, beam V96 reached the point of collapse (Figure 4) due to a significant reduction of the cross-section of its reinforcement, produced by the depth of the pitting caused by the corrosion. Whereas beam V100 broke at 160 days, at which time the tests were finalized. This indicates that the corrosive process as is known, affects the residual life of the structural element affected, but that pitting, in particular, can decrease it even more.

Figure 4. Beam V96 after collapse

more the areas with flexural cracks. That is to say, the total growth of cracking implies a decrease of the resistant section of the beam (due to the section decline of the reinforcement and of the mechanically useful section of the concrete), so that, in the case of there being loads close to the breaking loads of the element, it could lead to the collapse of the structure as was the case with beam V96 at 140 days into the test.

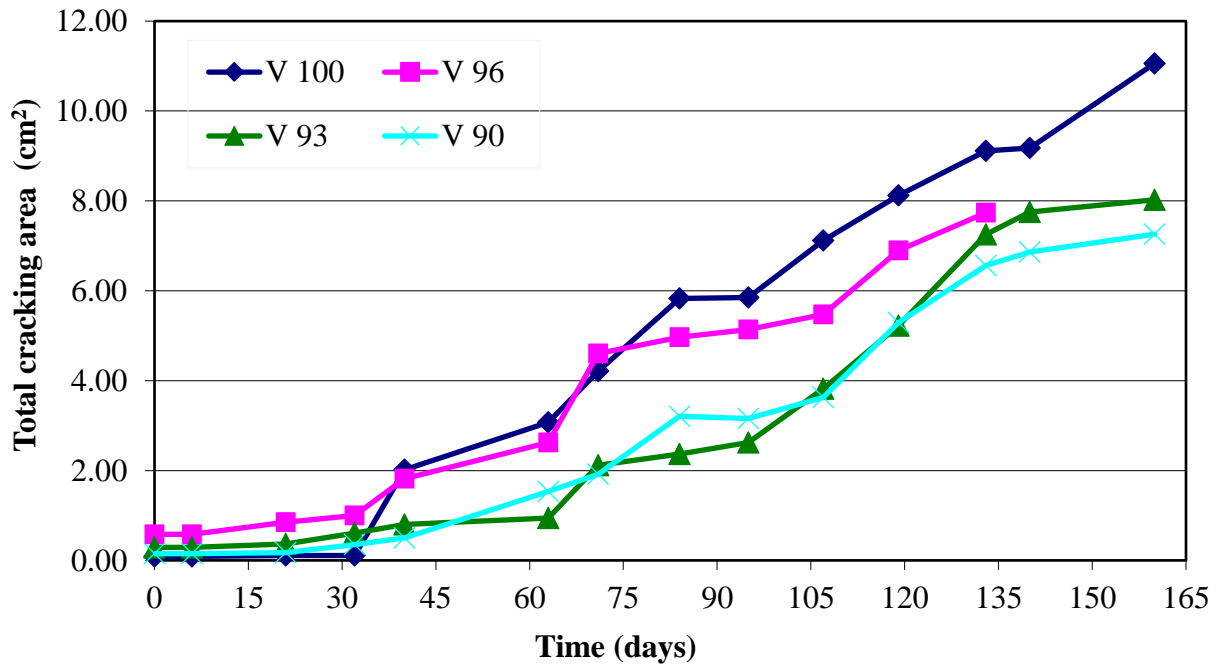
The cracks were measured from the moment the external loads were placed. Figure 5 shows the evolution of the total cracking areas in each beam; that is to say, those obtained from the sum of the flex cracking areas, plus the areas of cracking by corrosion (in the same direction as the main reinforcement of the beam). It is worth remembering that the so-called cracking area is the sum of the products of the longitude by the width of each crack.

Figure 5. Total cracking area in terms of time

As predicted, the start of the cracking by corrosion manifested later on the beams with greater coating. Beams V90 and V93 had a similar evolution of the total cracking area throughout the duration of the test, taking into account the degree of dispersion that normally appears in most experimental works; whereas beams V96 and V100 showed a differentiated behavior, with total cracking areas greater than those of the remaining beams, this is due to having a lower  $r/\phi$  ratio of the reinforcement. However, if the flexural cracking area is analyzed separately (Figure 6), it can be observed that beam V96 showed higher values than the rest. This can be clearly observed with the state this beam reached, in which the deterioration by corrosion presented itself to a greater extent in the area of the flexural cracks, whereas the rest of the beams showed a more generalized cracking. Evidently, this greater initial cracking due to flexion was a significant means of entry for the chlorides that reached all the way to the reinforcement, with beam V96 showing the largest total cracking areas (Figure 5) during the first 30 days of the test, after which their behavior was within the expected.

This behavior observed in beam V96 explains its collapse prior to that of beam V100. However, this evidences the influence of the lesser  $r/\phi$  ratio of beam V100, which, having the least flexural cracking

If the evolution of the maximum cracking width is compared with that of the cracking areas (Figure 5), it can be observed that the latter are a more representative indicator of the general evolution of the deterioration, due to the fact that it is common for the maximum width to vary in its location on the beam throughout the corrosion process. Furthermore, it tends to evolve in jumps in terms of the emergence of new cracks that cause the redistribution of the internal stress in the coating. For example, Figure 8 shows that beam V90 has the most cracking between days 40 and 90, when in reality it ought to be the one with the lesser values. This situation was also found in other works (Aveldaño, 2009; Aveldaño, 2013). Nevertheless, this figure is included due to the fact that it is common to introduce limitations on the maximum width of the cracks in the standards, and therefore it is used as a reference in many international bibliographies. It is worth noting that it would be necessary to carry out research to standardize the cracking area, so that valid comparisons between various deteriorated beams could be carried out, for example, in terms of the length of the affected element or the length of the corroded area, to later establish representative deterioration indicators and then limit it.

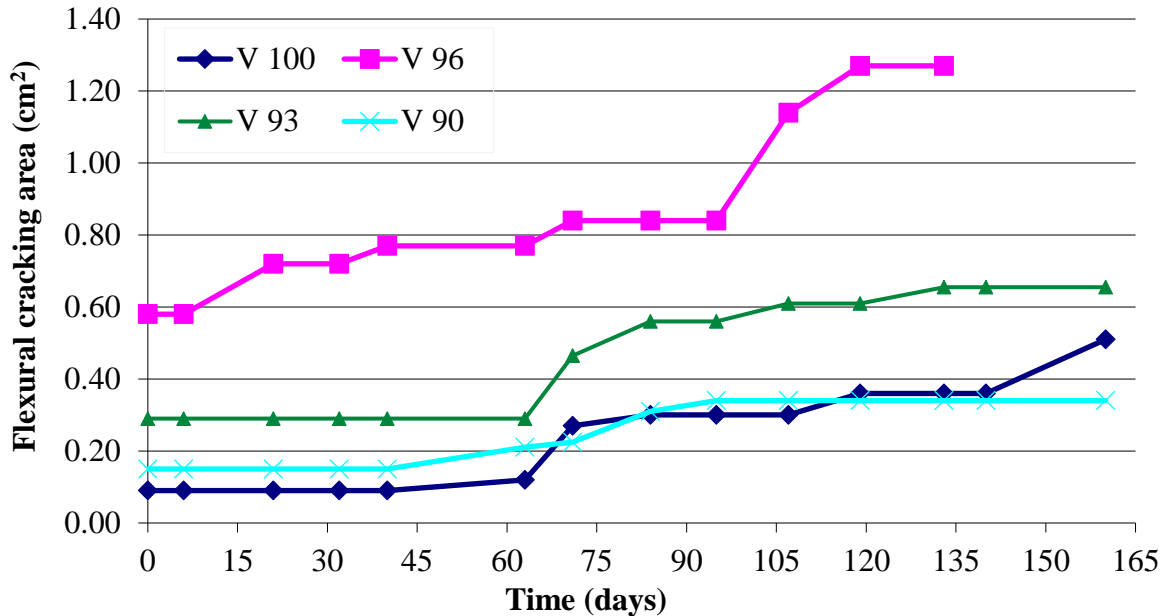
Figure 6. Flexural cracking area in terms of time

during almost the entirety of the test, presented greater cracking by corrosion than the rest; as well as the importance that flexural cracking has in the deterioration of a structure subjected to corrosion, as is the case of beam V96.

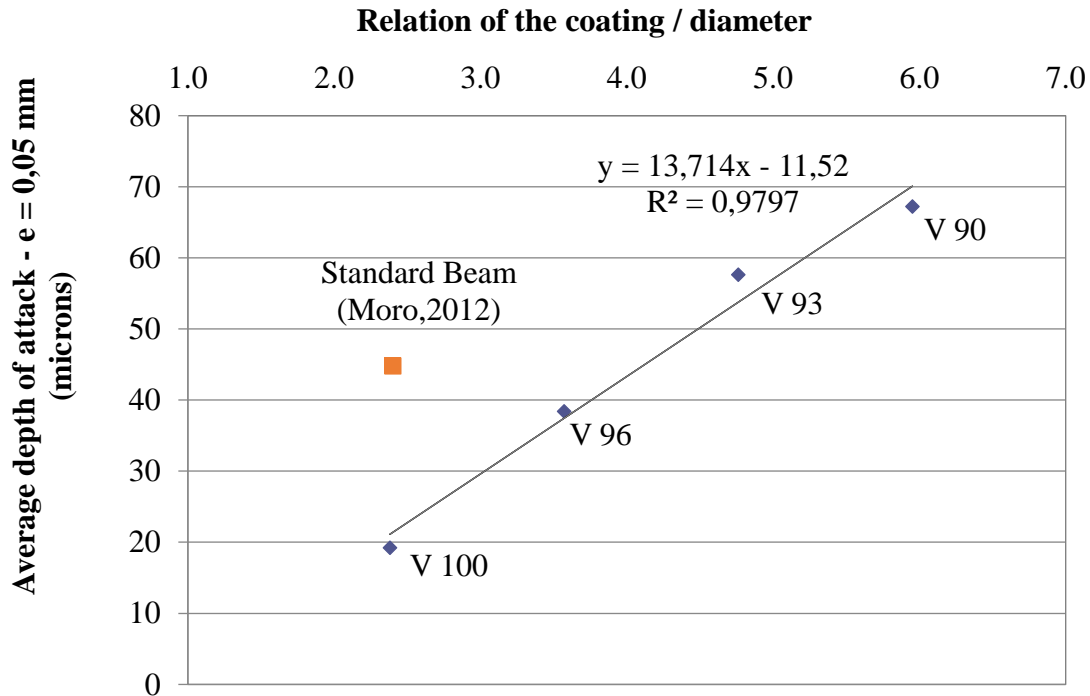
It can be observed in Figure 7 that the appearance of the first visible cracks due to corrosion is delayed (the average depth of the attack is proportional to the time, expression (1)) as the thickness of the coating increases (greater  $r/\phi$  ratio). The increase in the thickness of the coating causes a delay in the appearance of the first cracks due to corrosion (Figure 7), as well as slowing their evolution (see Figure 5) due to the fact that the aggressive external elements (chlorides, oxygen, and water) take longer to reach the reinforcement. This situation, in the case of the tensile reinforcement with lower  $r/\phi$  ratios, is worrying due to the fact that this greater depth of attack on the bars, with less external symptoms (cracking), encloses a significant risk because it decreases the warning time in case of a structural collapse—more worrying still if there are chlorides that cause pitting. In Figure 7, a point corresponding to the standard beam (without external loads and a  $r/\phi$  ratio = 2.4) of the aforementioned work (Moro, 2012) was incorporated, where it can be observed that a greater depth of attack is necessary for the appearance of the first visible cracks.

Figure 7. Relation between the average depth of attack on the reinforcement that produced the first visible crack ( $e = 0.05$  mm) due to corrosion, and the relation of the coating / diameter of the bar.

The equation in Figure 7 obtained through a regression analysis ( $y = a + b x$ ) can be compared with the one obtained in other researches (Alonso, 1998) where concretes made with water/cement ratios between 0.52 and 0.65 were used, while the rest of the test conditions are similar, among which the following stand out: a slightly broader variance range of the coating/diameter ratio than the one adopted in this paper, in both works the abutments were placed, and the same current intensity was utilized. The results achieved in the cited work were:  $a = 7.53$  and  $b = 9.32$ , with  $R^2 = 0.92$ . The slope of this line is much lower than the one obtained in this work ( $a = 13.71$ ), therefore, it could be said that in structures subjected to external laws, the degradation generated by the corrosion of its reinforcement is accelerated, even for cements made with a water/cement ratio somewhat lower to that of the reference.

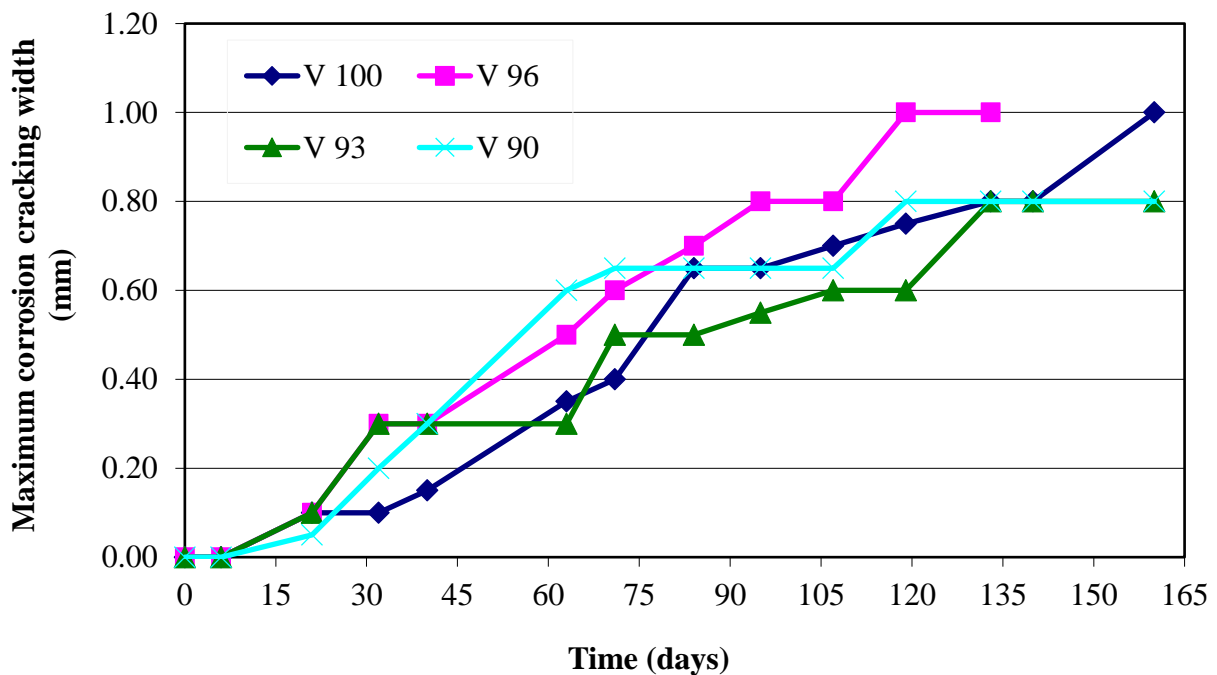
Figure 8 shows the variation of the maximum cracking width in terms of time. It can be observed that the maximum cracking width, during the greater part of the test, was superior on beam V96 due to the influence of the flexural cracking. No great differences were observed in the evolution of the rest of the beams, which was due to the fact that the distribution of the cracking was developed differently on each beam, whether in a more generalized or localized manner, without generating evident differences between the different samples tested.

Figure 8. Maximum cracking width in terms of time
