Rebuilding Nepal for next earthquake

B. L. Nyachhyon*¹

DOI: <http://dx.doi.org/10.21041/ra.v7i1.176>

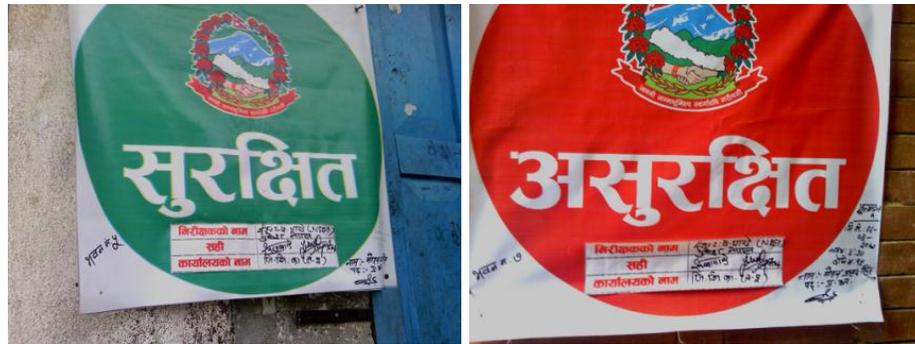
No matter how good the design is, the building is not the one it should be if it is not built or used as specified. This is what we have seen happening quite often. The buildings designed and constructed have neither the quality monitoring certificates, nor operational monitoring like design load maintenance, occupancy and maintenance certification. Even a well-built building age, which means its properties change, and we have a problem if we do not address these issues. One of the most important actions carried out in Nepal immediately after the earthquake was the rapid visual vulnerability assessment of buildings. But the action faced controversy because of lack of adequate preparation and legal provisions. The tools used were informally borrowed from ATC 40 without proper legal backup and training. Most controversial action was the issue of Stickers (Green, Yellow and Red) categorizing the buildings into Safe, Caution, Unsafe (Figure 2). The actions created confusion in the community about its rationale and relevance. Surely, that was the result of lack of preparedness for such rapid action.

Strikers: Safe and Unsafe Category of Buildings
Figure 2. Rapid Vulnerability Assessment

The stickers were a good example of lack of adequate preparation. They were issued in very unprofessional manner and illegally since there were no such laws or guidelines that provide authority to do so. The Rapid Vulnerability Assessment forms were borrowed from elsewhere without authorization, proper guidelines and did not match with typology of the buildings in the country.

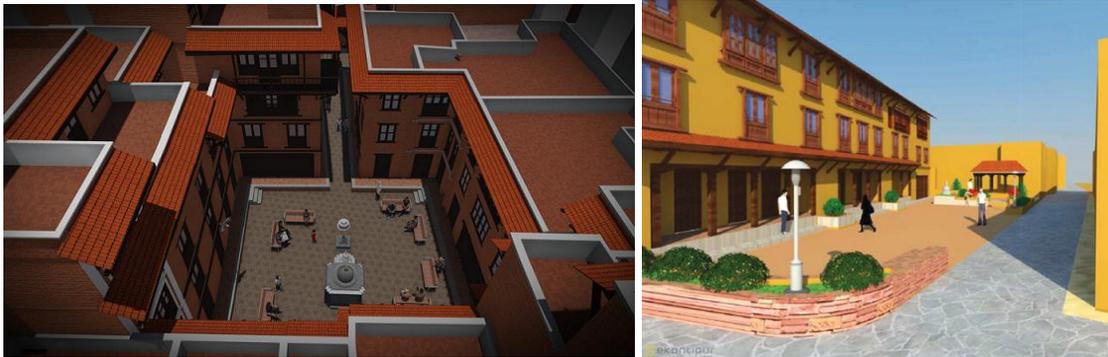
Figure 3. Some cases of proposed recovery of traditional heritage settlements in Lalitpur.

could be very redundant. There are several approaches being forwarded under the principles of “Integrated Settlement Development” which will be developed following massive dismantling of damaged buildings to produce an outlook (Pillachhen Integrated Reconstruction in Lalitpur and Khokana, 2016, Figure 3).

A: Pillachhen redevelopment
(Source: Maya Foundation)

B: Khokana reconstruction
(Source: Kantipur Daily)

This will be totally a new construction and will carry none of the cultural or historical values represented in the settlements. The modern trends towards quick recovery will change the landscape and will lead to the extinction of ancient values and a total loss of the whole heritage assets. The broad objectives of these reconstruction as stated are: 1) To provide safe living and healthy environment by repairing and reconstructing houses of the local residents, 2) To protect the traditional architecture, 3) To develop infrastructures and improve vehicular accessibility, 4) To promote local business, 5) To increase income of local residents by promoting the tourism - oriented business, and 6) To conduct programs in social buildings and open space for encouraging social interactions.

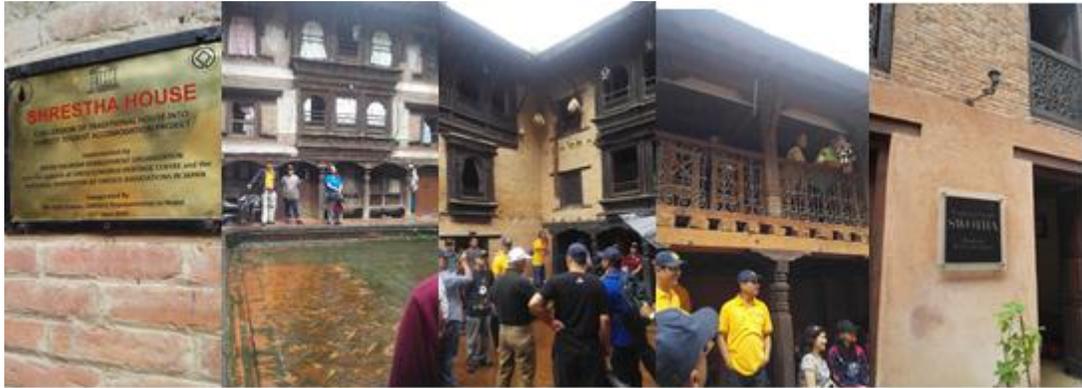
Though the reconstruction program has prevision for protection of traditional architecture in its objectives, it has ignored the conservation of heritage and historic values of 2,500 years. Possibly, we are wandering in the forest of post-earthquake slogans and terminologies like Building Back Better, rebuild, recovery, retrofit, renovation, rehabilitation, protection, conservation and reconstruction. Until we are clear about our needs, we are sure to be swept away by the flood of funds being poured in the reconstruction. Immediate resource mobilization and the money power it represents is much stronger than represented by professionals struggling with lack of resources and time. However, sharing information on best practices may be still relevant and useful if only to give some lessons and directions for future. Some of the examples of regeneration based on recovery of cultural heritage settlements promoted under the principle of “Conserve and Earn” have successfully carried the message for paying attention to heritage conservation. These schemes are very popular and are better known as “Home Stay” tourist accommodation. Some of the better examples are: Shrestha House and Swotha Café (Figure 4).

Figure 4. Shrestha house and Swotha Café converted to “Conserve and Earn” projects

The innovative concept of “Conserve and Earn” was recognized by UNESCO and given “World Heritage” recognition. These structures did not suffer during Gorkha Earthquake. Some of the cultural heritage monuments restored with International assistance suffered severe damages and totally collapsed (See Figure 5). Apparently, earthquake resistance was not in their agenda.

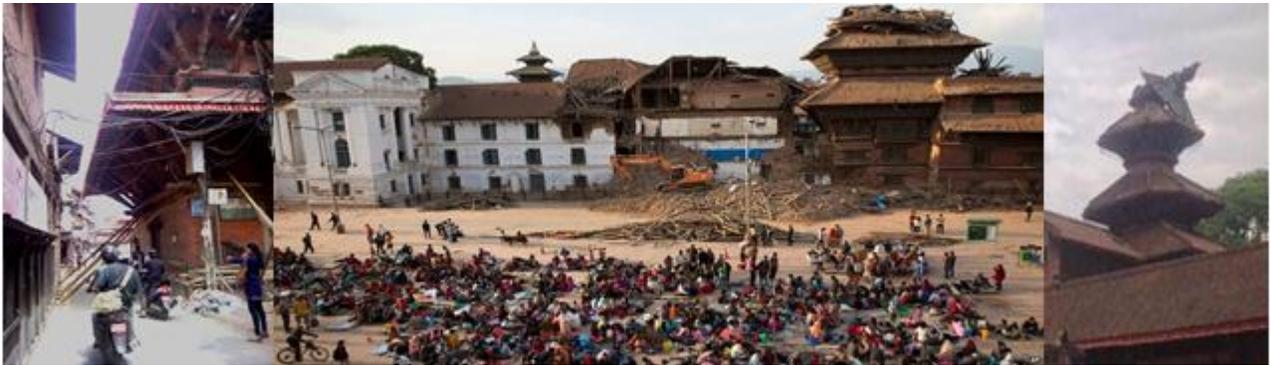
Bhimsen Temple, Lalitpur; Nautalle Durbar, Basantapur; Digutaleju, Lalitpur.

Figure 5. Heritage monuments restored with international assistance damaged during Gorkha Earthquake

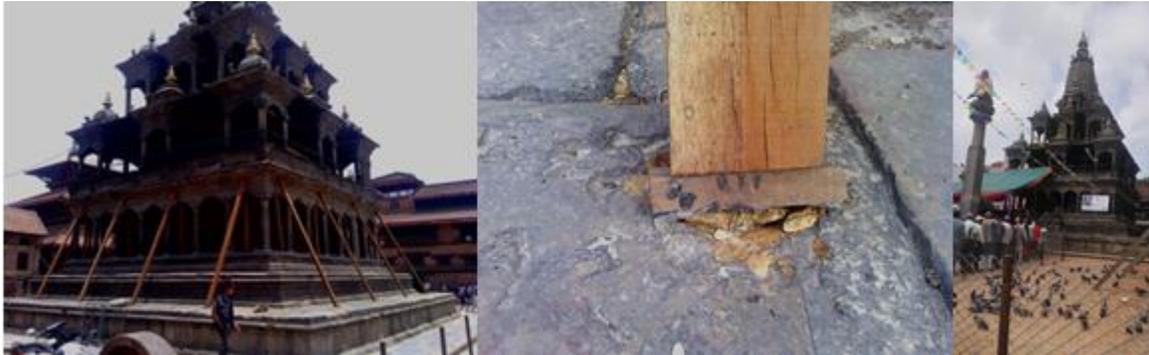
Similarly, there are a few instances where local authority intervention damaged structures of cultural heritage post Gorkha Earthquake (Figure 6). Temporary timber struts were erected without any purpose and without the authority’s knowledge and without consultation with local community. The struts were removed again without any information nor evaluation of required strength or caution. This shows lack of ownership at the Government level and lack of consultation with the professional and local community. The world-famous Krishna temple of Lalitpur was damaged by the municipality’s unthinking intervention with erection of timber struts immediately after the quake, causing considerable damage to the temple. Note the damage to ancient inscription on the stone.

Figure 6. Krishna Mandir at Patan, damaged with post-earthquake protection efforts

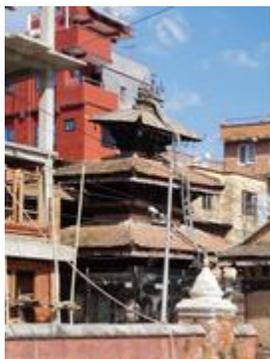
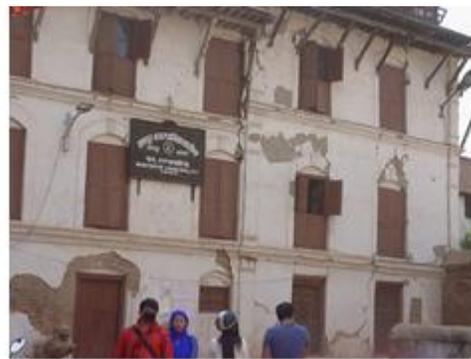
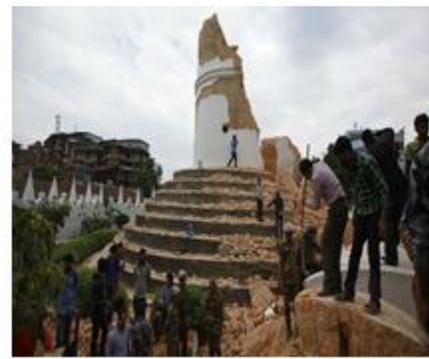
The Chandeshwori temple of Lalitpur, Bhaktapur municipality building and Bhisn stambha of Kathmandu.

Figure 9. Existing Building stock waiting for rebuilding

Protecting existing building stock of Nepal with over 5.5 million is a big challenge in itself. There is not a single building, affected by the Gorkha Earthquake, specially the rural brick/stone buildings in mud mortar. The biggest threat to the rest is from a society that views demolition is the best way in three reasons: 1) The building does not belong to them or the owner is from the different community or neighborhood, 2) It is the easiest way to be safe from the risk it is associated irrespective of the actual physical condition, and 3) There are no funds or technical assistance available for detailed damage assessment and to determine the wisdom of demolition or protection through retrofit techniques. Surely, when wisdom fails and the fear-mongers prevail.

Demolition and reconstruction of 5.5 million houses is not a figure any economy can afford, and surely not Nepal. If the Bhimsen stambha (Dharahar Tower) reconstruction with a price NPR 3 billion were to contest with the recovery of more valuable heritage objects like Chandeshwhori temple, among 15,000 heritage monuments country wide, besides the 745 prepared by the Department of Archeology, not counting the recovery of 5.5 million houses. Nepal Reconstruction Authority needs to look seriously at formulating a judicious policy, with a set of priorities that will ensure the recovery of most valuable national assets associated with the daily life of the people.
