Fire in residence in the City of Recife: An experimental study

This article presents the results of an experimental test of a fire in a bedroom of typical building burned in Recife city – Brazil. A room in the Pernambuco Fire Department training facility, a structure of reinforced concrete with a ceramic bricks' wall, has been used. The room has been renovated and adapted for the test. This compartment has been prepared with furniture and household appliances generally found in a typical fire that occurs in the city during three-year period of 2011-2013. The test was setup with 24 type K thermocouples to monitor the thermal behavior of the gas layer of the dormitory, as well as the temperature on the furniture and walls, both internal and external sides. The experiment has been monitored through hi-resolution camera and thermal image camera, in order to show an effective cooling down of the walls using atomized water applied by the firefighting crew.

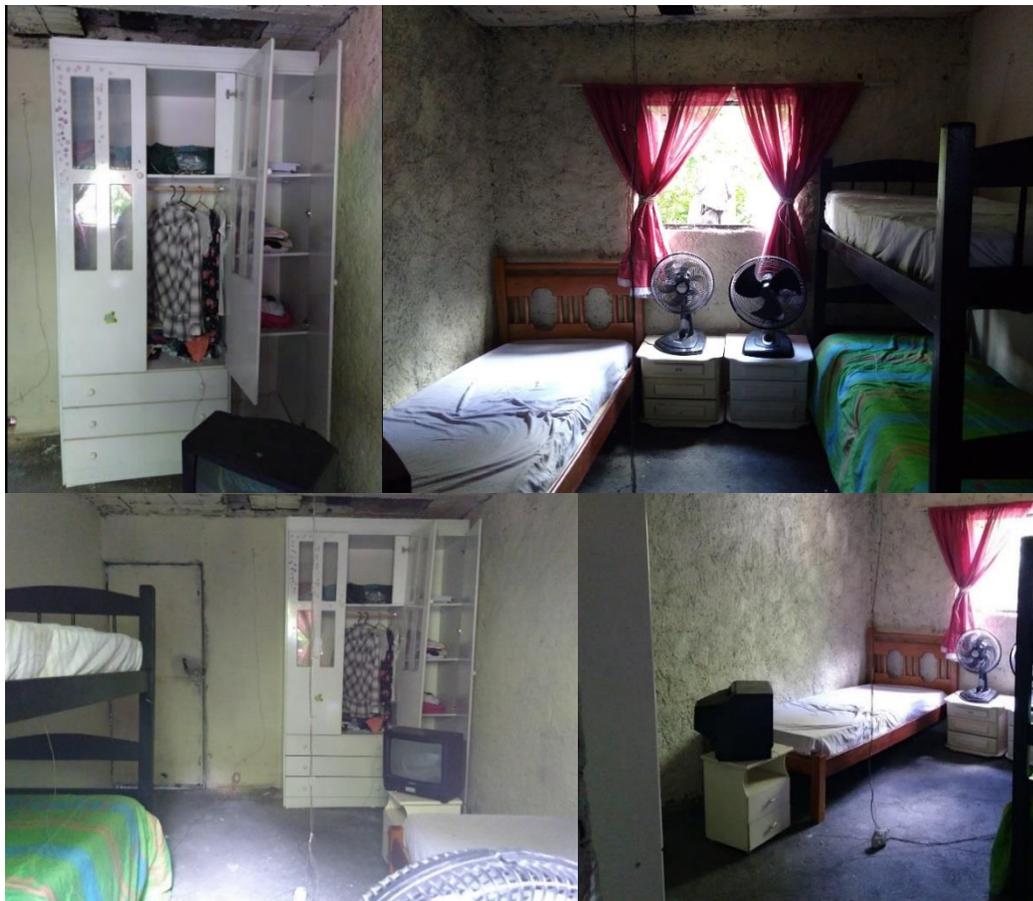
After the room was renovated, it was properly prepared with the described furniture and the measuring instrumentation. The Figure 3 below shows the bedroom just before the test.

Figure 3. Bedroom setup before the fire.

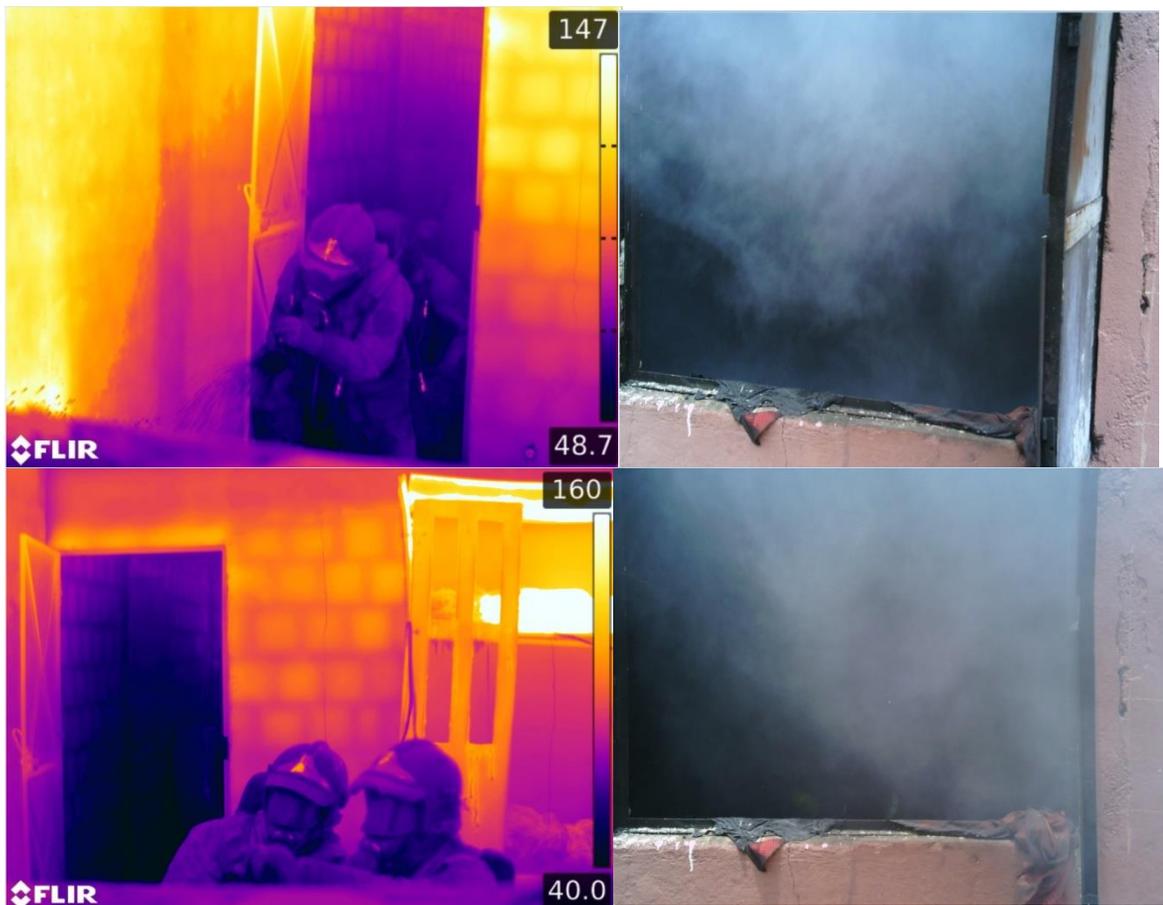
Thermal images were taken by a technician in thermography provided by the company 'FLIR Thermal Camera'. Figure 10 shows some comparative images between those captured by conventional and thermal image cameras.

Figure 10. Thermal images of the firefighter's entry.

Using thermal image cameras can provide a large amount of information for the firefighters. It can help to locate the fire through the smoke layer, as well as pointing out different structural components such as ceramic bricks hidden beneath the coating, or even give indications of structural failure not perceived by the naked eye, leading to the evacuation of the affected and adjacent areas.

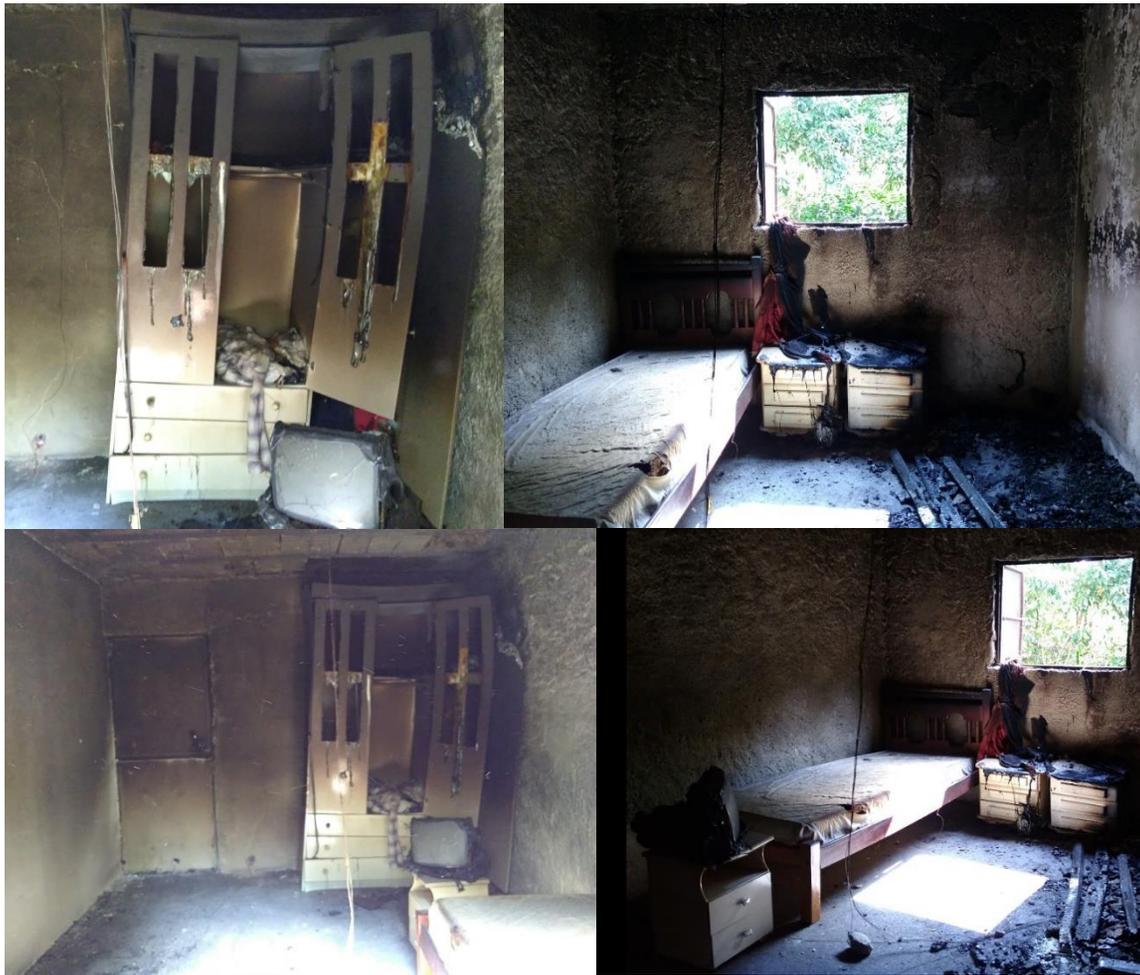
After the experiment, it was observed some furniture completely consumed (bunk bed, mattresses, fans) or partially consumed (cabinet and television). The walls were completely charred, but without any sign of visible pathologies. Figure 12 shows the images of the room after the fire.

Figura 12. Imagens do cômodo após o incêndio.
