Microstructure and mechanical properties of AISI 439 ferritic stainless steel welds without filler metal

Juan Manuel Salgado Lopez^{1*}, Marc Preud'homme¹, Francisco López Monroy¹,
José Luis Ojeda Elizarrázaz¹, Arturo Toscano Giles².

¹ Laboratorio de metalografía y análisis de falla, Tecnología de materiales, Centro de Ingeniería y Desarrollo Industrial, Querétaro, México. Av. playa pie de la cuesta No.702, Querétaro, México. C.P. 76125. *Correo electrónico: msalgado@cidesi.edu.mx

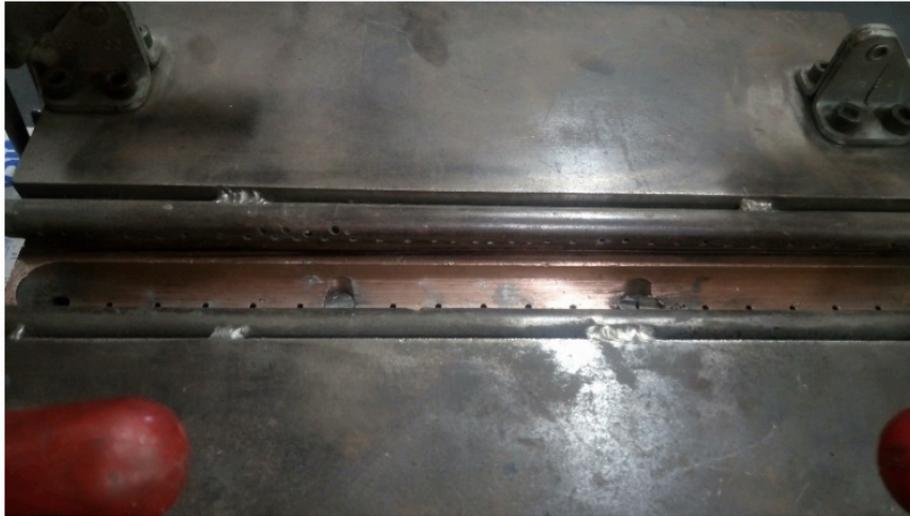
Figure 1. Protection chamber used during welding the FSS of this research.
Source: Author's own elaboration.

The welding process applied in this work was automatized pulsed current Gas Tungsten Arc Welding (P-GTAW) with high purity argon (99.999% of purity) as shielding gas. This process was chosen because it generates low heat inputs, and the theory establishes that a low heat input leads to lower grain coarsening. In figure 1 it is shown the protection chamber, which was applied during the welding of the AISI 439 in this work. The welding parameters are shown in table 1. In the technical literature similar values to the ones chosen here have been reported as the ones that generate the best microstructures (Amuda & Mridha 2010; Silva *et al.*, 2007; Zaman *et al.*, 2018). Therefore, such values were applied in this work.

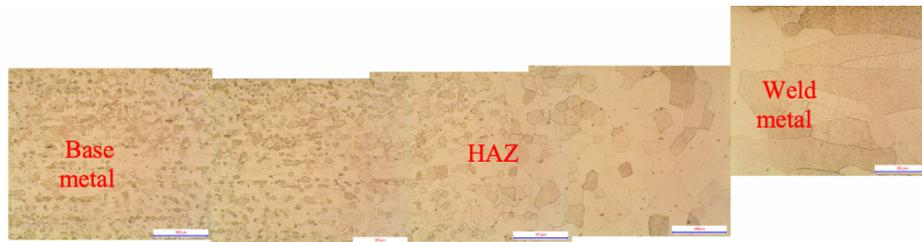
Figure 5. Microstructure of sample 3 at 100X.
Source: Author's own elaboration.

In figure 4, it is observed the microstructure in the HAZ of sample 1 (figure 4). It is clear a lower grain coarsening compared to sample 3 (figures 5), where the grains are bigger and the lack of fusion in sample 1 is clear. Despite of the fact that all samples showed grain coarsening, the HAZ of sample 3 had the lowest grain coarsening among the samples without flaws (figure 5). In the same way, in the microstructures of samples was not observed evidence of martensite needles at the grain boundaries. Also, in figures 4 and 5 it is observed that the grain size is not homogeneous. Moreover, the grains in the HAZ are recrystallized or partially recrystallized, while in the base metal the grains are deformed. The micrographs showed a mixture of grain sizes along the HAZ of the samples, then it was not possible to define a region of the HAZ where no mix of grain sizes was found. Then, the grain sizes in the HAZ of the samples were not measured because ASTM 112-13 indicates that no attempt for measuring partially recrystallized grain size shall be carried out (American Society of Testing Materials, 2013).
