Reconstruction of rockfall events using dendrogeomorphological techniques in a highly visited climbing area

Stawamus Chief Provincial Park, north of Vancouver, British Columbia, is a popular climbing and hiking destination affected by frequent, potentially hazardous rockfalls. This study documents the recent rockfall history below the North Wall of Stawamus Chief using dendrogeomorphological methods, providing a case study ‘proof-of-concept’ of the use of dendrogeomorphology for assessing rockfall hazards. We produced a geomorphic map of the North Wall based on an interpretation of lidar imagery and collected 245 samples from 74 rockfall-impacted trees (*Tsuga heterophylla*, *Pseudotsuga menziesii*, and *Thuja plicata*) at the base of the steep face at three sites. We generated a 167-year rockfall chronology and reconstructed the spatial and temporal pattern of tree damage using the Shroder index. A total of 911 growth anomalies relate to 51 rockfall events, 11 of which occurred between 1940 and 1959. In a search for possible causes and triggers, we compiled rainfall and temperature data from four meteorological stations and earthquake data from Earthquakes Canada. The average roc

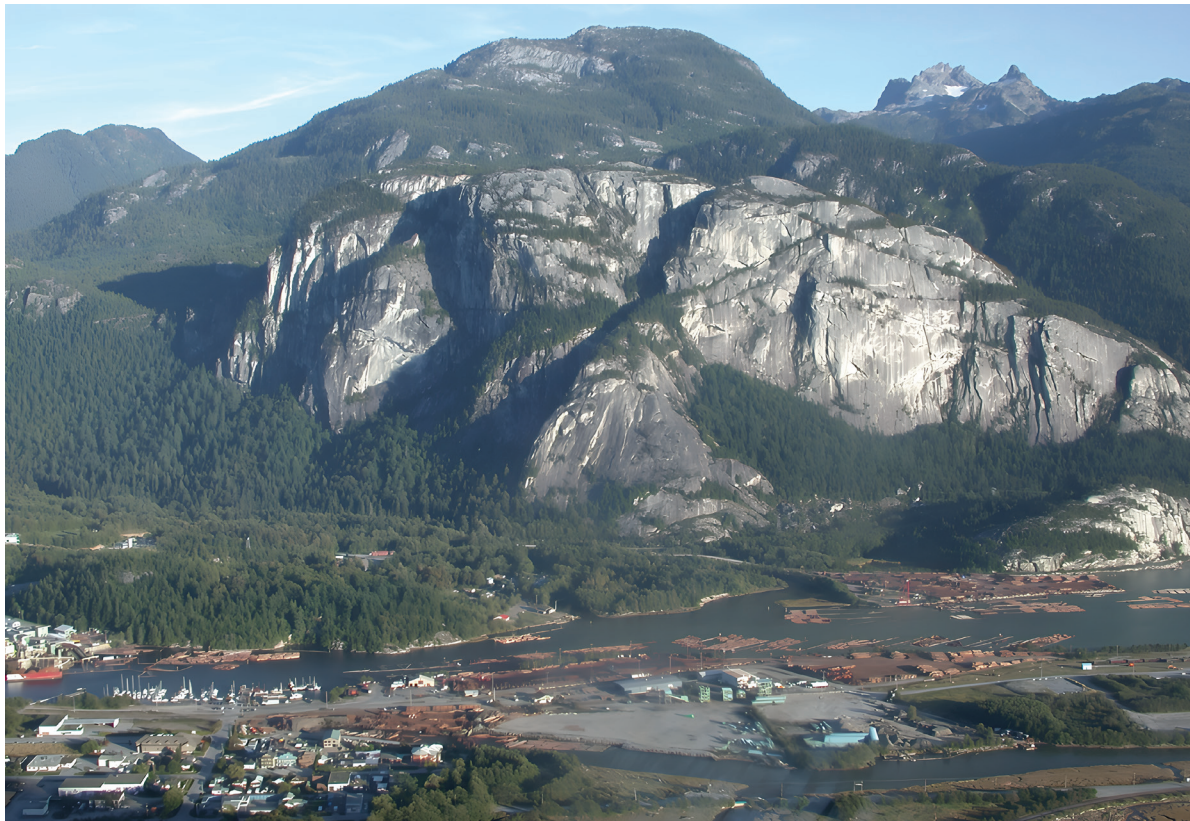
Figure 1 Oblique photo, depicting the Grand Wall and the North Wall of the Stawamus Chief Provincial Park. On the lower left, there is a portion of Squamish, and at the bottom of the North Wall, there is Valleycliffe.

Stawamus Chief Provincial Park, north of Vancouver, British Columbia, is the most popular rock climbing site in Canada and is a known site of large historic rockfalls (Figure 1). The steep rock faces in the park are a source of rockfalls that pose a serious risk to hikers and climbers. Sampaleanu (2017) studied rockfalls on Stawamus Chief and concluded that the hazard is not well understood

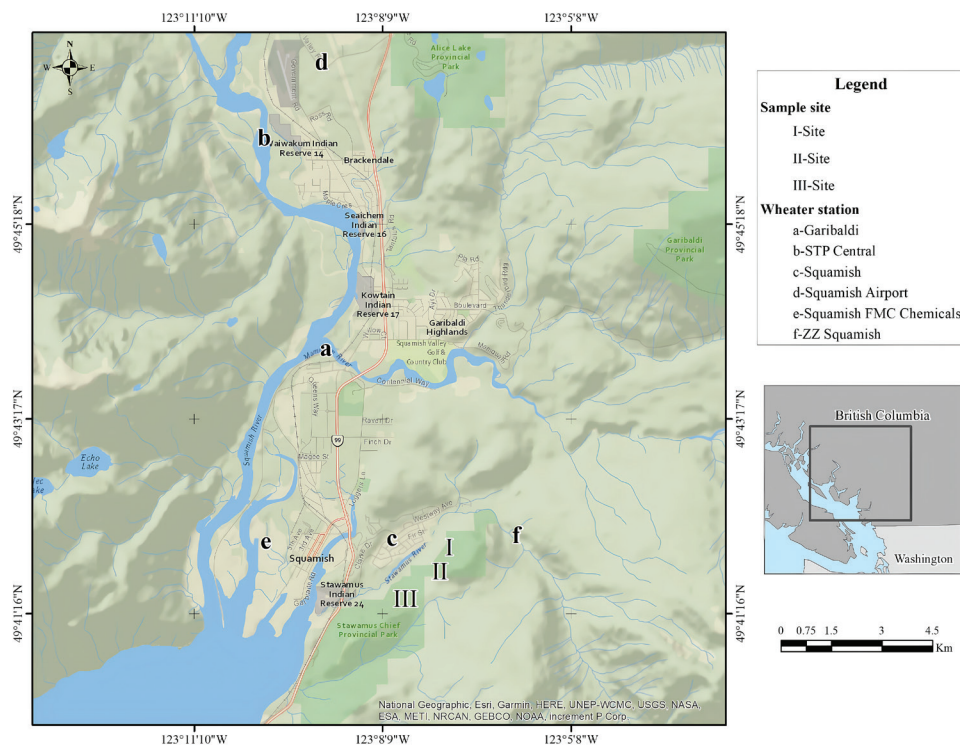
Figure 2 Study area and locations of the sampled trees and wheater stations.

Stawamus Chief Provincial Park is a 530-ha protected area at the head of Howe Sound in the District Municipality of Squamish, just southeast of the town of Squamish, British Columbia (Figure

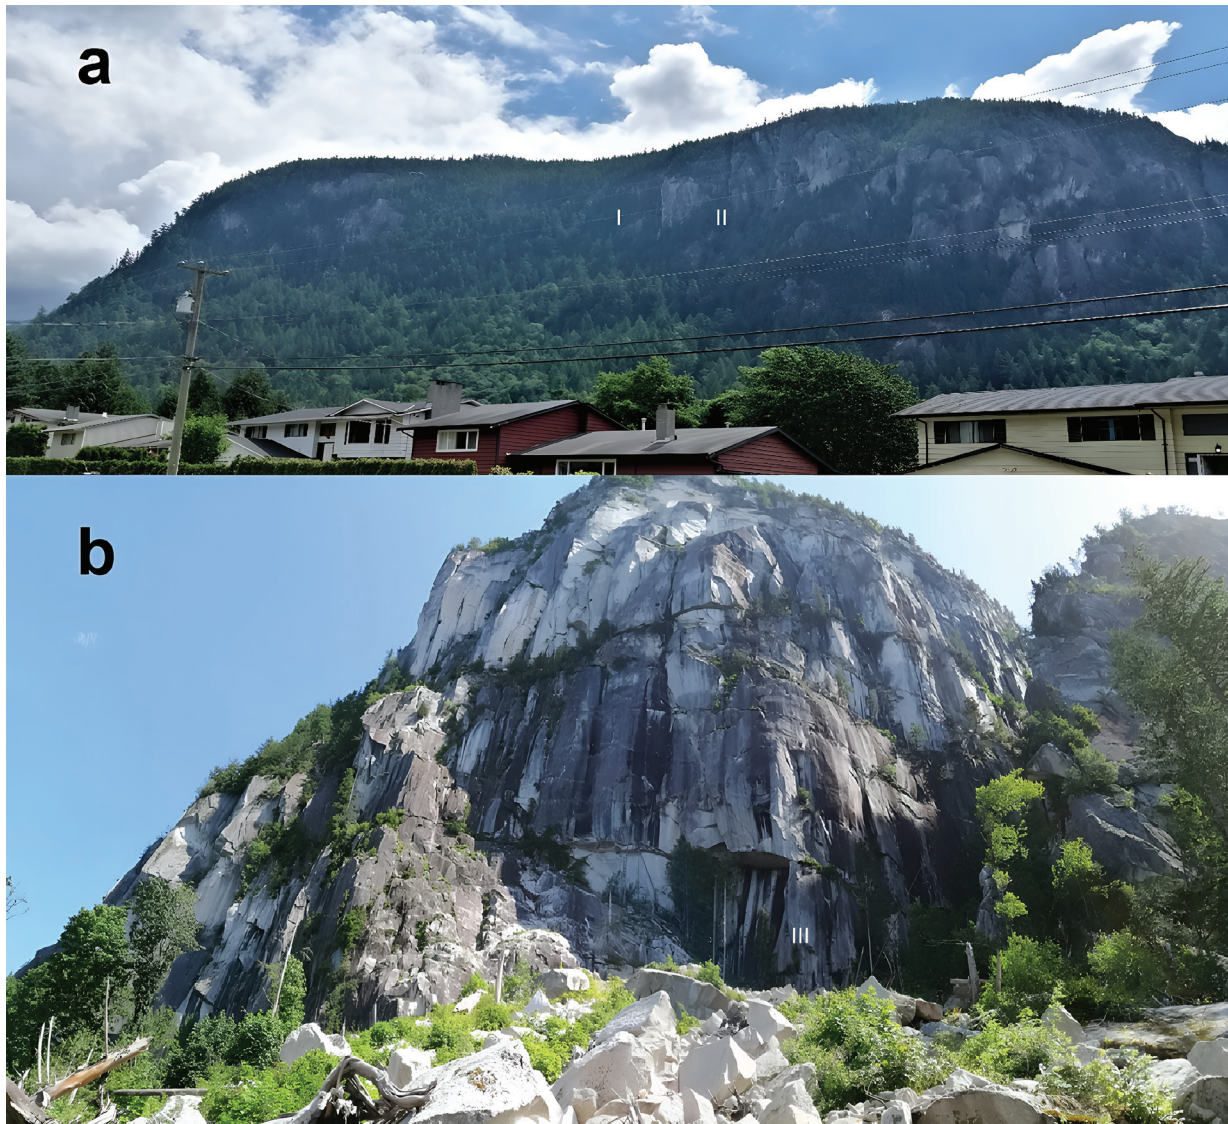
Figure 3 Views of the steep, glacially eroded rock slopes developed in the Middle Cretaceous granodiorite of Stawamus Chief. a) Valleycliffe, where sites I and II are located. B) North end of Grand Wall, site III. See Figure 1 for locations.

2). The Park was established in 1997 to preserve the spectacular, steep, glacially eroded, rock slopes developed in Middle Cretaceous granodiorite (Figures 1 and 3; Monger and Journeay, 1994; Cui *et al.*, 2017). The cliffs extend from about 10 to 695 m above sea level (asl).

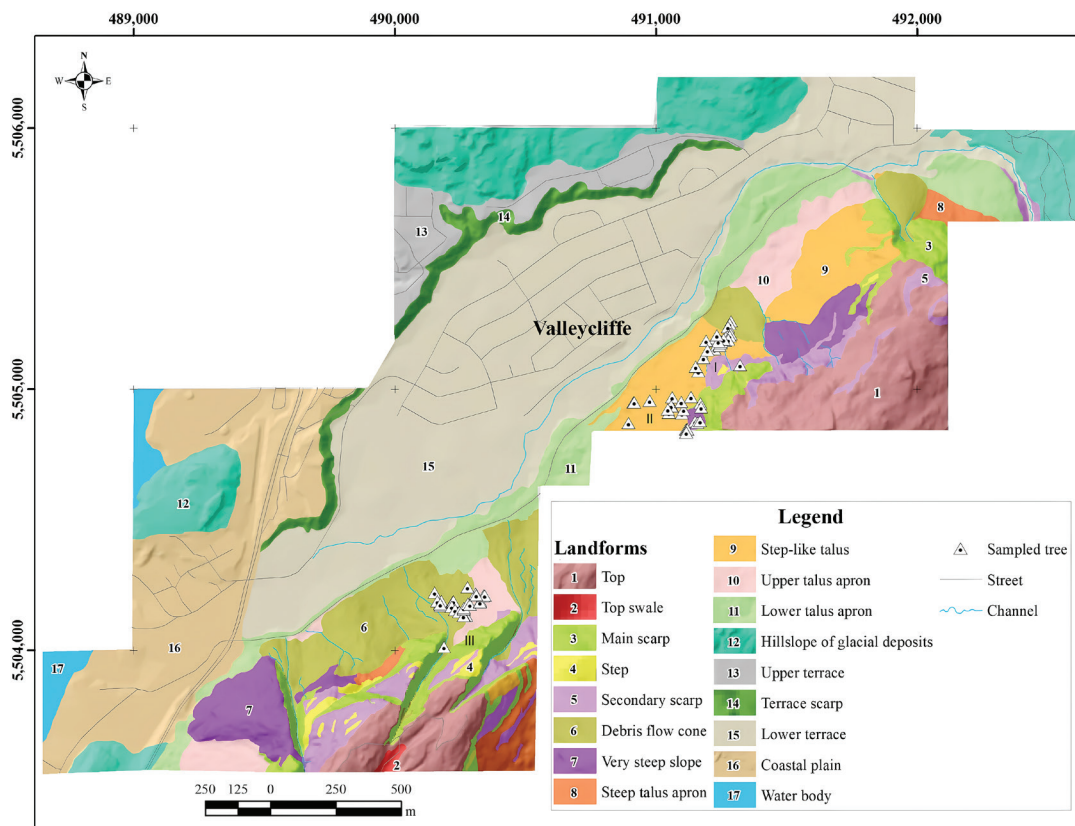
Figure 4 Geomorphic map of the northwest face of Stawamus Chief and the adjacent community of Valleycliffe. The three sample sites are labeled I, II, and III.

To characterize our study site, we produced a geomorphic map of the North Walls and environs in ArcGIS 10.6.1 using lidar imagery with a resolution of 1 m per pixel. The lidar dataset generated

contour lines, topographic profiles, shaded relief, slope, and aspect maps. Data inputs and fieldwork survey landform units were interpreted according to Zinck's classification system (2013).

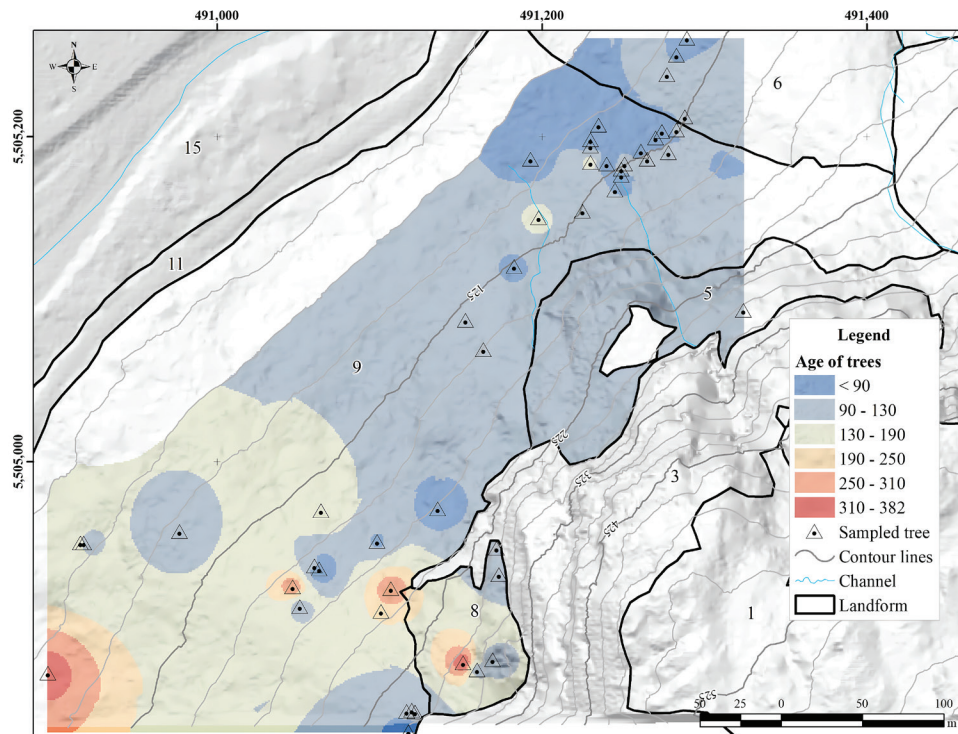
Figure 5 Distribution of tree ages at sample sites I and II. Landform symbols: 1. top of Stawamus Chief, 3. main scarp, 5. secondary scarp, 6. debris flow and rockfall cone, 8. steep talus apron, 9. step-like talus, 11. lower talus apron, 15. terrace.

Sampled trees on the northern part of site I are less than 120 years old, whereas those on the southern part of the site are >200 years old. Trees

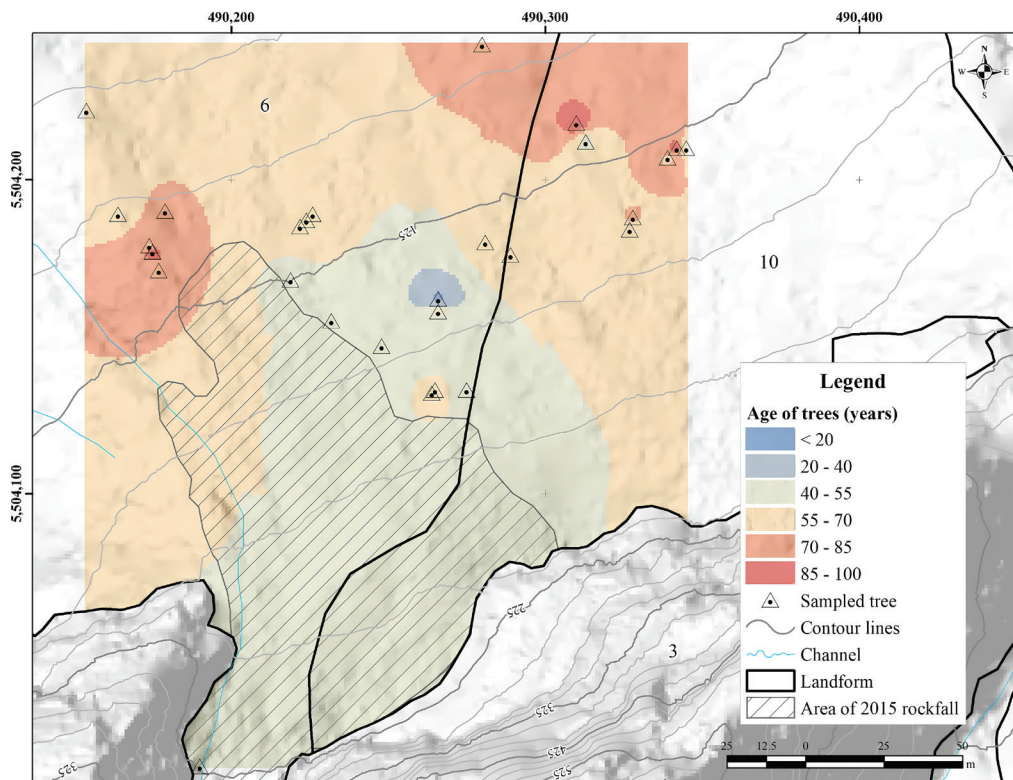
Figure 6 Distribution of tree ages at sample site III. Landform symbols: 3. main scarp, 6. debris flow cone, 10. upper talus apron.

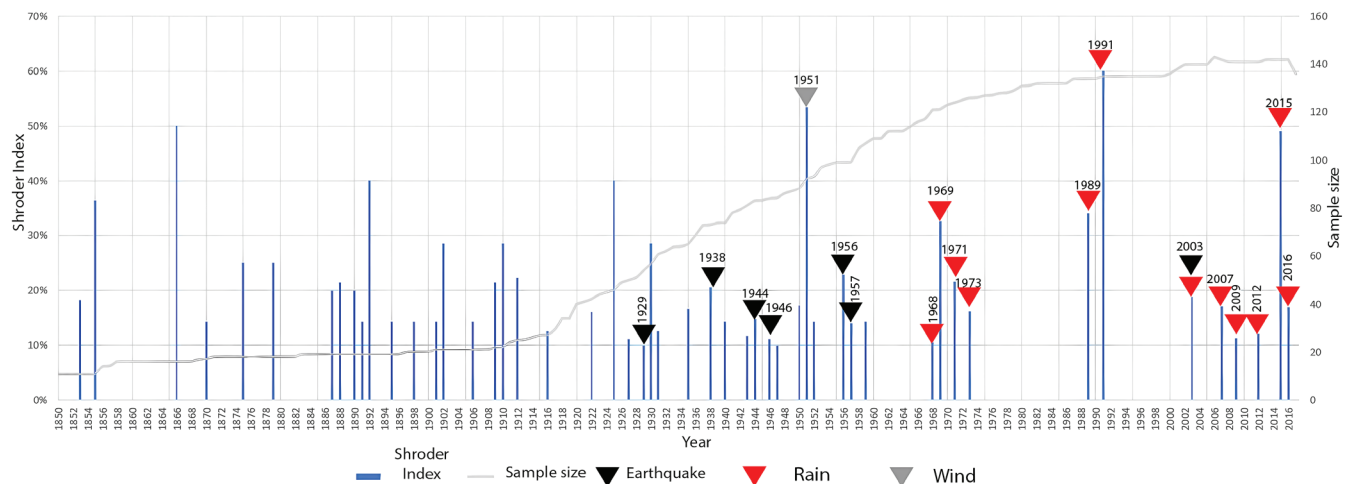
Figure 7 Rockfall events and possible triggers. Black triangles represent earthquakes; red triangles are three-day precipitation values exceeding 10% of the annual precipitation; grey triangles indicate strong winds.

period for which precipitation data are available (1959-2017). Maximum rainfall values of >50 mm over a 3–5-day period are limited to fall and winter months (November-February). Five-day cumulative precipitation values that are at least 10% of the total annual precipitation are limited to four years: 1989, 1991, 2009, and 2015. The highest Shroder index value (60%) we calculated is for the year 1991; this year had 275 mm of precipitation over five days (Table 5). Of these four years, 2009 registered the highest number of days (97) with a range of temperatures that enabled freeze-thaw processes; the other three registered between 53 and 68 days with a range of temperatures above and below 0°C. In 1991, 2003, 2007, and 2015, the maximum five-day precipitation was twice the total November precipitation. These years also correspond to rockfall events with event-response index values of 60.0, 18.8, 17.0, and 49.1, respectively. Those years had between 64 and 82 days with a range of temperatures above and below freezing. Between 1909 and 2005, there were 61 moderate to large earthquakes (Mw 4.5–8.1), earthquakes in British Columbia.

Ten of the largest earthquakes (Mw 6–8.1) occurred in years during which seven (14%) of the rockfall events happened.

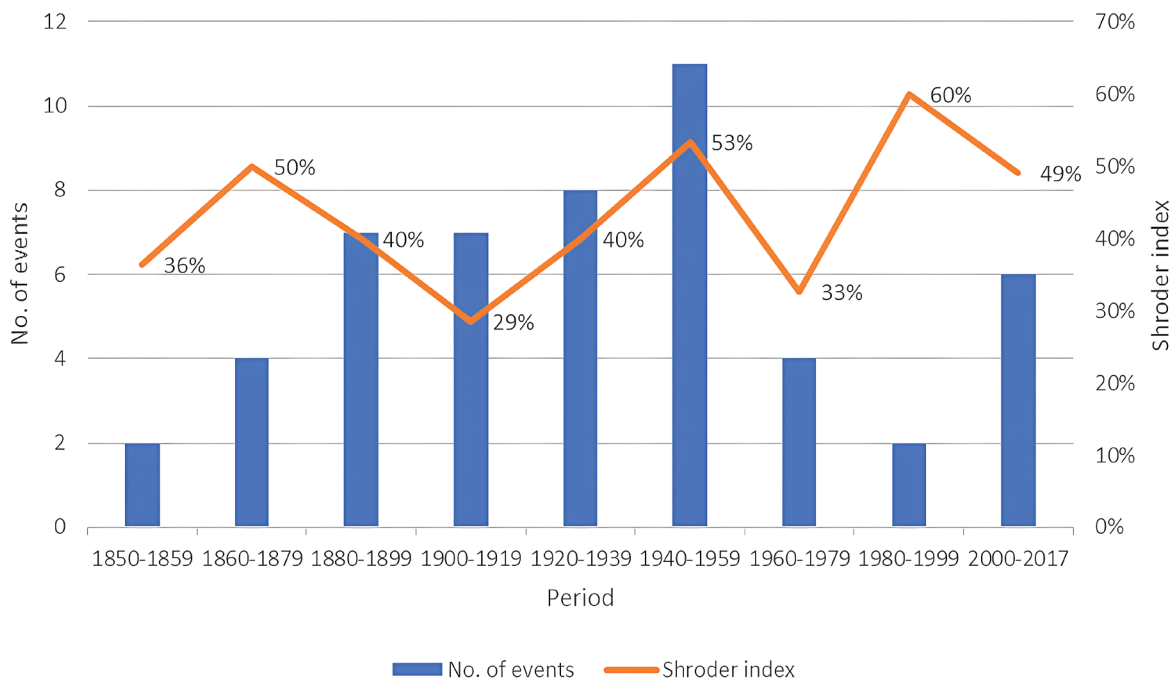
Figure 8 Number of inferred rockfall events and maximum event-response percentage index values binned in 20-year intervals.

whereas between 1980 and 1999, we found only two rockfall events, with event-response index values of 49 and 60%.

to more frequent rockfalls than those in site I (Figure 9). However, samples collected on a step-like talus apron near the base of a very steep slope at site I have an average return period of <8 years, whereas those in a similar position at site II have return periods of >18 years (Figure 8).

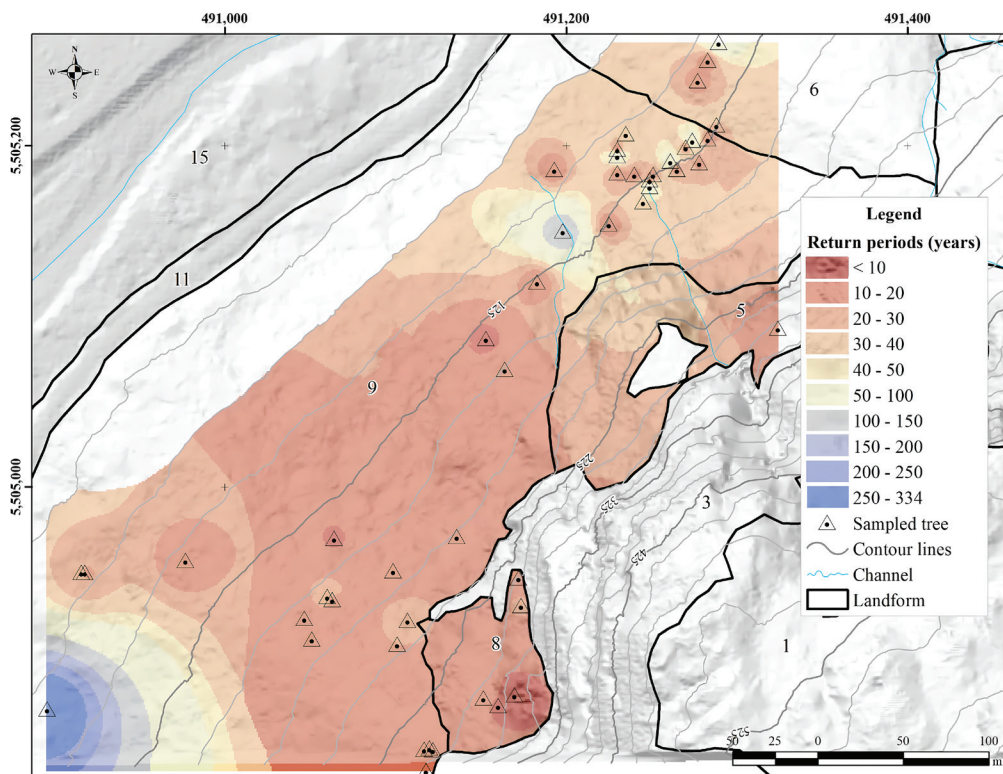
Figure 9 Return periods of rockfalls in sites I and II. Landform symbols: 1. top of Stawamus Chief, 3. main scarp, 5. secondary scarp, 6. debris flow and rockfall cone, 8. steep talus apron, 9. step-like talus, 11. lower talus apron, 15. terrace.

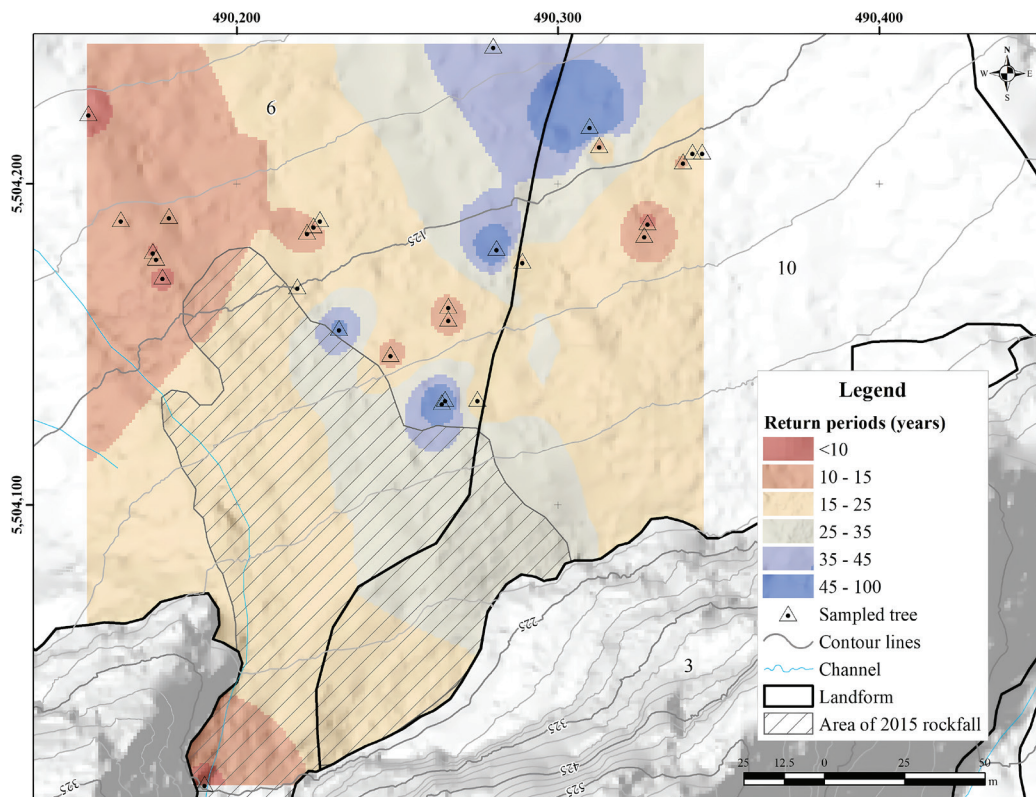
Figure 10 Return periods of rockfalls at site III. Landform symbols: 3. main scarp, 6. debris flow cone, 10. upper talus apron.

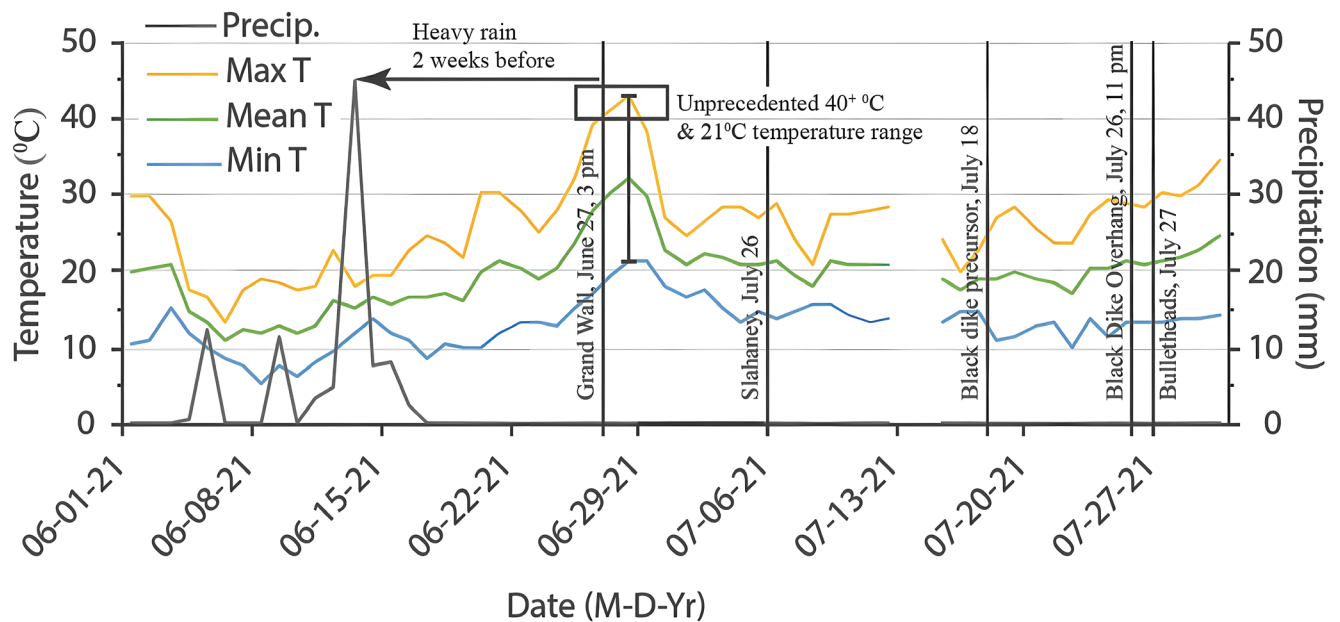
Figure 11 Daily weather values associated with the 2021 rockfall events.

above-normal 5-day rain event. A moderate-sized rockfall occurred on the North Wall on June 27, 2021 (Chua, 2021) during an unprecedented heat wave, when the temperature in Squamish exceeded 40°C for the first time in recorded history. The daily temperature range from July 26 to 28 was also extensive (22°C). Another significant rockfall happened one month later, on July 26, 2021, this time from the west-facing Grand Wall (Gripped, 2021). Although there was no obvious trigger, this event and a series of intervening smaller undocumented events were likely related to the June heat wave (Friele 2022; Figure 11). Extreme temperature has been recently evaluated as an environmental factor affecting mountain geohazards, such as debris flow and rockfall (Xu *et al.*, 2024); they explored the responses of mountain geohazards to climate change, including the rising temperature and precipitation, identifying their close relation to a warming climate. Personal observations by the authors, the climbing community, and social media indicate that an unknown number of small rockfall events go unrecorded.
