Recognition and Reuse of Industrial Heritage for its Conservation. Cornish Machine Houses in Pachuca and Real del Monte, Hidalgo, Mexico

Cornish engine houses; industrial heritage; recognition; conservation; reuse

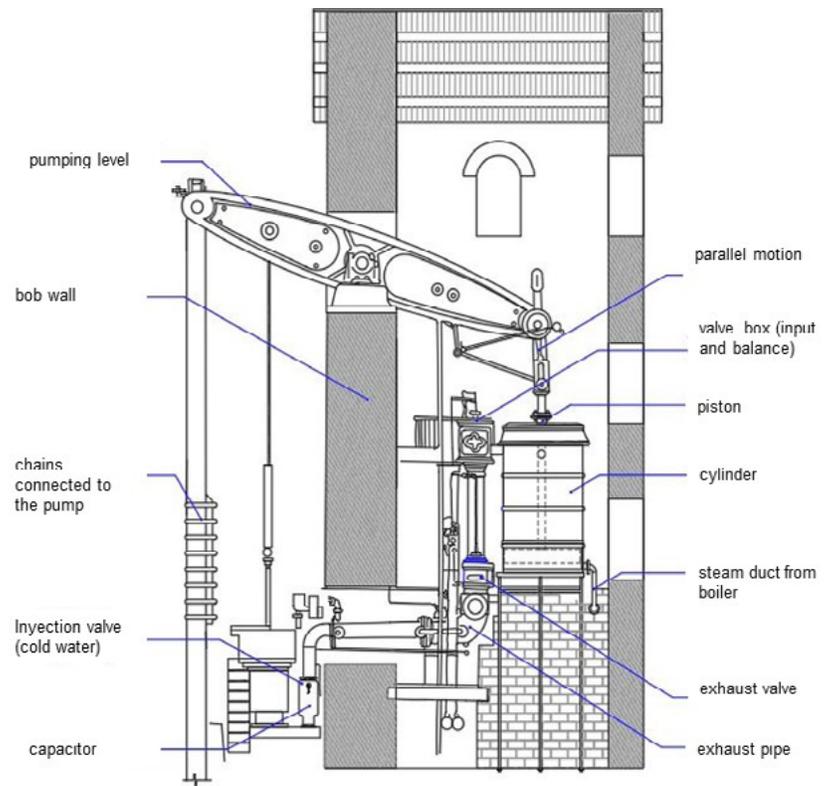
FIGURE 1. Schematic diagram of a drainage machine in cut, together with the Cornish house (Schematic diagram: Lozada y Lagarda, 2021; source: Laws, 1978, p. 5).

Figure 1 shows its basic parts —installed inside the powerhouse— and then shows the operating cycle, based on the description of Hernández (2002) and the company Crofton Beam Engines, one of the most important companies in the preservation of this type of heritage in England, which used Watt's version (Crofton Beam Engines, 2015, p. 2).

1. The cycle started with the pumping lever in a downward position, facing the draft. The cylinder inlet and exhaust valves remained open while the balance valve was closed. The operator would open the valve, steam would enter at the top of the piston and push it down, this would raise the pumping plunger; halfway through the stroke, the inlet valve would close and the steam would continue its expansion (Crofton Beam Engines, 2015, p. 3).
2. Halfway through the cycle, the exhaust valve would close and the balance valve would open, allowing steam above the piston to pass into the cylinder, which is lifted by the weight of the plunger, displacing steam into the vacuum below the piston (Crofton Beam Engines, 2015, p. 3).

3. At the end of a cycle, the balance valve closes as the exhaust valve opens. At the same time, the inlet valve opens to allow another steam injection. When the exhaust valve opens, a stream of cold water is injected into the condenser; the valve is connected to the exhaust system, causing the steam under the piston to condense, thus producing a vacuum (Crofton Beam Engines, 2015, p. 3).

4. At the next cycle, the pressure difference between the steam above and the vacuum below causes the piston to drop. In this way, steam is injected into the cylinder which was used twice and recovered as hot water inside the boiler (Crofton Beam Engines, 2015, p. 3).

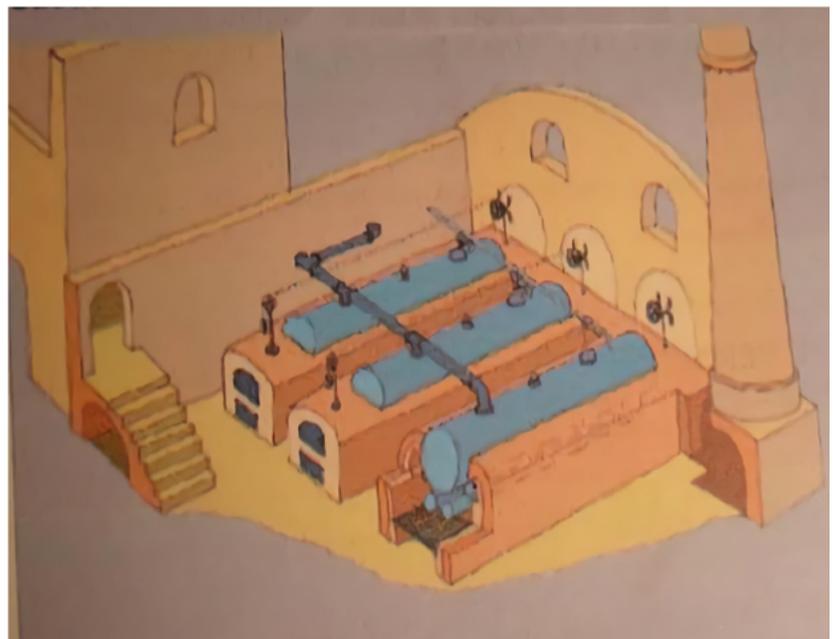
FIGURE 2. Isometric of a section of the pumping house within the boiler room (Source: Arrayanes Project, 2006).

To one side of the pumping machine house was the boiler room (Figure 2)² (Colectivo Proyecto Arrayanes, 2006), an elongated enclosure of a single level, practically half the height of the house mentioned above. Nearby must have been the sheds where firewood or charcoal was stored. Naturally, in that room were the boilers, whose bases were made of stone or brick, which were connected to the base of the chimney. The walls were made of stone laid with lime and sand mortar, flattened with the same material. They would usually have a gabled roof with openings made for ventilation.

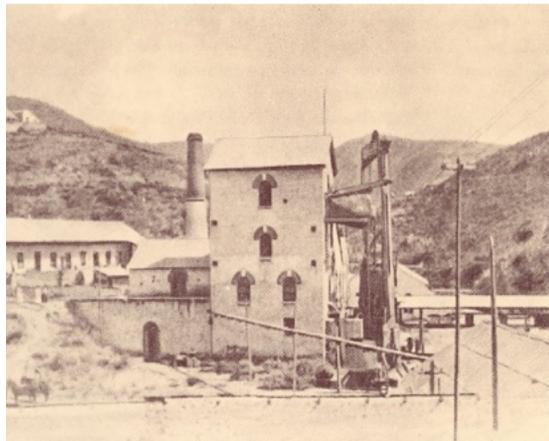
FIGURE 3. Maravillas Mine (Source: Soto, 1985, p. 250).

For the powerhouses, only photographic records survive to tell the tale of the predominance they once had over the landscape. Among them, the Maravillas mine (Figure 3) and the Xotol mine (Figure 4): yet, architecturally, only the chimney of the latter survives.

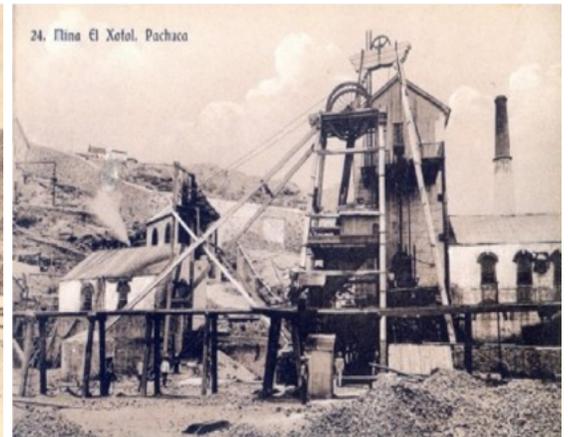
FIGURE 4. Xotol Mine, Barrio de Camelia (Source: Mediateca del INAH, ca. 1900).

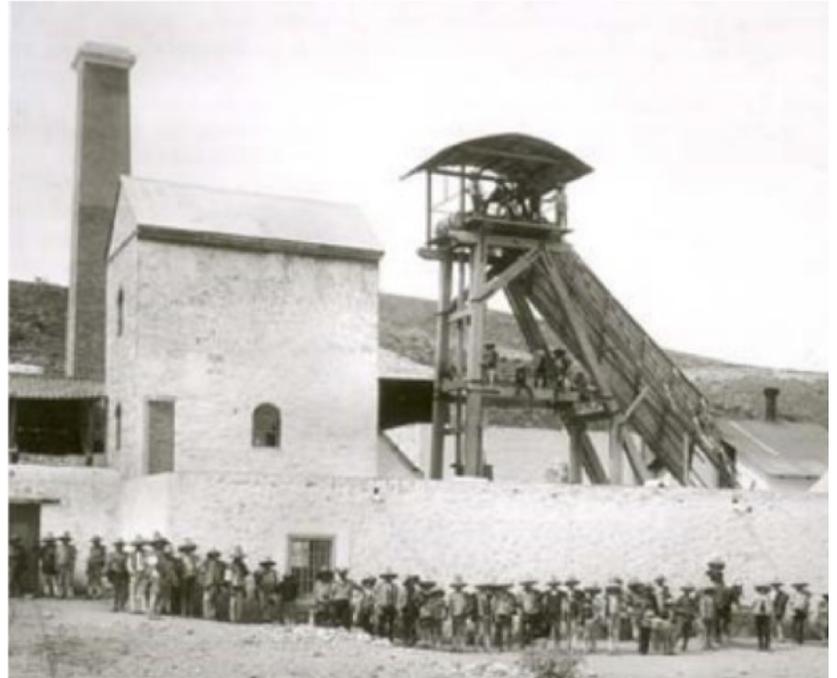
FIGURE 5. La
 Corteza Mine
 (Source: Villalobos,
 2004, p. 26).

The Corteza mine (Figures 5, 6 and 7) is located north of Pachuca, in the Anáhuac neighborhood, one of the most disadvantaged in the city. According to data from the Archivo Histórico de Minería, in a report by the mayor of Tulancingo, Pedro José de Leóz, by 1750 good metals were being extracted from it. In 1770 another report, made for the Viceroy Marquis de Croix, mentions it as abandoned due to it being too full of water, a situation that continued until 1780. At the beginning of the nineteenth century it began to enter production again, but due to the pressure of the insurgents,

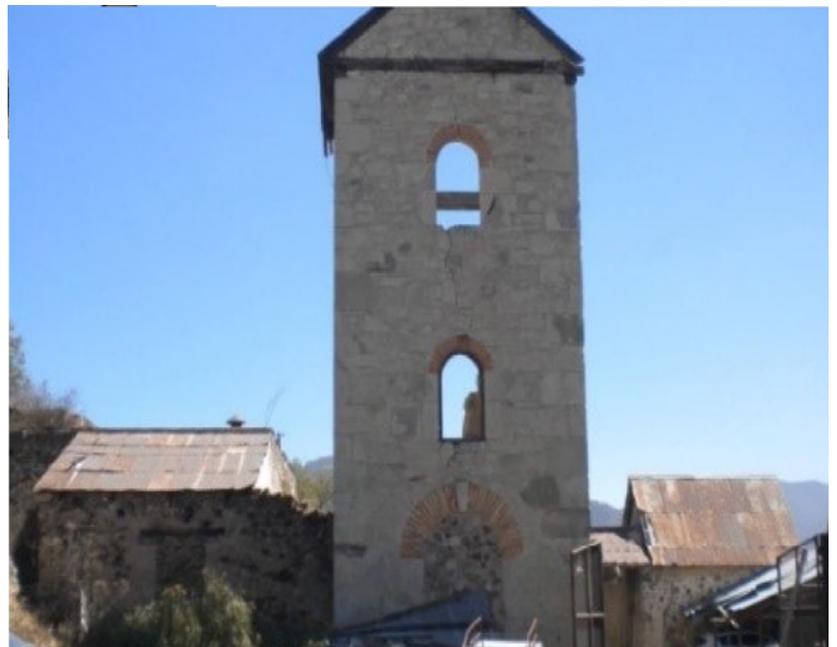
FIGURE 6. La
 Corteza Mine.
 Current state
 (Source: Hidalgo
 Tierra Mágica, A. C.,
 2021).

The mine has no current use; its vestiges are abandoned and parts of the roof and walls have already collapsed. There are no visible traces of the chimney.

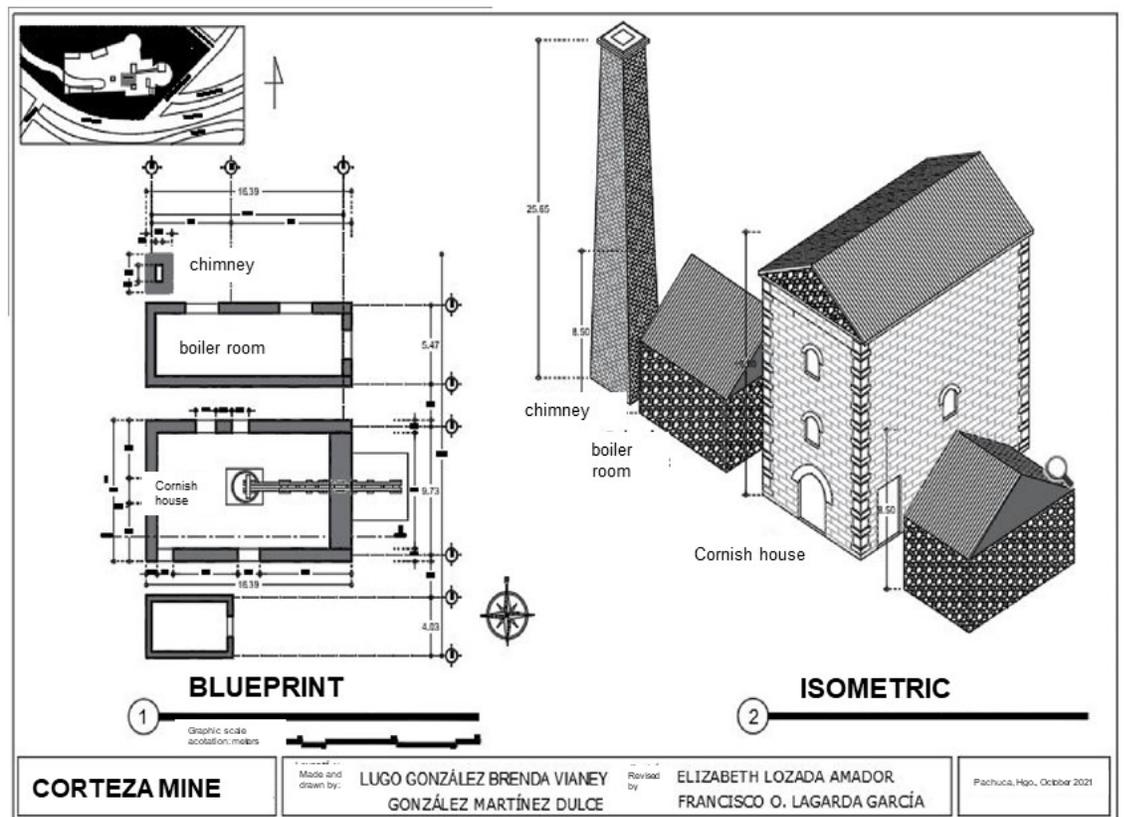
FIGURE 7. La Corteza mine. Hypothetical reconstruction (Plan: Lugo, & González, 2021).

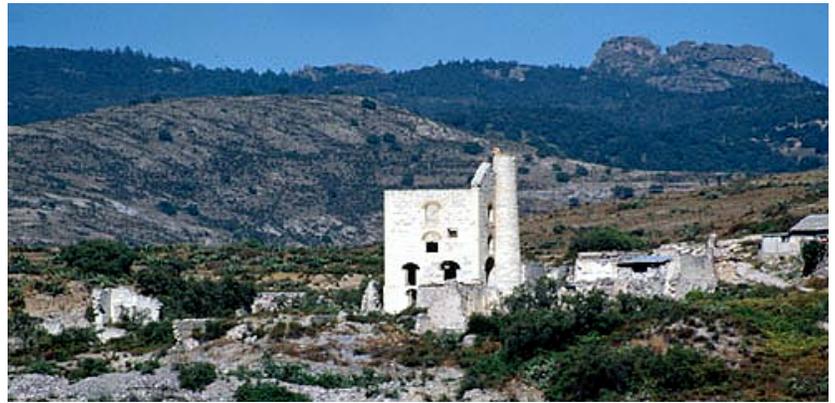
FIGURE 8. San Pedro la Rabia Mine
 (Source: Schwartz, 2021, <https://projects.exeter.ac.uk/cornishlatin/cornishlatinamerica.htm>)

The San Pedro la Rabia mine is north of Pachuca (Figure 8), in the middle of a desolate landscape where the expanding urban sprawl has not yet reached. Although it is difficult to get close to it, it can be seen from the road leading to the Cristo Rey viewpoint on the Santa Apolonia hill. This powerhouse is different in that it has a chimney attached to it (in the others the chimneys are free-standing) (Figure 9). Its state of conservation is perhaps the most dilapidated, but its natural context makes it stand out and gives identity and historical context to the landscape of the region. It currently has no practical use or function.

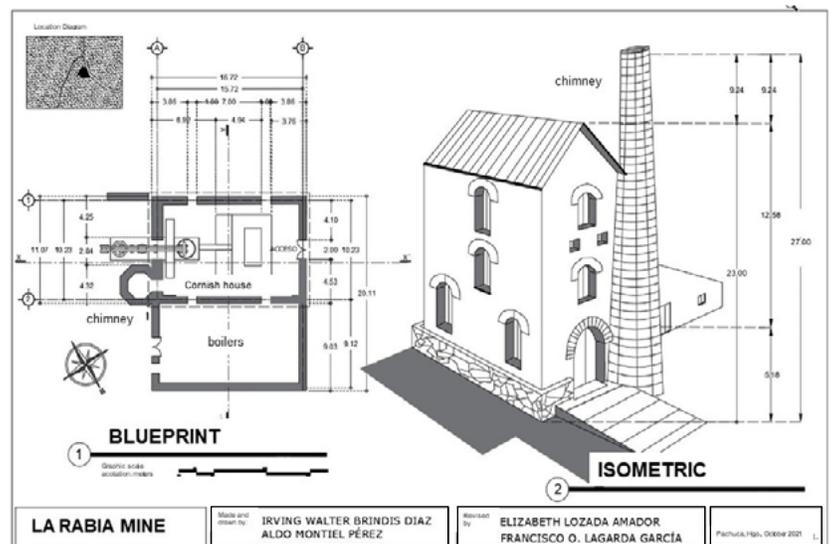
FIGURE 9. San Pedro la Rabia mine. Hypothetical reconstruction (Plan: Brindis, & Montiel, 2021).

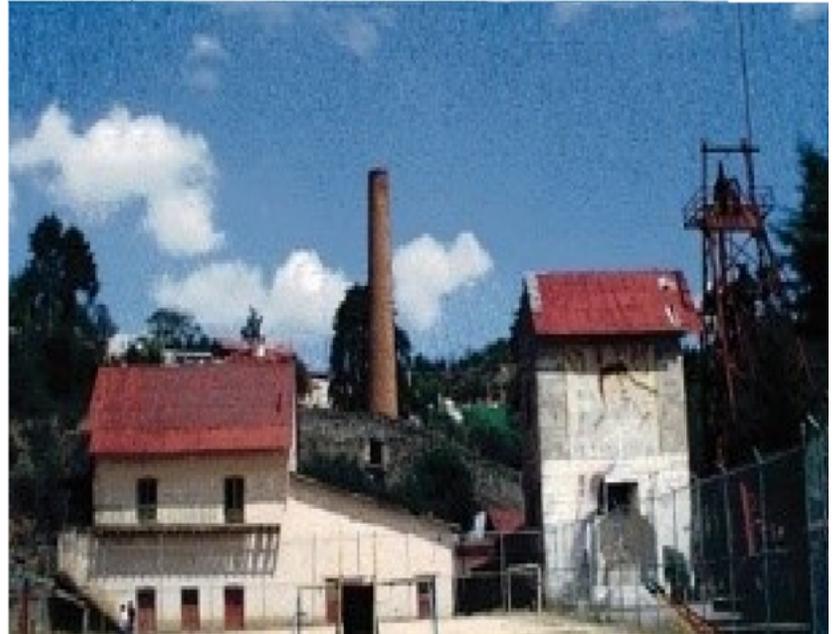
FIGURE 10. Dolores Mine (Photo: Lozada, 2007).

The Dolores mine is located in Real del Monte (Figures 10, 11), next to the main public parking lot for visitors to the town. It was exploited since the 18th century by Pedro Romero de Terreros. The British company received it in ruinous conditions. According to the inventory of 1824, it was an operating shaft 135 m deep, with the mouth provided with masonry arches, walls, remains of galleries, stables and barns, all in a disastrous state. By 1849 the British handed it over to the Mexican Company with the following: “A steam engine with a 65-inch cylinder, used in the general drainage; its three boilers; buildings for living quarters and for housing the engine, boilers and a furnace; three sets of pumping apparatus”¹⁰ (Randall, 1997, pp. 240-241). Warehouses and workshops

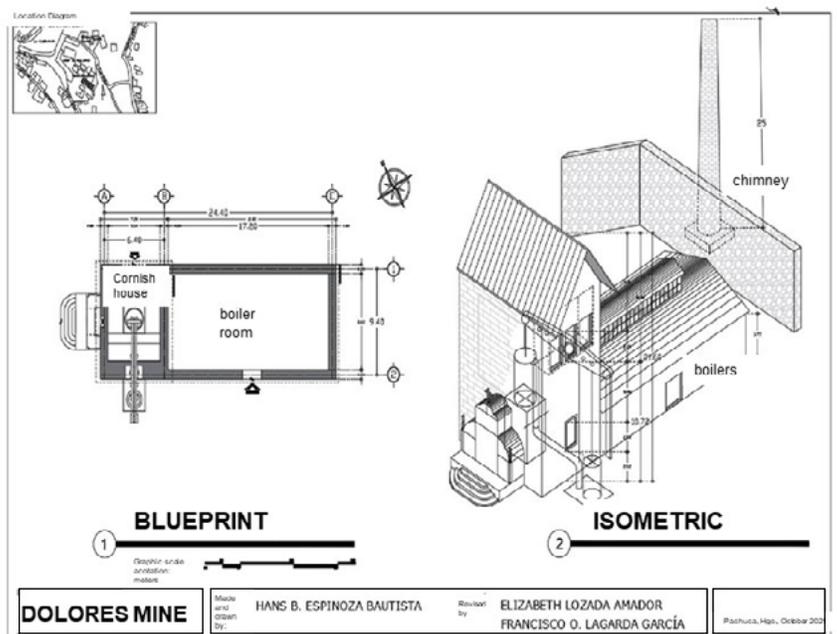
FIGURE 11. Dolores Mine. Hypothetical reconstruction (Plan: Espinoza, 2021).

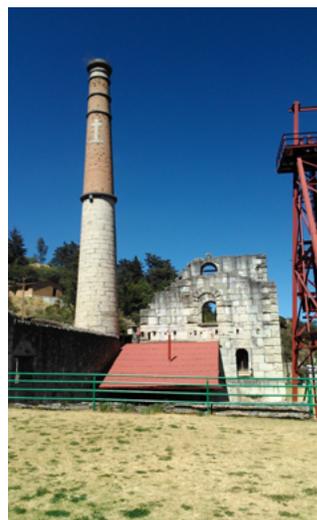
FIGURE 12. Acosta Mine (Photo: Lozada, 2007).

The Acosta mine (Figures 12, 13) is located within the boundaries of the town of Real del Monte; and still has passable vehicular access road. Its exploitation began in the Spanish era, pass-

ing through English and North American entrepreneurs, and it still has vestiges from that time. The arrival of steam technology at the mine was recorded in mid-1839, when John Rule ordered the installation of a 30" engine (Randall, 1997, pp. 109-110). By 1861 it had two steam engines, which were dismantled along with the buildings that housed them. The current Cornish house that stands out in the complex dates back to 1874, a date carved on its east facade. It houses an engine that was completed on January 11, 1875. The bases of the boilers are preserved and its chimney, is one of the only ones that remains perfectly preserved in the region. The superintendent's living quarters are also preserved from the same period (Archivo Histórico y Museo de Minería, 2008). It is currently a site museum in which the entire complex has been restored, yet, the Cornish house, together with its chimney, are the undisputed protagonists of the place.

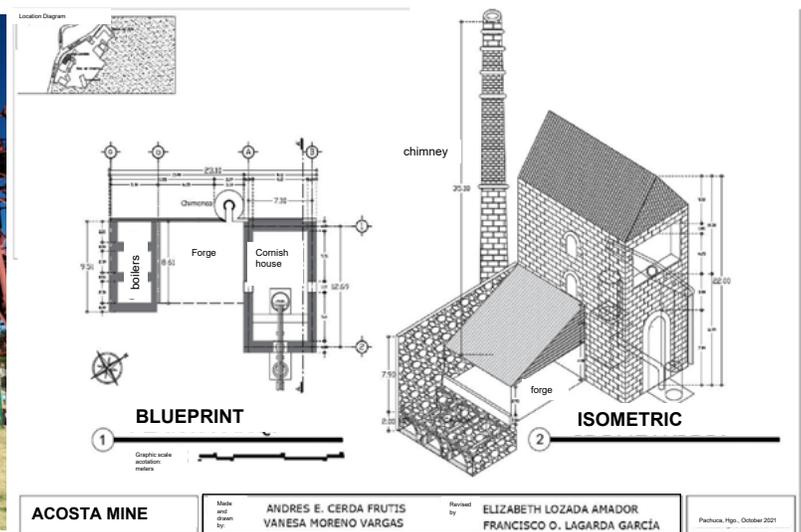
FIGURE 13. Acosta mine. Hypothetical reconstruction (Plan: Cerda, & Moreno, 2021).
