Image analysis on disintegrated concrete at the post-heating stage

A. H. Akca^{1*}

, N. Özyurt²

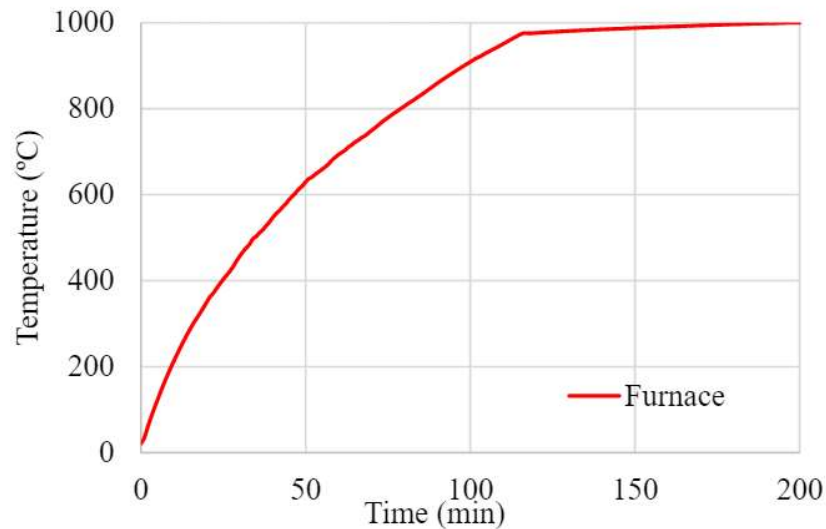
Figure 1. Heating procedure.

An electrical furnace which has a 1250 °C maximum operation temperature was used in this study. Two stages of heating were determined and during the first stage, specimens were heated to 1000 °C and during the second stage specimens were kept at this temperature until the end of the total heating time (200 minutes). Figure 1 represents the heating procedure. Electrical furnace was operated at full power and temperature inside the furnace reached 1000 °C in approximately 120 minutes. Since furnace heating capacity was limited, heating rate was 20°C/min at the beginning but the rate decreased to 5 °C/min at the end of the first stage of heating. After the second stage completed, hot concrete specimens were not taken out until the furnace cooled down to 100 °C.

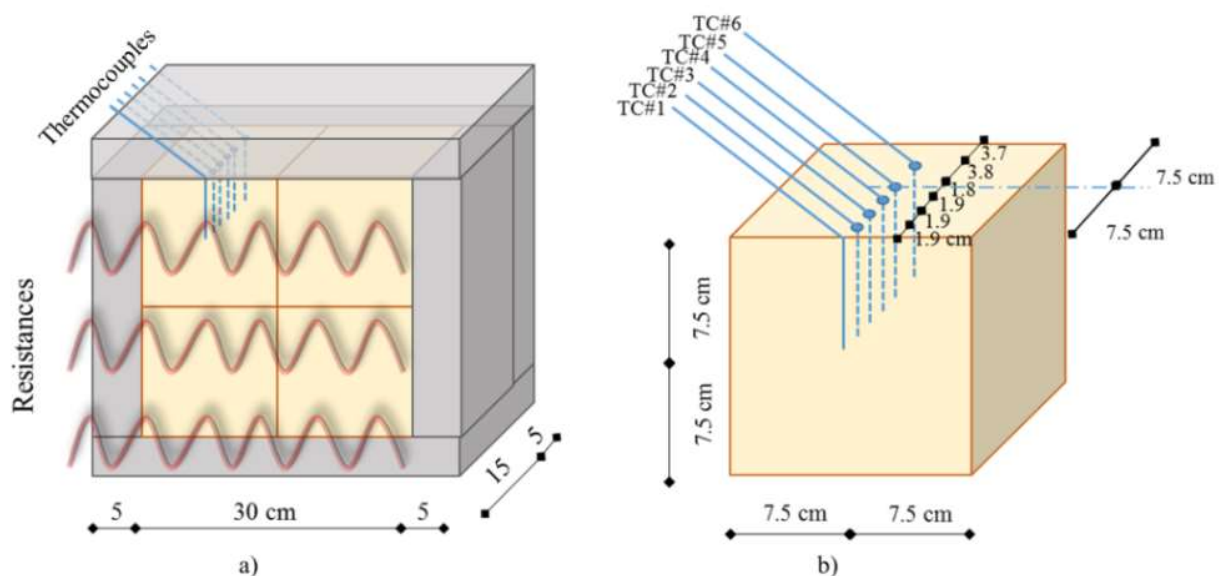
Figure 2. a) Heat insulation of concrete specimens in electrical furnace, b) positions of the K-type thermocouples used to monitor temperature change.

Four concrete cubes were placed together in the electrical furnace and in order to simulate one face heating conditions they were insulated with aerated concrete blocks as shown in Figure 2. For temperature monitoring K-Type thermocouples were placed inside a concrete specimen during heating.

Temperatures of heated surface and inner parts of concrete cubes were monitored during heating and temperature monitoring continued further during cooling of the furnace (150 minutes more). In cooling period, although heating of furnace was stopped, temperatures in concrete continued to increase. Thermocouple data was very close when they were compared in terms of cementitious material types. Therefore, all concrete groups were gathered under two categories depending on use of AEA in them. Table 2 shows average maximum temperatures monitored in concrete categories with and without air entrainment during total temperature monitoring (200+150 minutes). Results showed that, temperatures experienced in air entrained concrete were less than that of concrete without air entrainment. When the whole heating and cooling period is considered it can be seen that concrete groups experienced at least 583 °C of temperature which may result in severe strength losses (Poon et al. 2001; Akca and Özyurt, 2013).

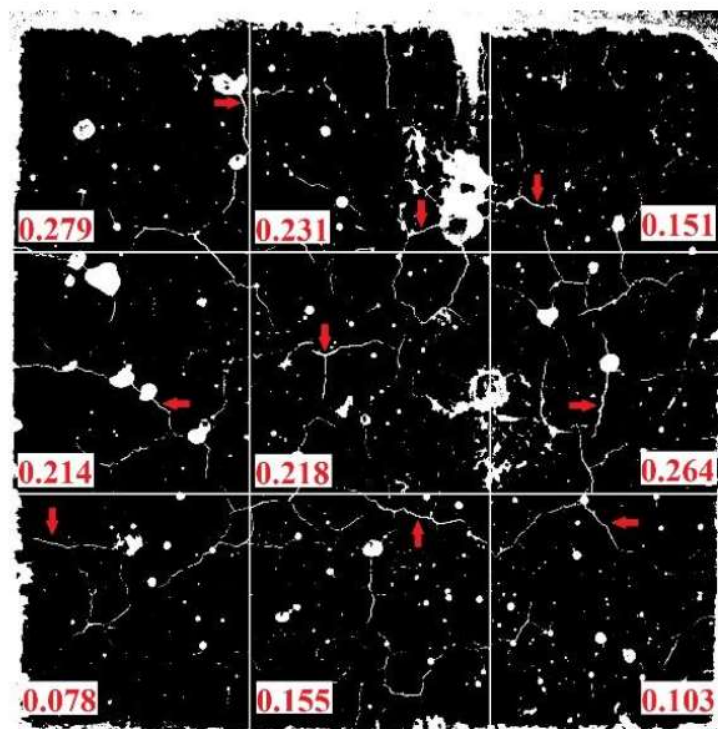
Figure 3. Crack width measurements on a C00X specimen (surface just after cooling).

Visual changes on heated or fire exposed concrete give information about maximum temperature experienced and amount of deterioration of concrete (Yüzer et al. 2004; Ingham, 2009). Therefore, photograph of the heated face of a survived specimen from each concrete group was taken by using a DSLR camera. These pictures were analyzed via software called Image J as can be seen in Figure 3. During an analysis the whole picture area was divided into 9 subareas and maximum crack widths of each subarea were measured and then mean crack widths were obtained.

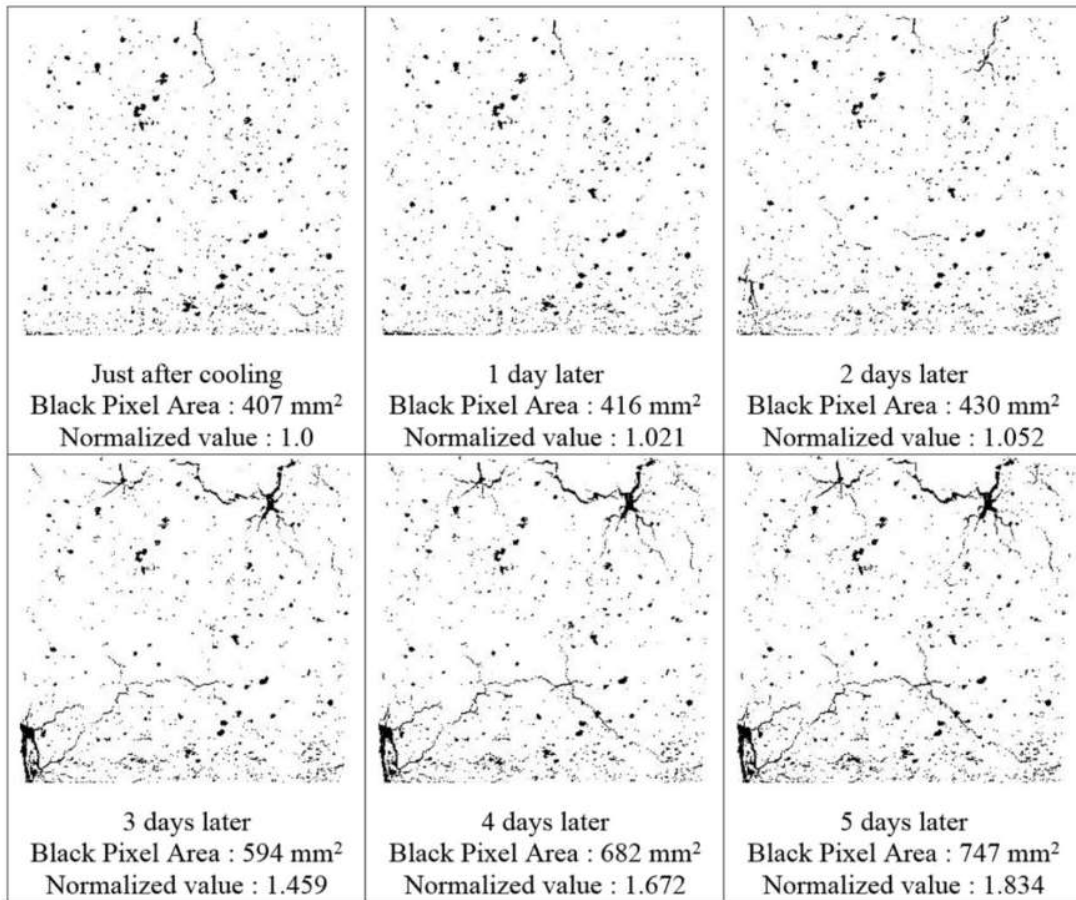
Figure 4. Crack growth monitoring on black and white images captured from COPZ specimen during air re-curing.

Development of cracks during air re-curing was monitored by taking photos of heated surfaces at every hour for a week. A high resolution DSLR camera and a 100 mm macro lens were used in order to obtain detailed images. As can be seen in Figure 4, these images were converted to 8-bit black and white images by using Image J and black pixel analyses (BPA) were conducted on them. Black pixels represent cracks, air voids, surface delamination and shadow (due to positions of spotlights) on the heated surfaces of specimens. Total areas of black pixels were calculated for all images separately. Then these calculated values were divided to black pixel area of first image in order to obtain normalized area values. Finally, normalized area-time graphs were drawn for all concrete groups except the groups experienced spalling during heating and trend lines were fitted on the graphs as shown in Figure 5. These curves were used to monitor deterioration of concrete for a week. The slopes of fitted trend lines were called BPA rates and they were compared to compressive strength reduction ratios of air re-cured concrete groups.

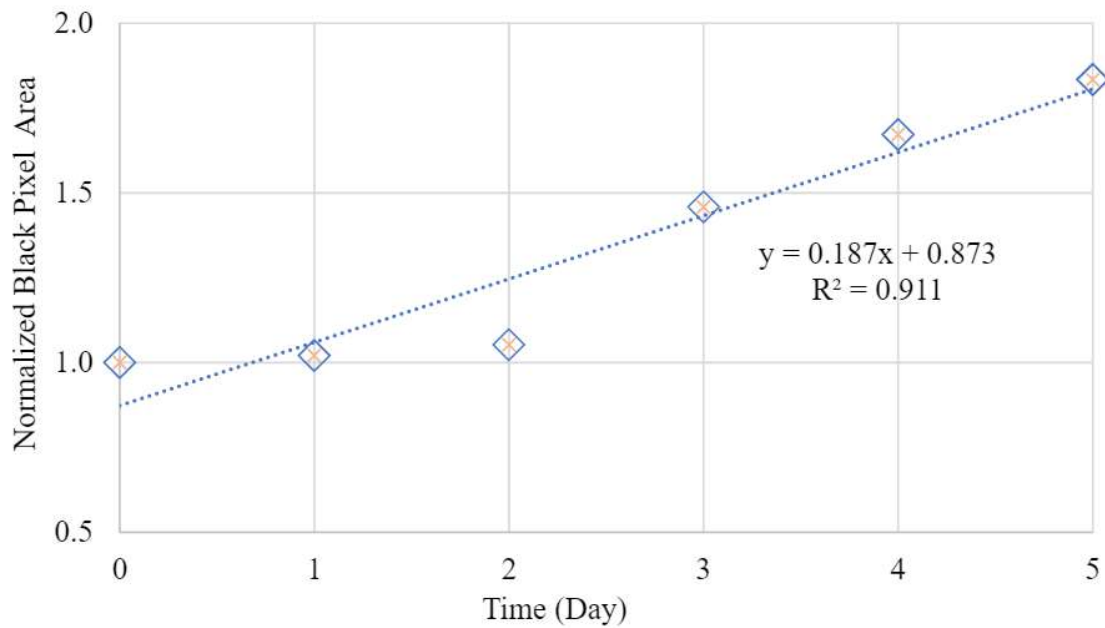
Figure 5. Black pixel analysis value of COPZ specimen.

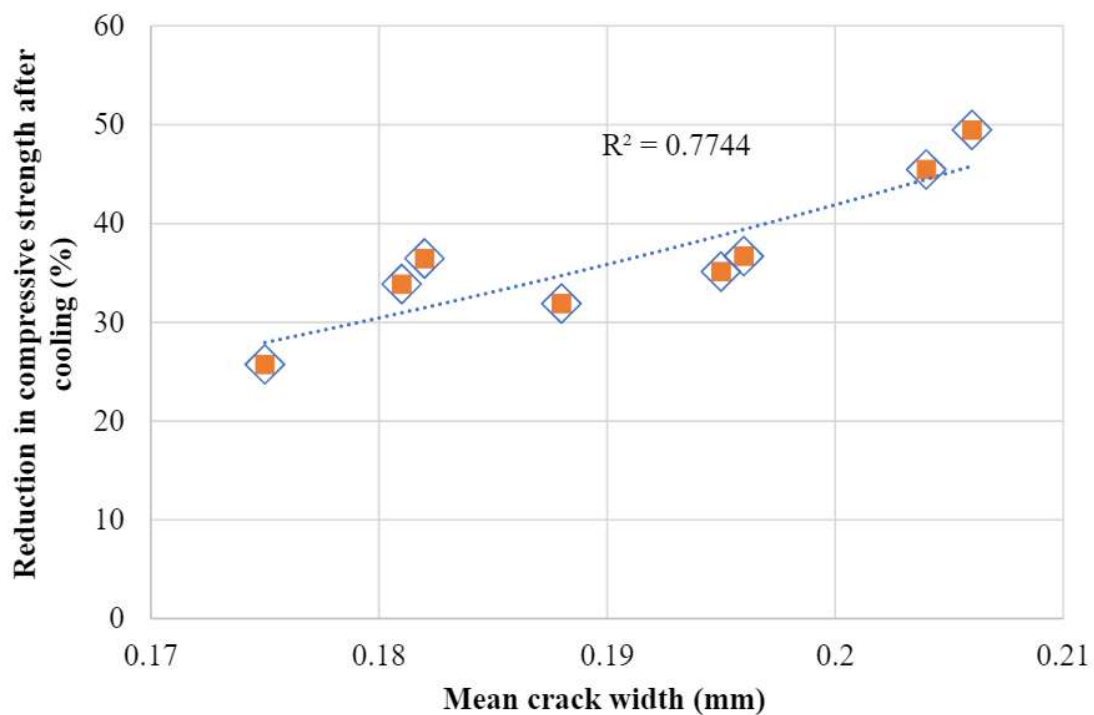
Figure 6. Relation between reduction in compressive strength and mean crack width after cooling.

Calculated average crack widths were compared to reduction in compressive strength of specimens after cooling as can be seen in Figure 6. Results showed that increase in average crack width of specimens caused increase in reduction in compressive strength. This relation can be used to predict the extent of the deterioration in residual mechanical properties of concrete elements without applying destructive tests on them after an event of a fire.

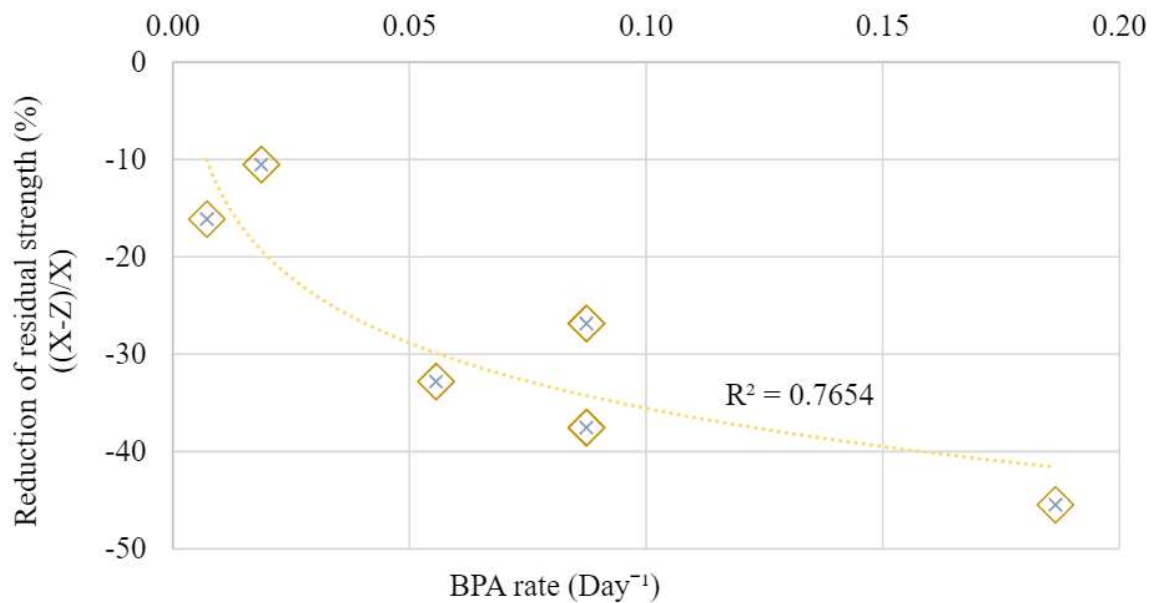
Figure 7. Black pixel analyses results.

After comparison a scatter gram was obtained as shown in Figure 7 and it showed that there was a logarithmic relation between changes in compressive strength and BPA rates. Calculated R² value for all set of data was 0.77. This rate can be increased by using advanced photographing techniques, by analyzing in specific software, by increasing sample size etc. For example, air voids on the surface of the specimens influence the total amount of black pixels. If the effect of air voids is somehow eliminated more accurate BPA rates can be obtained.
