## The pathological manifestations and risks of the protectors of air conditioners in buildings

Faced with the large number of partial or total collapses in buildings, the objective of this study is the identification of the pathological manifestations and the risks of the supports for air conditioners of reinforced concrete in the buildings. The data were collected by 3D software and consolidated in the field. Of the 61 buildings analyzed, 48% are of the window model which, in a situation of degradation and fall, can reach the ground with an impact of the order of tons. In coastal regions, we add the accelerating effects of the corrosion of the reinforcement, such as high humidity, pollution by automotive vehicles and marine region. It was concluded that these supports do not have adequate structural designs, allied to the low quality and accelerating effects of the reinforcement corrosion, rendering them not recoverable.

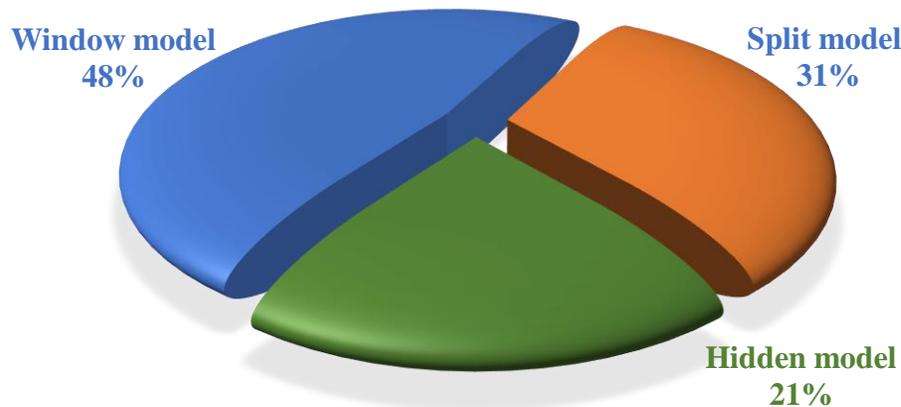
Figure 2. Building cooling system support systems.

After gathering information, it was possible to identify 3 types of support systems for refrigeration appliances, which are: reinforced concrete protective boxes (window type), others supported by windows or spans (adopted as a hidden model) and the use of structures already incorporated into the building (split model), thus reaching a total of 61 buildings analyzed, Figure 2.

Thus, it was found that 48% of buildings use window type models, 21% with the hidden model and finally, with only 31% the models that integrate the structures of buildings (split appliances), by the way come from latest projects.

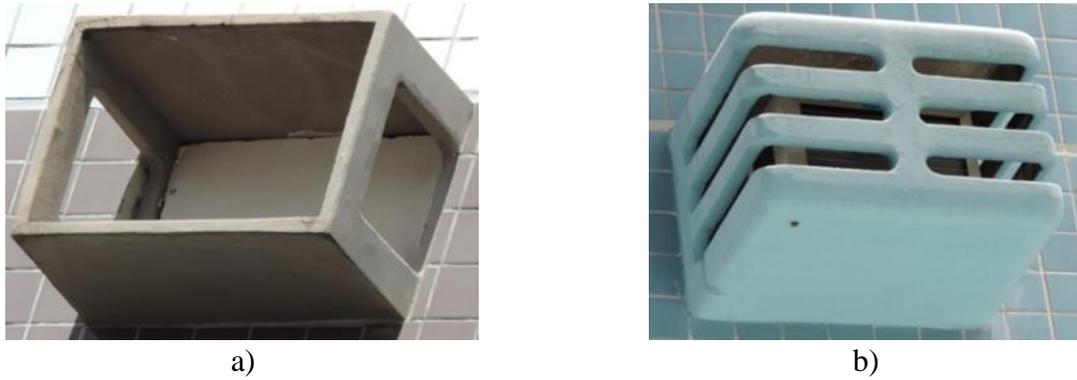
Figure 3. Reinforced concrete support, window type: a) open model; b) closed model.

What can be highlighted from the collected data is the existence of two models of window-type reinforced concrete protectors, out of a total of 29, 20 for the open model and 9 for the closed model, for their characteristics and dimensions, one can consider the most open model fragile, that is, almost 70% of the buildings that have window-type reinforced concrete protector have the simplest model and therefore generate a higher risk of premature wear. Below are the models represented in Figures 3 and 4.

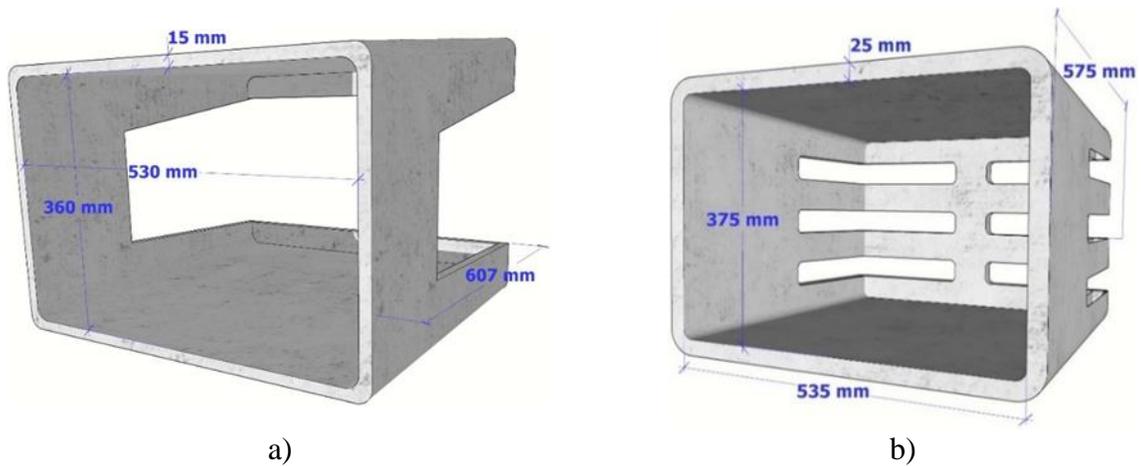
Figure 5. Structure of window type templates: a) open; b) closed.

Below is the schematic representation of the open and closed models, Figure 5.

Because the dimensions of the open model are quite simple, the manufacturing becomes easier, but the fragility of the structural model becomes visible.

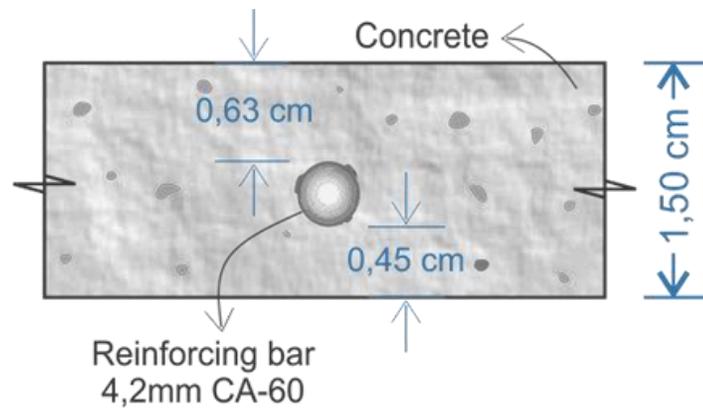
Figure 6. Reinforcing bar detail of open window model.

There is the detail of a section of this model, which will identify the position of the reinforcement, in bracket wall, which in this case uses the 4.2 mm CA-60 reinforcing bar, this consideration, as stated in ABNT NBR 7480: 2007. According to (Oswaldo and Helene, 2001), CA-60 steel has a higher corrosion resistance than CA-50 steel due to its higher carbon and manganese content, associated with lower internal stresses of the structure, detail section can be seen on Figure 6.

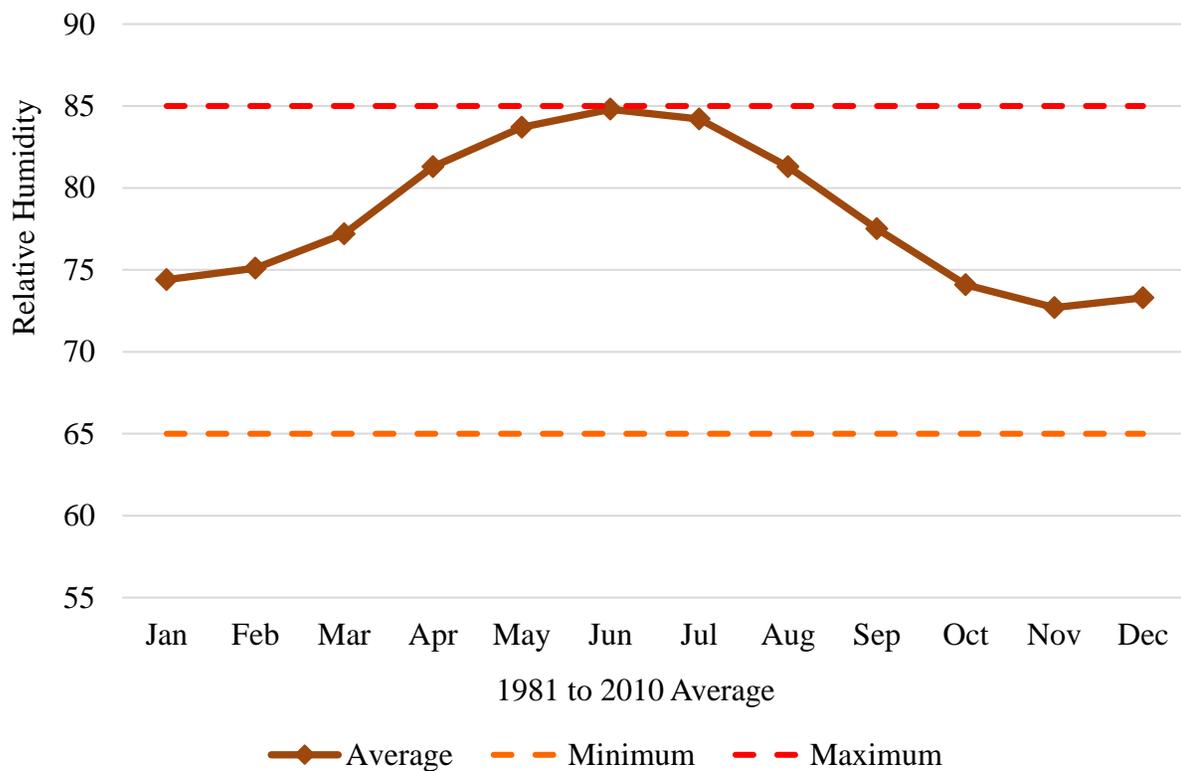
Figure 7. Relative humidity range (1981-2010), source: INMET.

For this analysis it was collected through INMET - National Institute of Meteorology, Brazilian Climatological Normal 1981-2010 (INMET, 2018) and the city of Recife was separated during this period, based on the Relative Humidity Map of Compensated Air and the In two monthly and Annual Compensated Relative Air Humidity Spreadsheets, it was found that, based on the average, humidity ranged from 65% to 85% throughout the year, indicating humidity within the standards that accelerate corrosion processes, Figure 7.

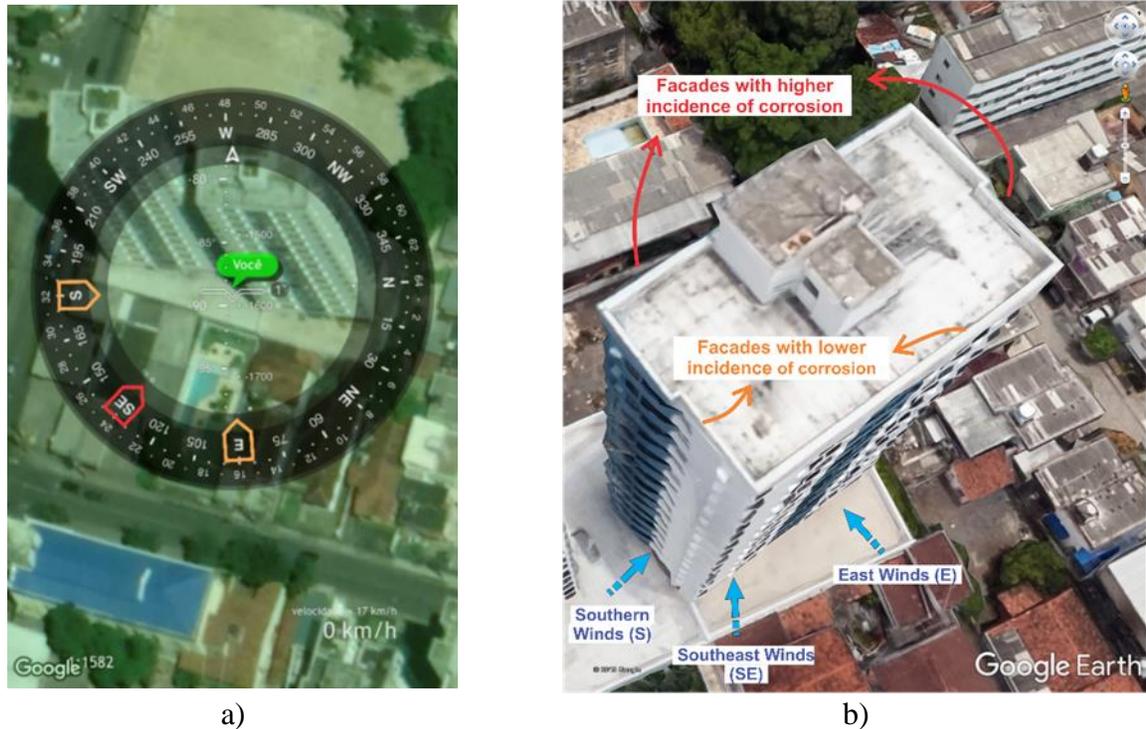
Figure 8. Wind direction building: a) wind direction in the year; b) winds in the building.

Using a residential building as an example, we used the Commander Compass Go 3.9.9 smartphone GPS app, using the gyro compass and the direction of the geographic coordinate inserted on the Google map, it was possible to visualize the direction of the windswept on the facades, year-round, Figure 8a.

This building has closed-model reinforced concrete protectors on all facades, but it can be seen that in the North (N) and West (W) facades, these structures tend to show more degradation, Figure 8b.

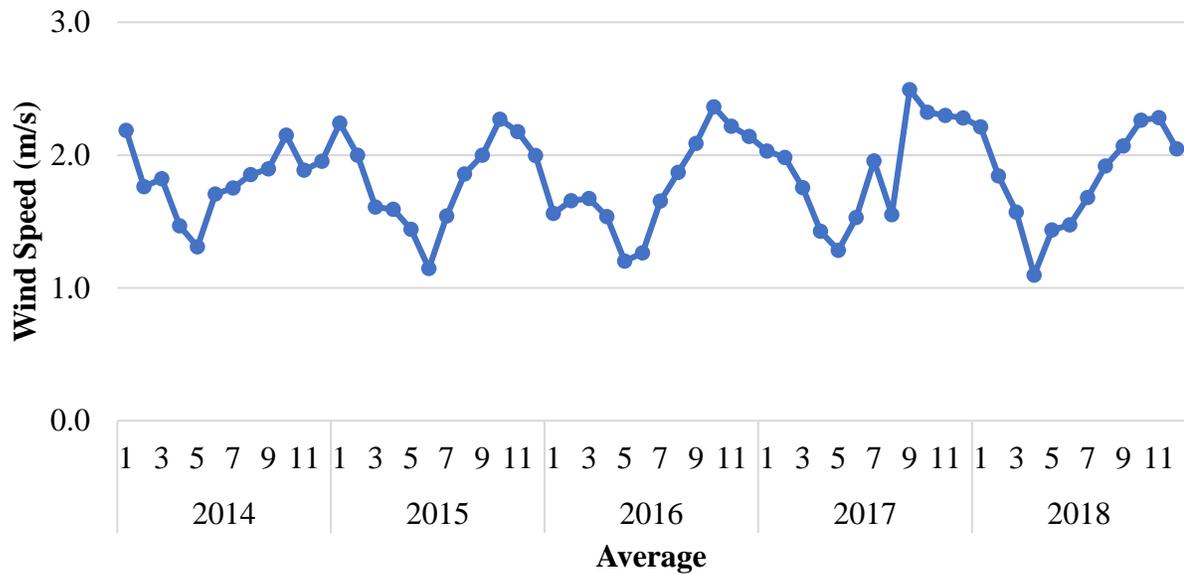
Figure 9. Wind speed (average), source: INMET.

Based on data from the BDMEP - Teaching and Research Weather Database, INMET, Average Wind Speed (mps) (INMET, 2018), it can be seen that over 5 years, the wind speed in Recife has not exceeded 2.75m/s, as a location of milder winds, Figure 9.

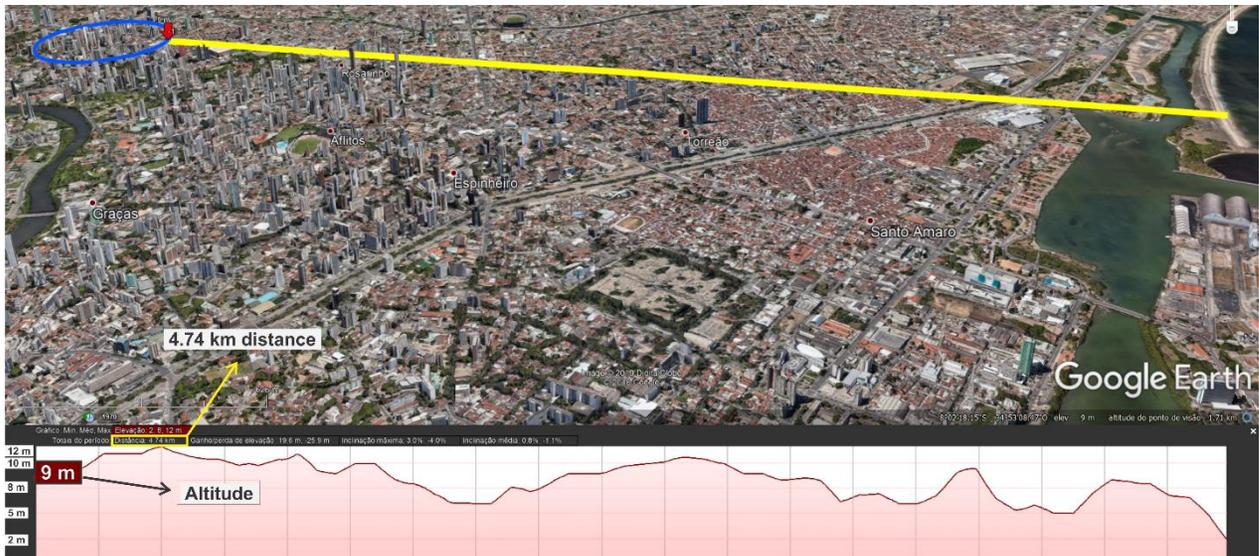
Figure 10. Distance from the analyzed region to the sea.

Because Recife is in a coastal region, close to the sea, the distance between the surveyed region and the breaking of the sea waves may indicate an attack of chloride ions (sea mist), Figure 10.

As can be seen, the distance from the breaking of the sea waves to the point under study, is around 4.74 km, according to (Pontes, 2006). After analyzing the seaside of the neighborhood of Boa Viagem in Recife, with measurements by the wet sail apparatus method for distances from 7 m to 320 m from the coast, where it was verified by an adopted model, that from 400 m there is a significant reduction in chloride deposition and boils down to tiny values at 700 m.

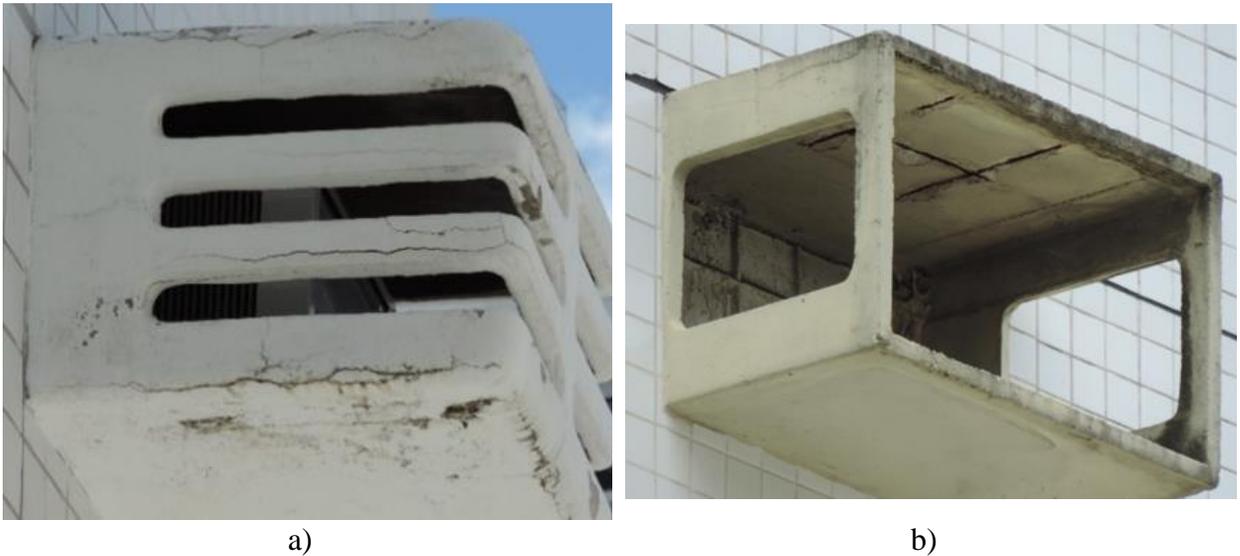
Figure 12. Reinforcement corrosion in window type model: a) fissures; b) concrete detachment.

In the first analysis, there is the visualization of cracks and reinforcement corrosion, possibly caused by carbonation or chloride attacks, Figure 12, as well as the most advanced state of degradation, when the structure stood out, due to the expansion caused by the volume increase of reinforcement and consequent expulsion of concrete by tensile force (Choi, et.al., 2014), Figure 13.

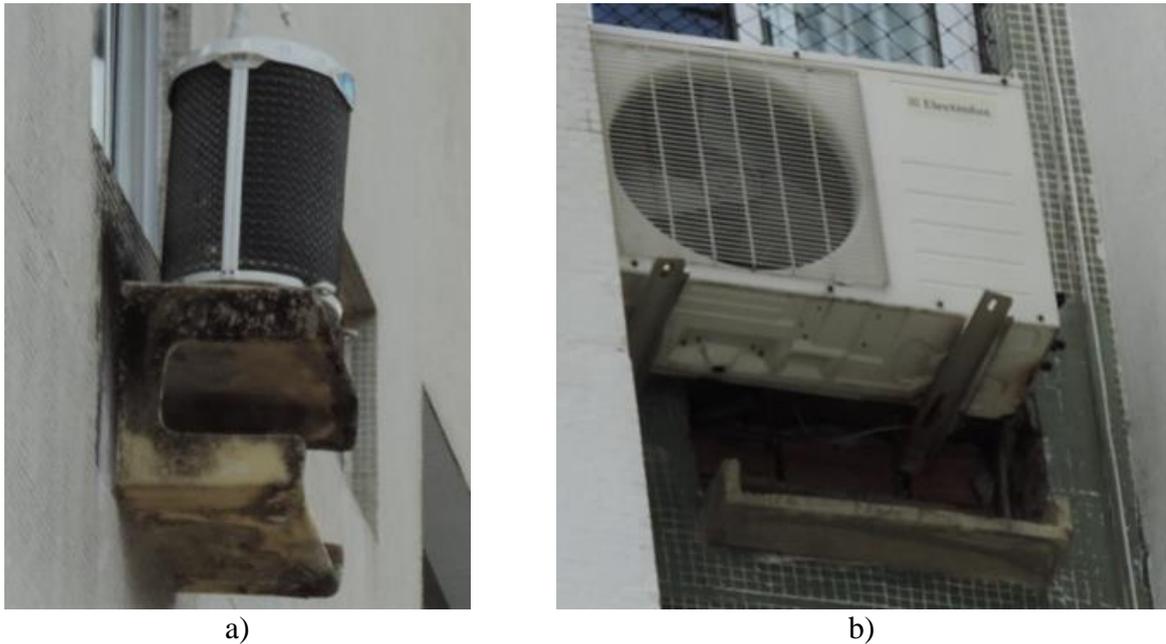
Figure 14. Improper Use: a) non-dimensioned efforts; b) facade infiltration.

Another point to highlight and no less aggravating, is the improper use of these supports, situations created by the users or refrigeration technicians who, due to lack of knowledge or inability, make use of these supports to make modifications with the addition of another cooling system, which generate undersized efforts, favoring the infiltrations in the façade, overloading the existing supports, already in the process of intense degradation, Figure 14.

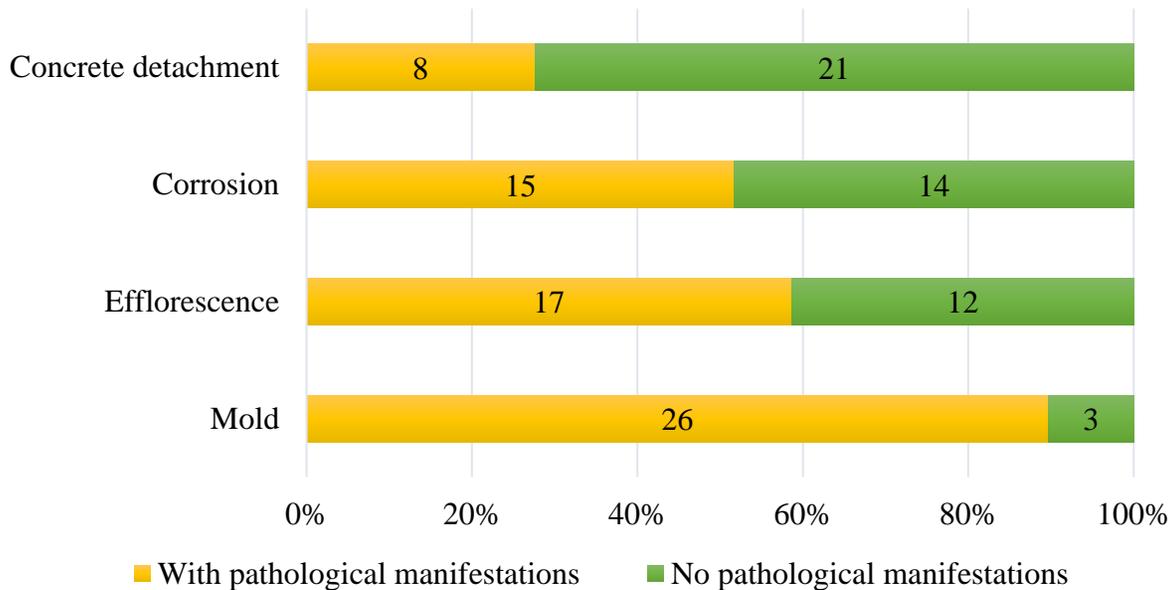
Figure 15. Pathological manifestations of reinforced concrete supports.

For the buildings that have reinforced concrete supports, the main pathological manifestations were visually identified in the field, such as: mold, efflorescence, reinforcement corrosion and concrete detachment, Figure 15. From the 29 surveyed buildings, 11 had a history of replacement of these supports, of which 9 already had recurrence of some pathological manifestations, including detachment of the concrete.

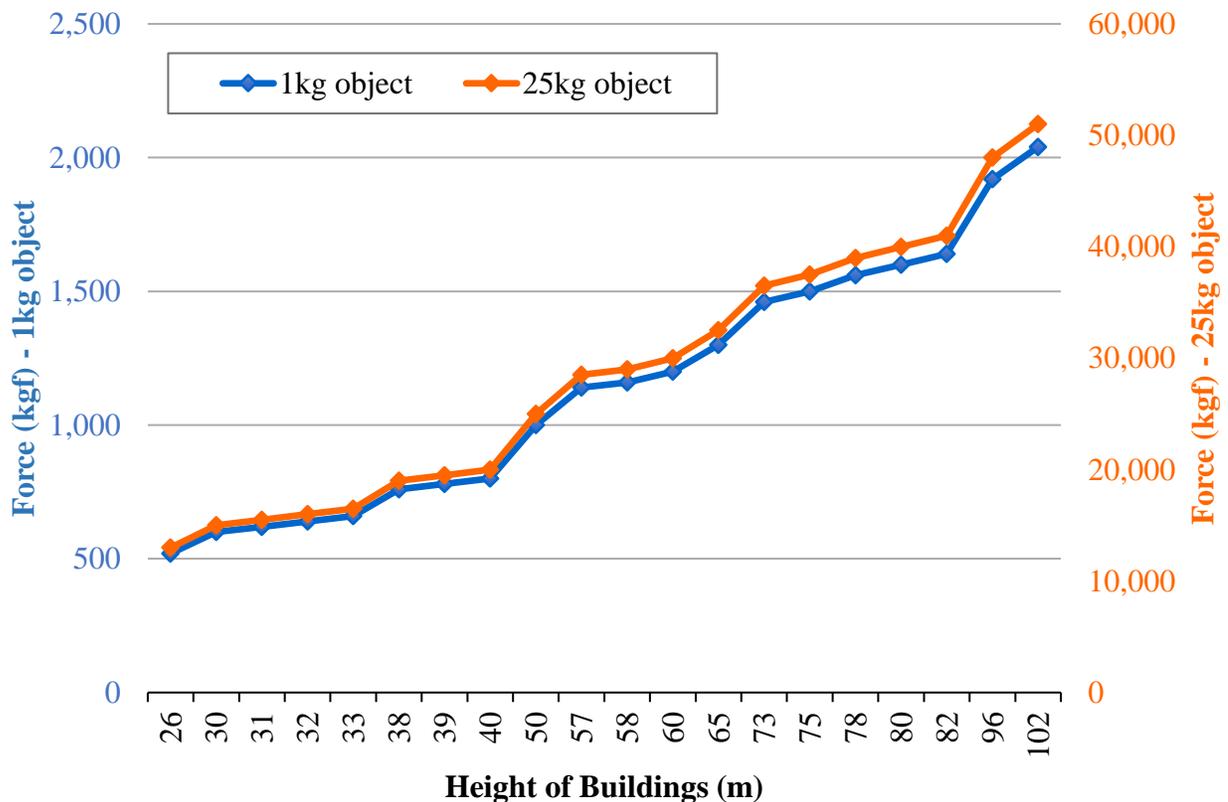
Figure 16. Force applied by the object in contact with the ground.

Taking advantage of the calculation demonstrated by (Silveira, 2011), it was adopted for a 1kg object, considering the partial breakage of one support and another estimated weight of 25kg for a complete one, in a situation of detachment of the facades of the surveyed buildings and their respective heights.

$$F = \frac{M \cdot g \cdot H}{D} \tag{1}$$

Which one has: F - force; M - body mass; g - acceleration of gravity; H - height; D - hardness of a concrete floor.

Figure 16 illustrates the information for the 1kg object in blue and 25kg in orange.

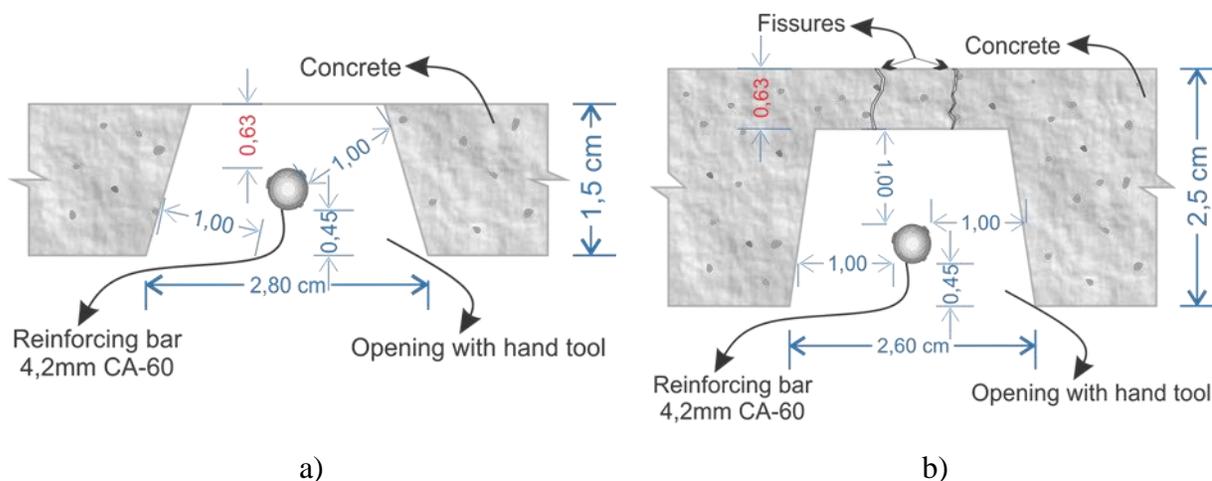
Figure 17. Detail of possible recovery: a) open model; b) model closed

It is noteworthy that the wall thickness of the open model box prevents this execution, since the wall itself is only 1.5 cm thick, leaving this possibility of unfeasible recovery for the closed model box, although the dimensions are larger, neither allow a proper recovery, even if the condition is to remove only 1 cm from the concrete (without minimum standards and recommendations and with difficulty of execution), the possibility of cracking and breaking of the top are very large, because the structure itself is compromised, that is, in the case of this model, the possibility of recovery is also considered unfeasible, as shown in Figure 17.

For the recovery to be performed correctly, according to (Souza and Ripper, 1998), the need to remove the concrete that surrounds the reinforcement is considered, being considered thicknesses of 2 cm beyond the reinforcement, in order to ensure the total removal of the degraded concrete and return the reinforcement bars to alkaline condition, so that the cleaning and subsequent application of the grout are performed.

It is noteworthy that in the market there are models with much more robust thicknesses of 4.5 cm to 6 cm of wall thickness, thus having a tighter control of concrete, these could be meeting the recommendations for greater durability.
