Ecological condition in an altitude gradient of the Margaritas River, Chiapas, Mexico.

Please cite this article as/Como citar este artículo: Escalona-Domenech, R. Y., Barrios-Calderón, R. J. (2023). Ecological condition in an altitude gradient of the Margaritas River, Chiapas, Mexico. *Revista Bio Ciencias*, 10 e1405. <https://doi.org/10.15741/revbio.10.e1405>

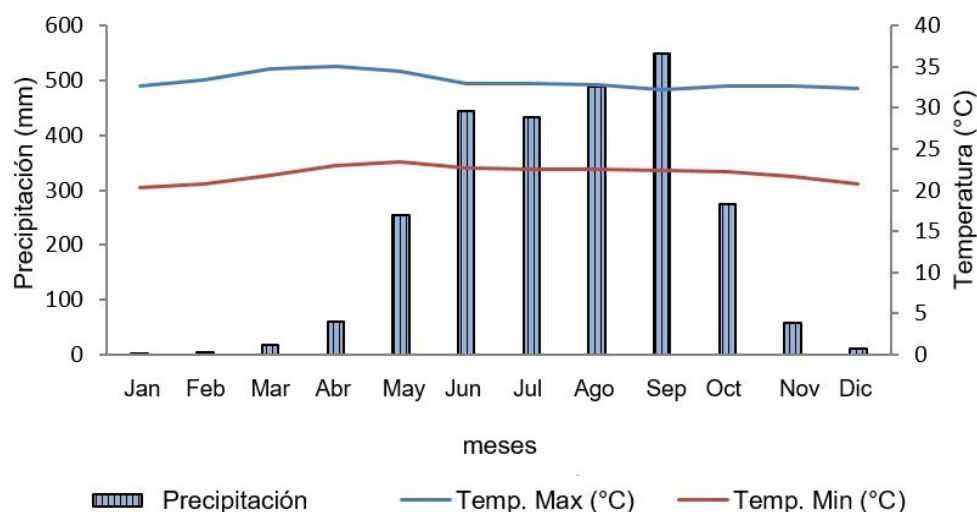
Figure 2. Walter and Lieth climate diagrams of the Margaritas River basin for the period 1951 to 2021.

part of the basin) (INEGI, 2008). An average annual temperature of 27.6 °C and an average precipitation of 2,596 mm are reported for the basin according to data from meteorological station No. 23018 of the Comisión Nacional del Agua (CONAGUA-MEXICO) (Escalona-Domenech *et al.*, 2022), although in the higher areas of the basin it can reach 2,600 mm per year. The flows of this river follow a behavior according to two marked seasons of the year, rainy and dry. The rainy season includes the months from May to October, while the dry season includes the months from November to April. The historical maximum precipitation values occur during the month of September and the minimum in January (Figure 2).

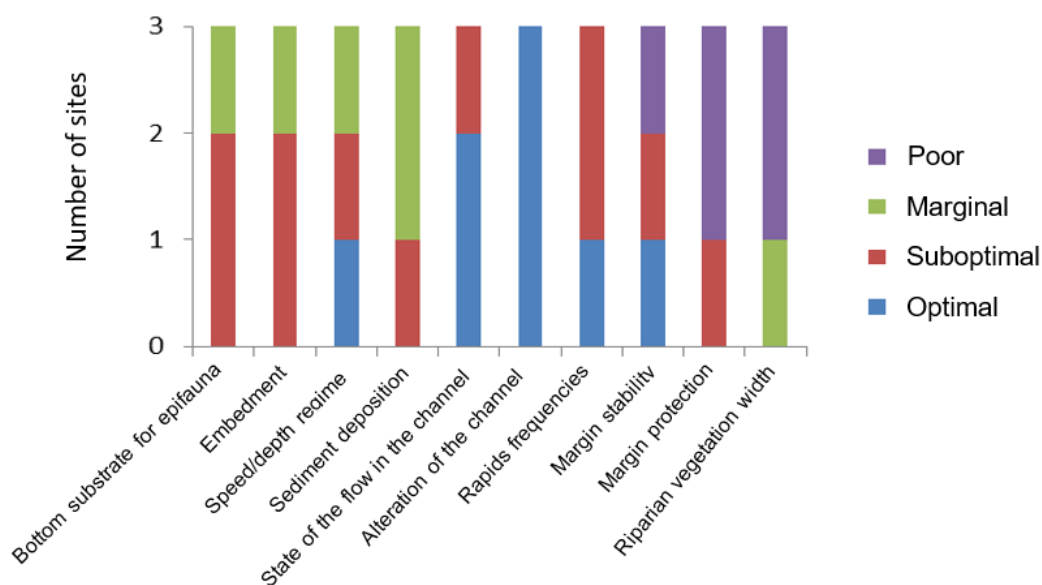
Figure 3. Status of each one of the attributes of the physical habitat of the protocol of Barbour et al, 1999 in the 3 sampling sites of the Margaritas River, Chiapas

The variables that most influenced this rating were those related to bank protection and riparian vegetation width (Table 3). The variable that showed the least variation among sites was channel alteration (Figure 3).

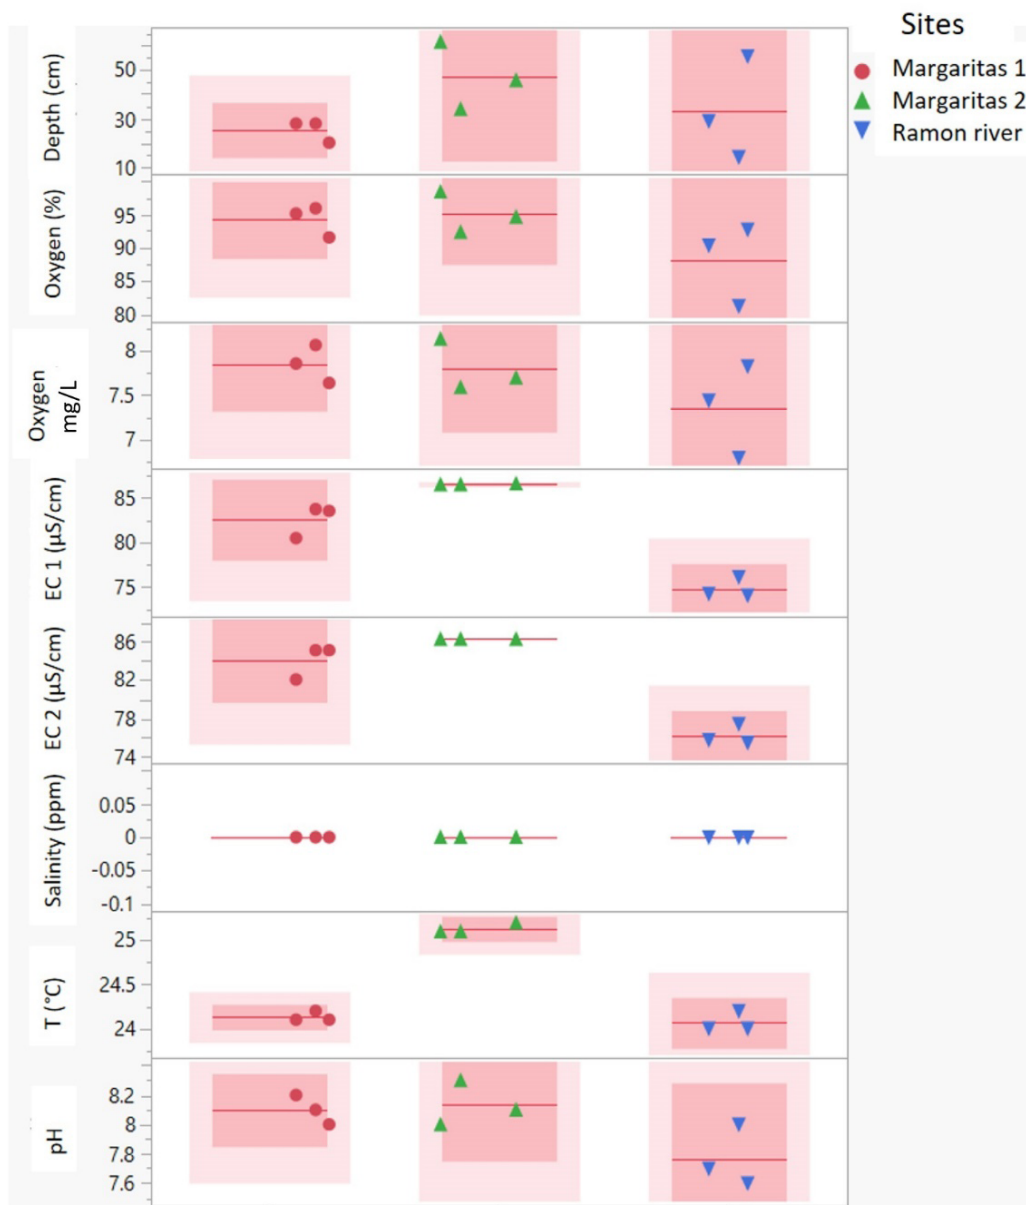
Figure 4. Graphic interpretation of each of the physical-chemical parameters evaluated at each study site and their respective repetitions with respect to the mean

The mean values obtained for each parameter evaluated are shown graphically in Figure 4, while the mean comparison test and ANOVA applied to each parameter are shown in Table 5.
