Non-destructive evaluation of the wooden beams from the Narciso López building in the Historic Center of Havana for reuse in its restoration

Non-destructive evaluation of the wooden beams of the Narciso López building in the Historic Center of Havana for reuse in its restoration

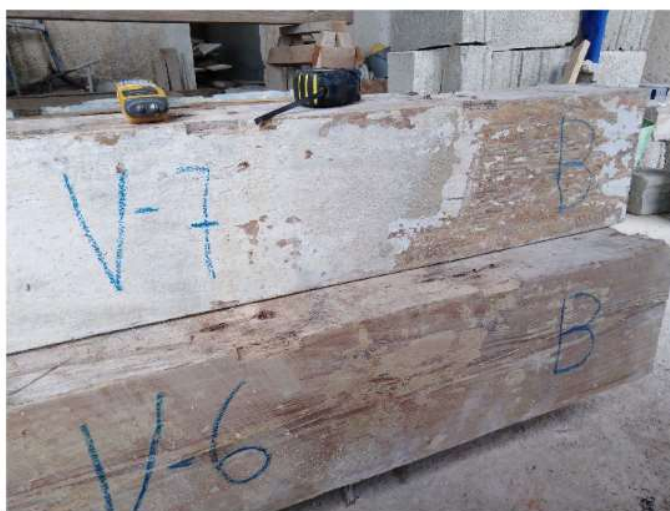
Subsequently, each beam was identified using the code (VA-x), where x represents a consecutive number, starting from 1. The local has a total of 32 wooden beams, which support each other axes 5-6. To determine the dimensions, a tape measure was used, and the measurements of width, depth and length were recorded (Table 1). The heads of the beams were identified with the letters A and B (Figure 8).

Figure 8. Identification of wooden beams

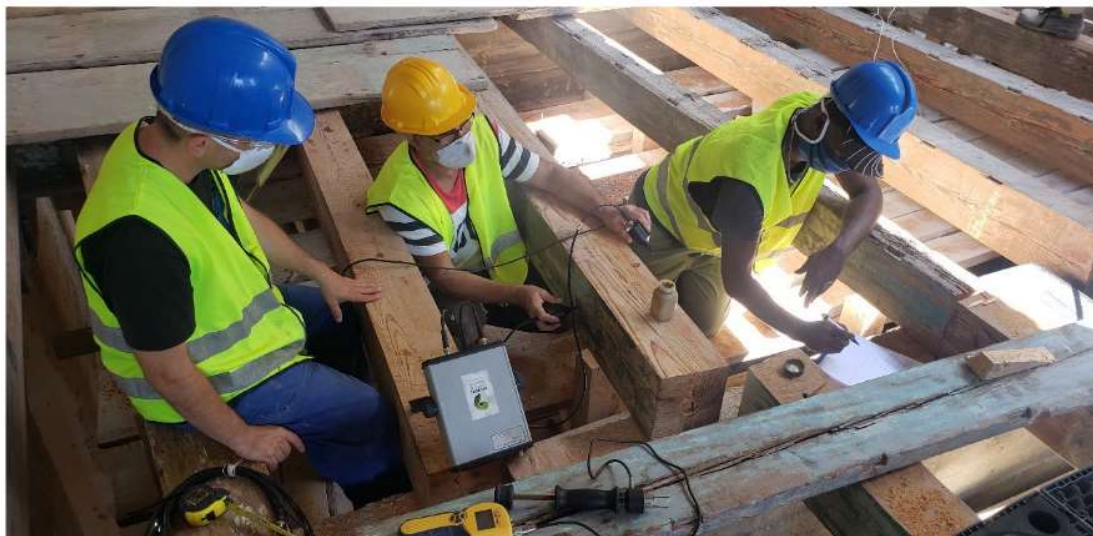
For the measurement of UPV, the equipment used was Proceq Pundit Lab+, with 54 KHz conical transducers (Figure 9). They were placed perpendicular to the fibers (Figure 10) and the distance between them was programmed in the equipment for each beam. The adjustment was made at 12% humidity using the following equation (Liñán et al., 2011):

Figure 9. Application of UPV tests on wooden beams

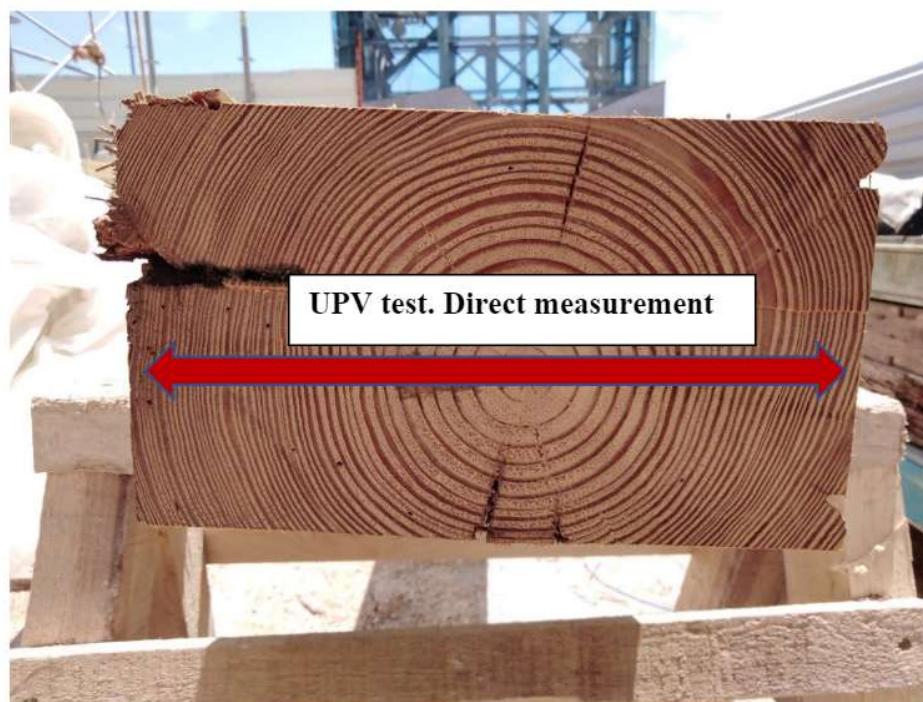
Figure 10. UPV application diagram perpendicular to the fiber

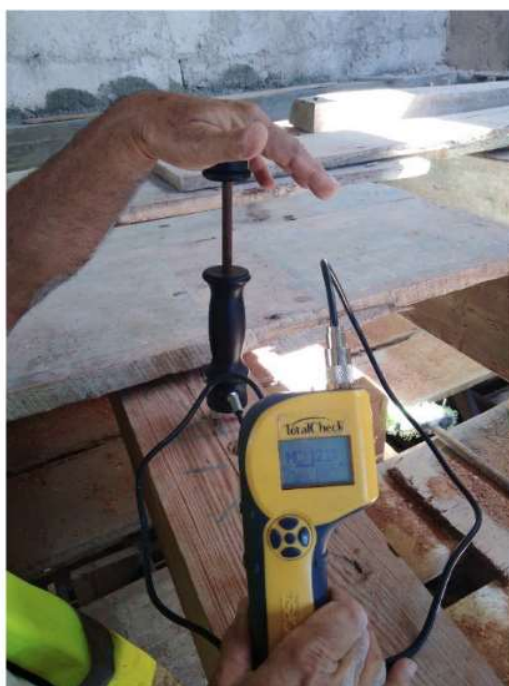
To measure the humidity on the timbers, the Delmhorst's TotalCheck thermo-hygrometer was used (Figure 11).

Figure 11. Surface moisture measurement with Delmhorst's TotalCheck thermo-hygrometer equipment

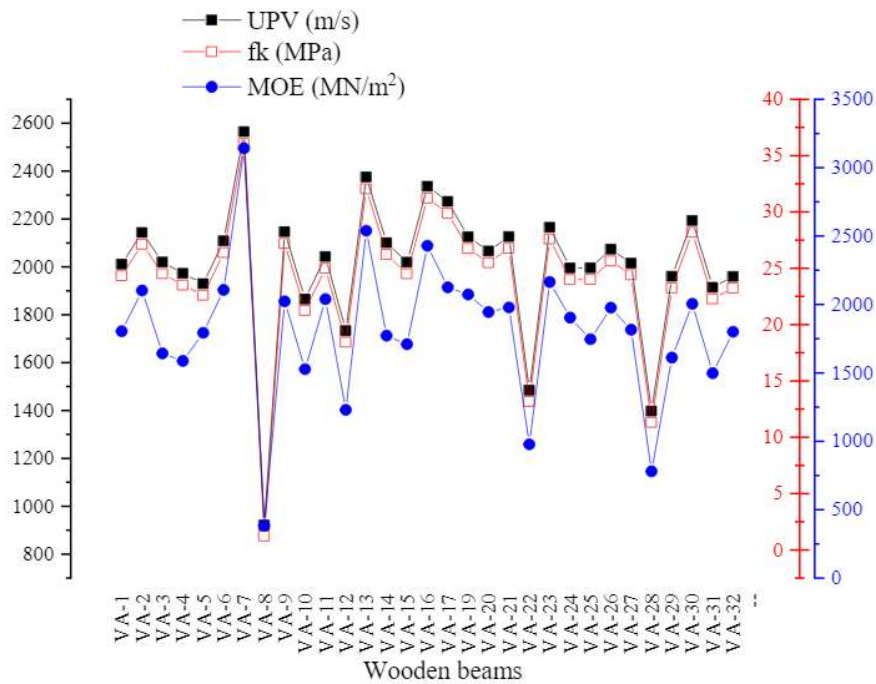
Figure 15. Correlation of results obtained from UPV, fk and MOE for wooden beams
