Diagnosis and solutions proposal to the damages present in the ceiling of the Convent of Santa Clara de Asís

DOI: <https://doi.org/10.21041/ra.v12i2.584>

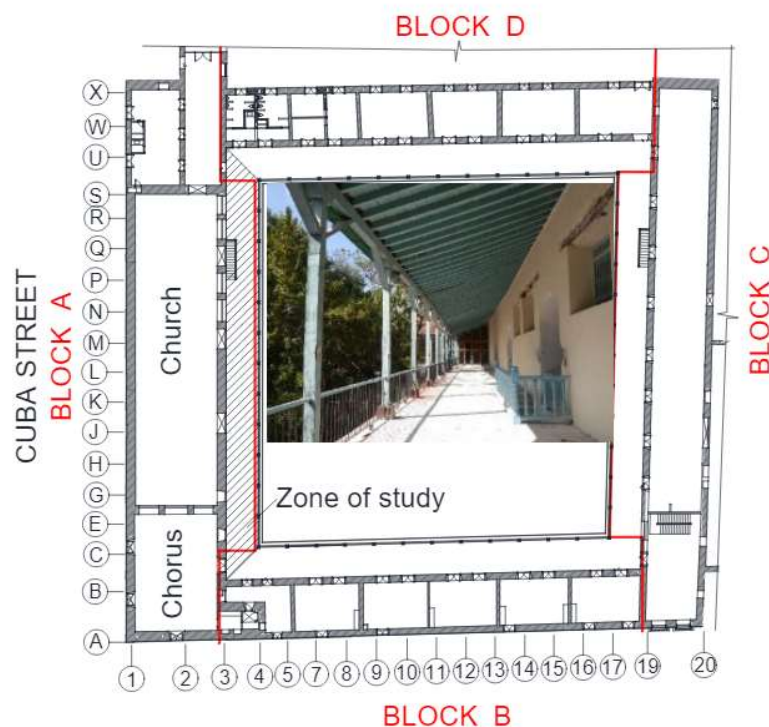
The structure is located on the upper floor of the first cloister, towards block A (Figure 1). It is based on a wood and plank slab made up of 98 beams of 9 cm x 13 cm (base x height), spaced between 43 cm and 45 cm with an inclination of 17 degrees from the wall towards the wood studs, supported on the 3rd axis on the rammed earth wall that forms the church, and along the axis 4 on a sliding beam that rests on 13 wood studs. The slide beam is made up of 12 beams joined by scarf joint, which rest on the right feet (Table 1). The roof is made up of red ceramic tiles.

Figure 1. Floor plan sketch of the first cloister, signs and photograph of the gallery studied

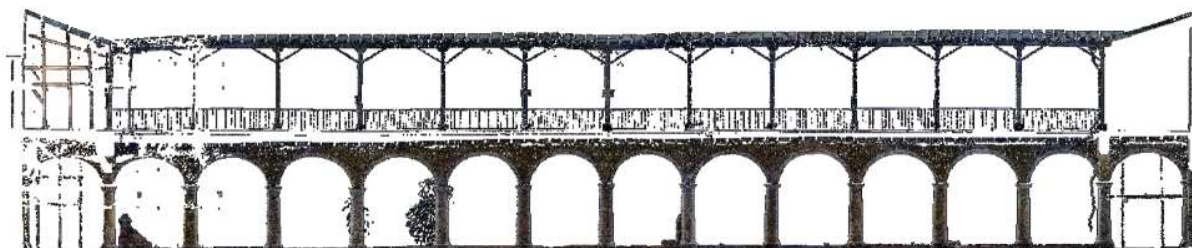
Figure 2. Orthoimage obtained from the gallery of block A

For the structural analysis of the slab beams, orthoimages were extracted using the Reconstructor software, and cuts were made using the Autodesk Recap software from beam number 17 to 98. All the beams that make up the slab present deformations to a greater or lesser extent, and some show flexural failures due to a decrease in their bearing capacity. The Cuban standard (NC 53-179:88, 1988), establishes that the maximum admissible deflection is $1/240$ of length for full load. This indicates that the admissible deflection for the wood beams is approximately 1.5 cm, but the values obtained on site are 2 cm to 4 cm higher than those acceptable by calculation. The standard establishes that the deflection of the beams will increase for load periods of more than 10 years by 50% for dry wood, and 100% for wet wood. Considering this, the allowable deflection would increase by 2.25 cm and 3.0 cm, respectively, for which there are still differences between allowable and actual values (Figure 4). It is important to note that not all the maximum deformations found are located in the center of the span, for the reason that there are areas where the element is more deteriorated than others; that is why the beams deform and fail in the most vulnerable area. It was identified that not all the beams are of the same wood species, which is why their hardness and resistance to bending also vary. In the right feet 1 and 7, the deterioration in the joints has caused the displacement of the same and of all the elements that adjoin it. These vertical movements that the right feet have suffered vary between 3.5 cm - 20 cm approximately, and the separation in the scarf joint between the beams that make up the sliding beam ranges between 1 cm to 2 cm, which represents considerable displacements.

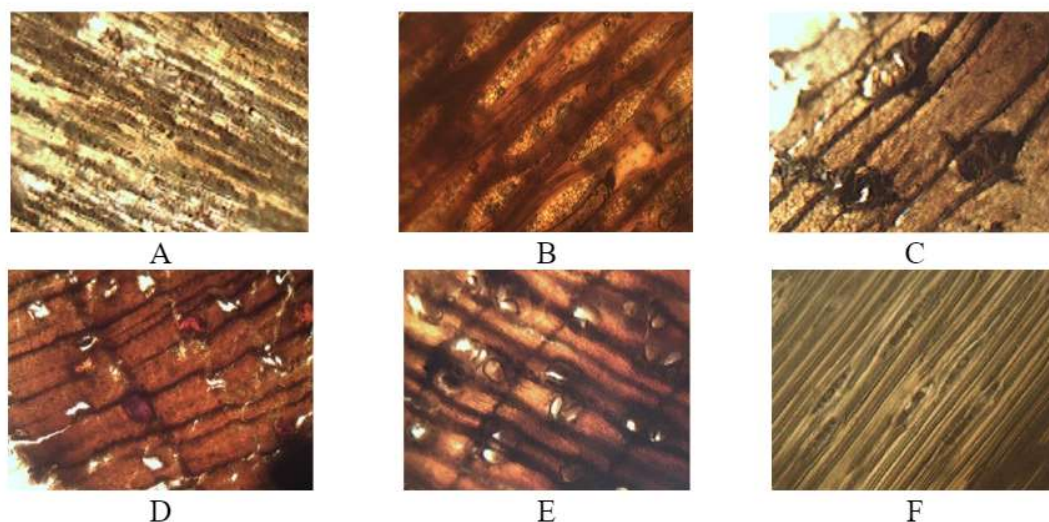
Through the application of the comparative anatomy method from the histological sections made in transverse, tangential and radial directions, it was obtained as a result that the species of wood that form the structure of the roofing and the support system of the wood stud are: cedar (*Cedrela odorata*), pine (*Pinus sp.*), baría (*Cordia gerascantus*), caguairán (*Guibourtia hymenifolia*) and ácana (*Mamilkara grisebachii*). Figure 5 shows the histological sections made to identify the existing wood species.

Figure 5. Histological sections at 40x of the identified wood species: A- ácana (longitudinal cut), B- baría (longitudinal cut), C- caguairán (cross-section), D- cedar (longitudinal cut), E- najesí (cross cut), F- pine (lengthwise cut)
