Evaluation of the pathological manifestations of the Rio Negro Building in Anápolis-Goiás

This paper shows the application of the methodologies GDE (Degree of Structure Deterioration) and GUT (Severity, Urgency, and Tendency) quantifying the pathological manifestations and determining the points of greatest need for maintenance. Thus, a quantitative perspective was used with the application of the previously mentioned methodologies and after building inspections and visual analysis with a photographic record, notes and mappings the methodologies were applied and it was obtained that most of the pathological manifestations that occur in the structure of the building have humidity as origin, resulting in efflorescence, spots or infiltration. Thus, this work defined the points that need priority, directing measures that can later be taken. The methodologies proved to be efficient and important for decision-making.

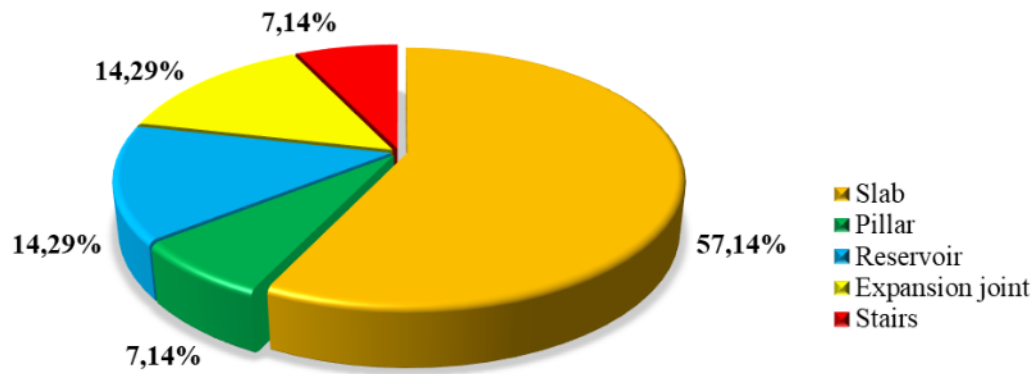
Figure 5. Graph of the frequency of pathological manifestations by family of elements.

First, it was observed that the family that has the largest number of elements that present pathological manifestations is the slab family, with 57.14% of the identified anomalies, as can be seen in Figure 5.

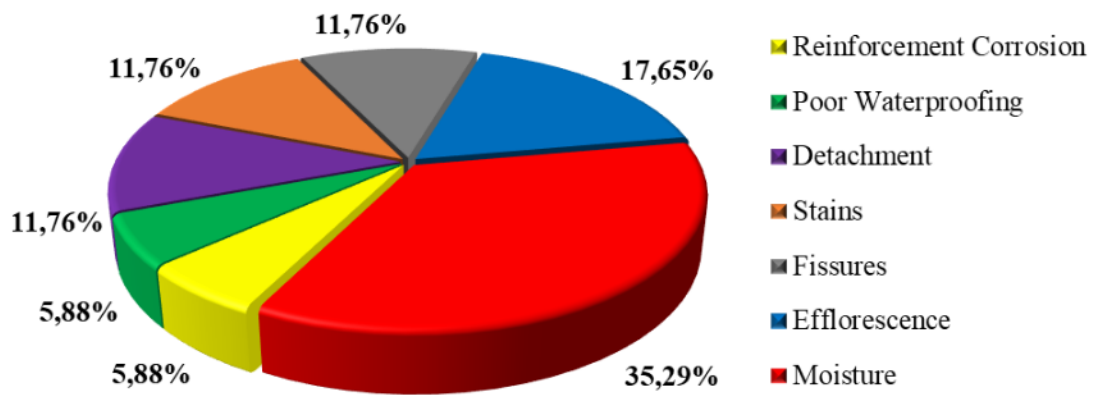
Figure 6. Graph of the frequency of pathological manifestations in the elements.

Through the mapping of the pathological manifestations that affect the building, it was noticed that in the 14 structural elements inspected, 35.29% of the pathological manifestations are originated due to the infiltration of humidity as we can see in Figure 6. In addition, other pathological manifestations such as efflorescence (17.65%) and dark spots (11.76%) also have a similar cause.

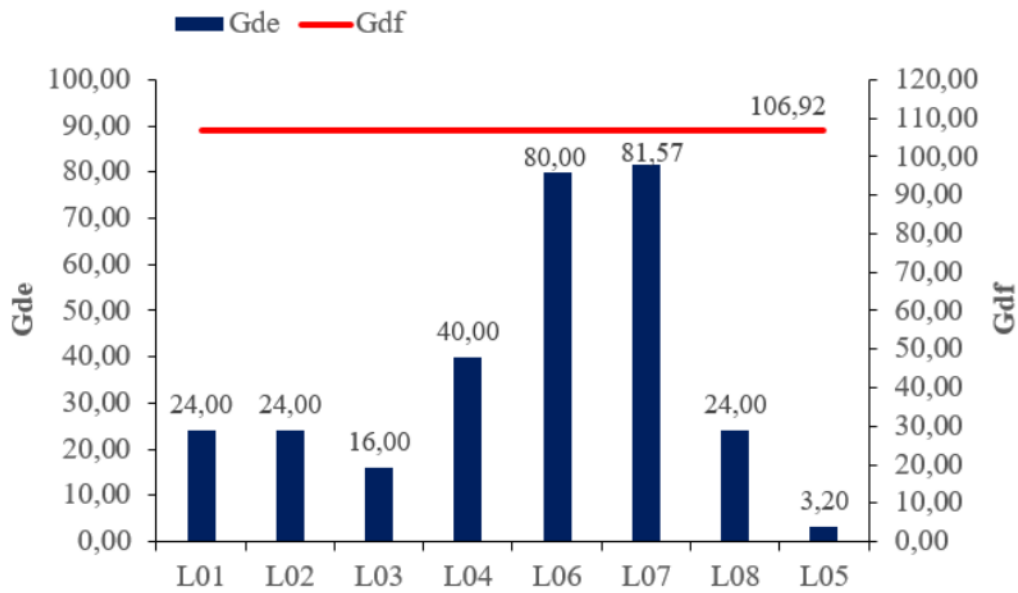
Figure 7. Degree of deterioration of the slabs.

Regarding the GDE/UnB (2007) methodology, it is possible to raise some analysis based on the graphic model used by Medeiros et al. (2020). In the slab family, elements L06 and L07 are the ones that most influence the calculation of the degree of deterioration of the family, as can be seen in figure 7. In addition, it is worth noting that element L05 is not taken into account for the G_{df} calculation for presenting G_{de} less than 15.

The application of the methodologies makes it possible to define which element or pathological manifestation needs priority within the global scenario, which can be decisive for assertive and efficient work. By the GDE methodology (2007) it is defined that the elements L07 and L06 need special attention, given that they present a poor and high level of deterioration, respectively, which implies a need for intervention within a maximum period of 6 (six) months for element L07 and 1

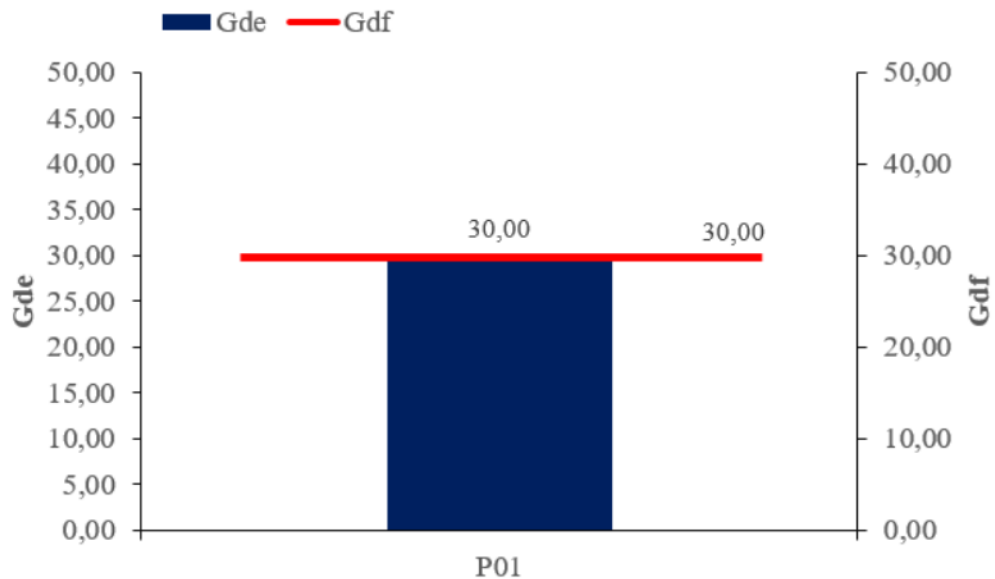
Figure 8. Degree of deterioration of the pillars.

The beam families have a null degree of deterioration, as no pathological manifestation was identified in the elements that compose them, in the family of stairs, the only identified element has G_{de} less than 15. Thus, for both, G_{df} equal to zero was calculated. As for the families of columns and upper and lower reservoirs, it is observed that they are composed of only one element, so the value of the degree of deterioration of the family corresponds to the value of the degree of deterioration of the element itself, this can be seen, respectively, in figures 8, 9 and 10.

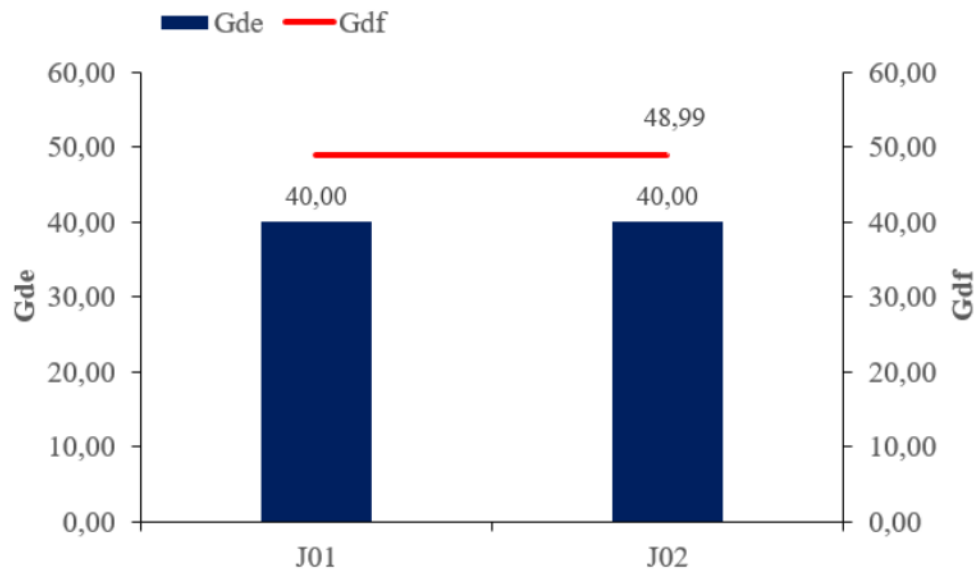
Figure 11. Degree of deterioration of expansion joints.

In addition, in the expansion joints, the presence of two elements that present the same degree of deterioration was found, but the degree of deterioration of the family is higher than the value obtained for the elements individually. Thus, by the mathematical formulations, it is possible to observe that the influence of the repetition of elements that have the same degree of deterioration does not represent such a significant increase since it has the maximum value as a reference, this value is multiplied by the result of the root that involves the sum and the maximum value. Figure 11 shows the value of G_{df} and the values of G_{de} for each element.

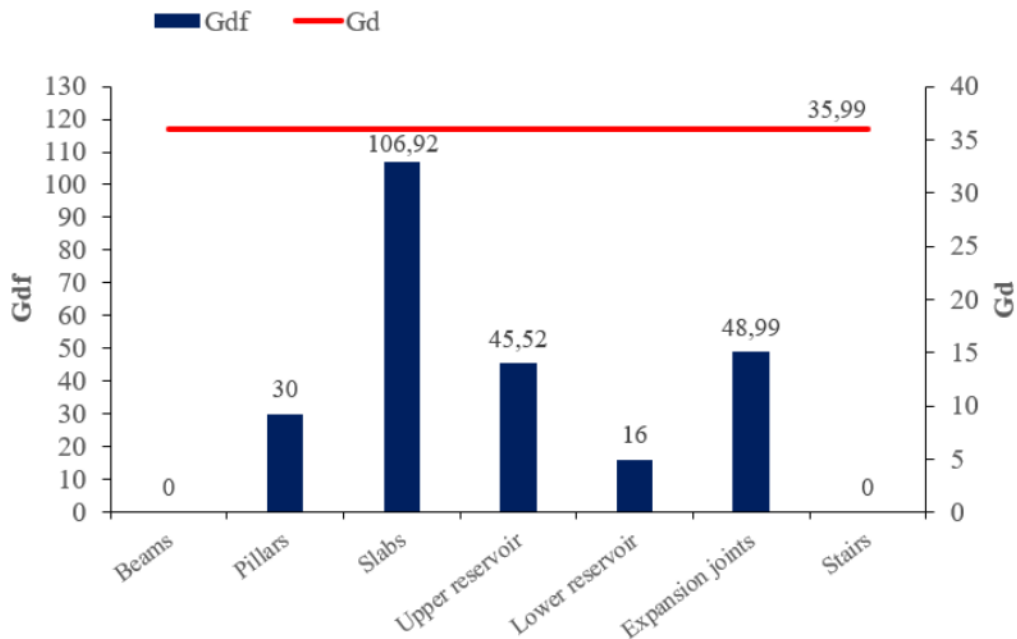
Figure 12. Degree of deterioration of the structure.

Thus, when evaluating the degree of deterioration of the families and the degree of deterioration of the structure, it is noted that the slabs are the ones that represent the greatest influence for the structure to be at an average deterioration level, 15 to 50, and therefore it needs intervention within a maximum period of 2 (two) years. Figure 12 shows the values of G_{df} of each family in comparison to the global value of the structure, G_d .

So, in summary, the building's maintenance priorities are the L07 and L06 slabs, which need an in-depth investigation, to identify if there is a need for reinforcement to resist the additional loading and in addition to the recovery of their cracks in order not to the situation worsens.
