Journal of the Latin-American Association of Quality Control, Pathology and Recovery of Construction

Structural strengthening of a historical building in Rio Branco city – Acre.

D. C. S. Amorim¹, D. R. C. Oliveira²

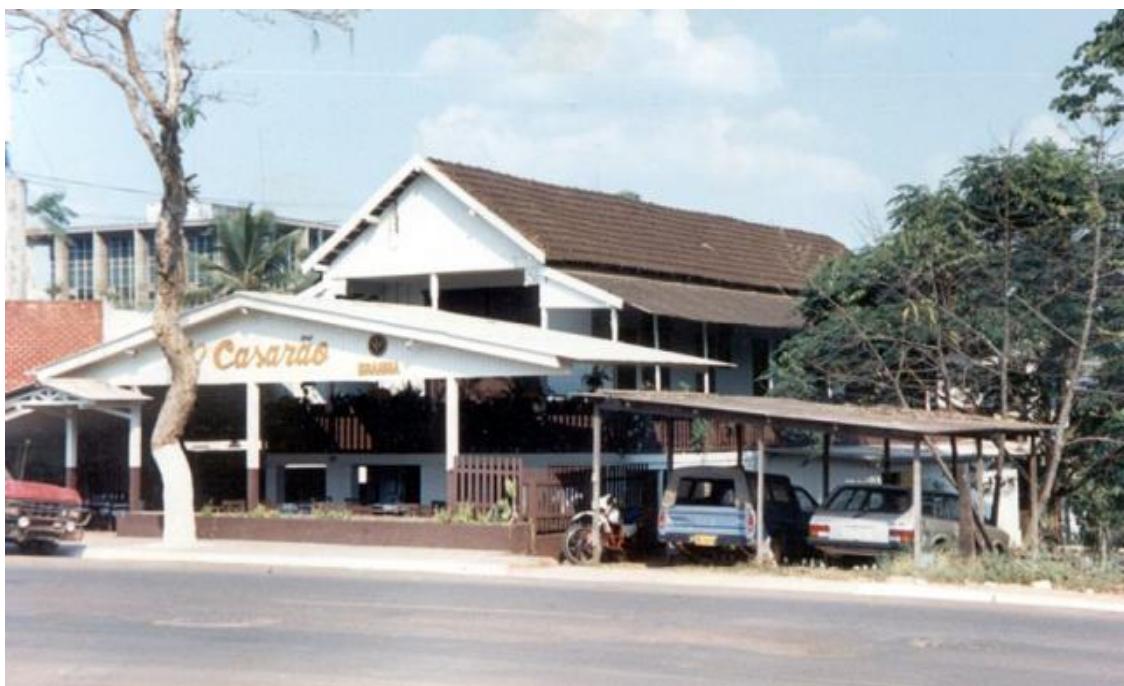
Figure 1. The Casarão.

The "Casarão" (Figure 01), public building built in the 1930s, has mixed structure of reinforced concrete and wood in good condition in its central part, maintaining eclectic Syrian and Lebanese architectural features with European influence, representing a regional style of great cultural importance of the city of Rio Branco, in Acre state. Its revitalization meets a society demand for the state government, which received a petition with hundreds of signatures to this choice. The historic building was listed by the State Board of Historical and Cultural Heritage on August 13, 2009, at the initiative of civil society, and approved on April 30, 2010, by the decree number 5,235, under the protection and supervision of the state government, through the Department of History and Cultural Heritage Foundation of Culture and Communication Elias Mansour.
