Building facade cladding detachment: A case study

A. C. Lordsleem Jr.^{1*}, H. Batista Faro¹

Citation: A. C. Lordsleem Jr., H. Batista Faro (2017). “*Building facade cladding detachment: A case study*”, Revista ALCONPAT, 7 (2), pp. 148-159, DOI: <http://dx.doi.org/10.21041/ra.v7i1.126>

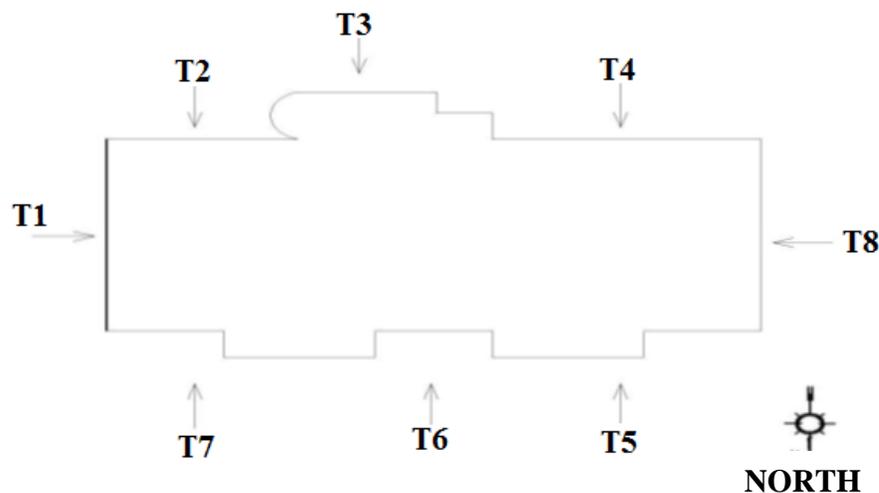
As shown in Figure 1, the facade was divided into eight sample areas (section T1: east facade; sections T2, T3, and T4: south facade; sections T5, T6, and T7: north facade; and section T8: west facade).

Figure 1. Sketch of building section identifying the facade and its division into sample areas.
