Application of GUT Matrix in the assessment of pathological manifestations in heritage constructions

The present paper presents the application of GUT (Gravity, Urgency, Tendency) Matrix methodology as a tool in the assessment of pathological manifestations in buildings. Three heritage constructions of the historic center of Sobral, Ceará, Brazil were studied through *in situ* inspections, photographic records and elaboration of the damage map. The GUT Matrix was used as a tool to rank, in each building, priority levels for each damage in order to define their order of treatment. Thus, it was possible to conclude that the applied method can be used as a useful tool to manage the maintenance of buildings through prioritization of the most significant problems and, to contribute directly to the preservation and safety of the built historical heritage.

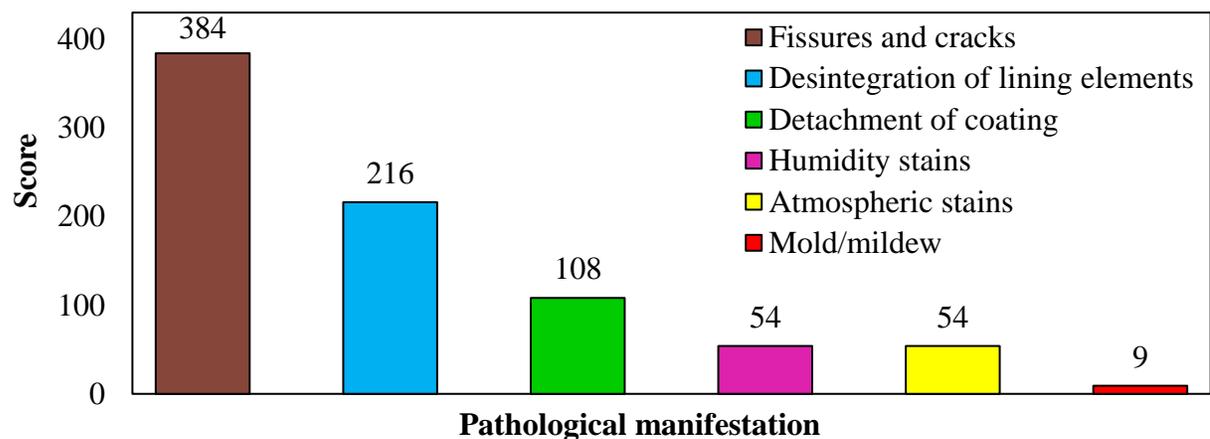
Figure 6. Priority graphic of the Nossa Senhora do Rosário Church.

From the application of the checklist of the GUT Matrix in this building it was possible to elaborate the graph of priorities, which is represented by Figure 6, where it is possible to verify that priority pathological manifestations, that must be treated first, are fissures and cracks, in this case, in the main altar of the church, because it presents the highest scores, 384 scores, and represents a high priority damage, according to the descriptions in Tables 1, 2 and 3 of Section 2.

Second, in the order of priorities, it is the disintegration of lining elements with a total of 216 scores, being framed as an average damage. In the third position are the detachments of coating with 108 scores, being also framed in the degree of average damage. Humidity stains and atmospheric stains, both with 54 scores, are also identified as average damage. The damage with lowest severity, which is in the last position of the order of priorities, is mold /mildew, with 9 scores and low damage.

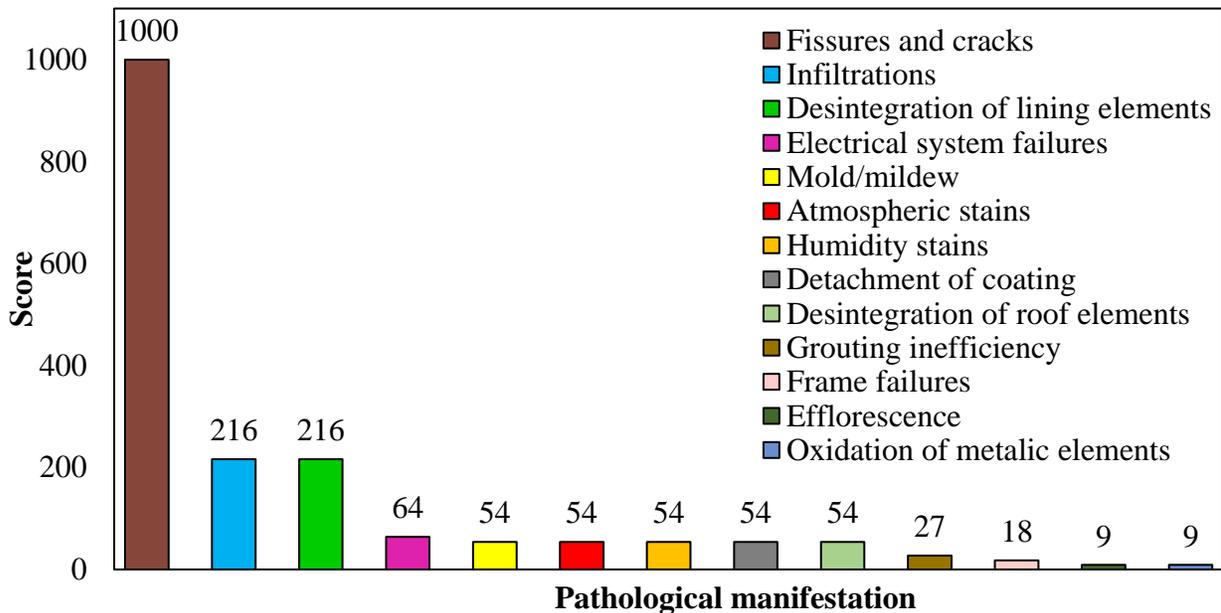
Figure 9. Priority graphic of the Nossa Senhora das Dores Church.

The data obtained from the application of the GUT Matrix in this building were organized in the priority graph shown in Figure 9, where it is verified that the pathological manifestation of highest priority is the crack in the central arch of the main nave, with a total of 1000 scores, which classifies it as a total damage, that is, of extreme gravity, urgency of solution and fast tendency of evolution. In addition, the difference between this damage and the two other (infiltration and disintegration of lining elements, both with 216 scores each) is very high, that corresponds to 784 scores, which show the severity of this crack.

Four pathological manifestations presented the same scores (54 scores): mold/ mildew, atmospheric stains, humidity stains, detachment of coating, which evidences pathological manifestations of average damage. The damages: grouting inefficiency (27 scores), frame failure (18 scores), efflorescence (9 scores) and oxidation of metallic elements (9 scores) correspond to category of low potential damages, the latter two occupying the final position of the order of prioritization. This building presented the largest number of pathological manifestations and this fact is connected to the lack of maintenance of the structure, moreover this church is now interdicted. The existing

damages, if left untreated, can evolve into more severe problems that can seriously compromise the stability and safety of the structure.

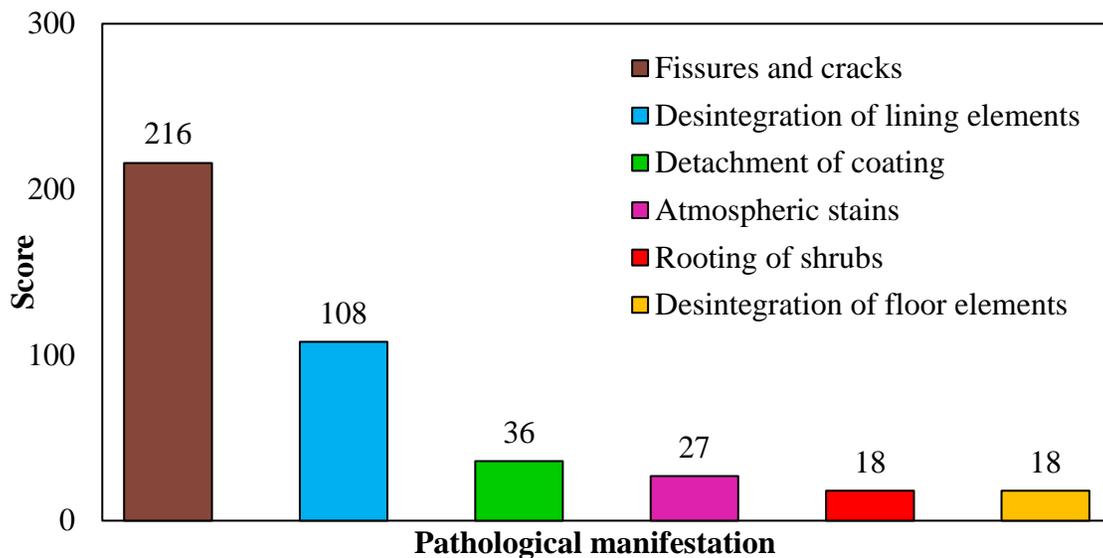
Figure 12. Priority graphic of the Menino Deus Church.

With the results of the checklist of GUT Matrix applied in this building, the graph of priorities was constructed and it is illustrated in Figure 12, where it is verified that the most prioritized pathological manifestation are the fissures, which can be observed in the upper opening of the front facade door (Figure 10) and also in an internal wall of the left lateral facade (Figure 11 (a)). The scores of this anomaly corresponds to 216 and are obtained by applying to the Severity, Urgency and Tendency 6 scores per each one, being therefore an average priority damage. In second position is the detachment of coating that presents a total of 108 scores, being also an average damage. In third and fourth positions are the disaggregation of lining elements and atmospheric stains, with 36 and 27 scores each one, being classified as average and low damage, respectively. In the final positions in the order of priorities, are the rooting of shrubs and the disintegration of floor elements, with 18 scores each, classified as low damage.

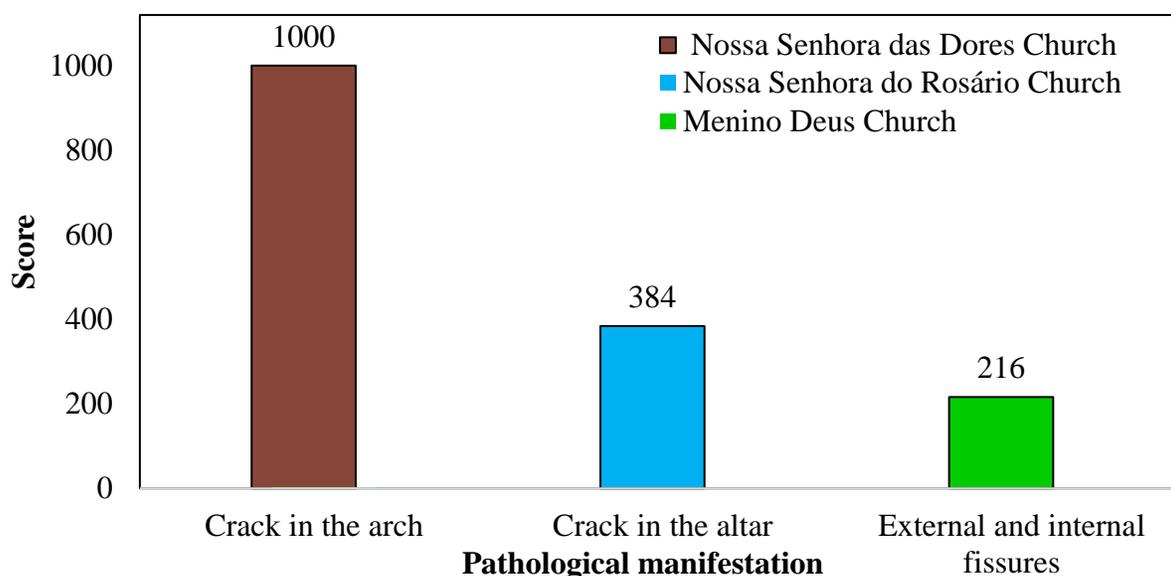
Figure 13. Comparative graphic between the most severe pathological manifestations for each church.

By the comparative analysis of the pathological manifestations listed in first position for each church and having as parameter its total score, among the three buildings studied, the Nossa Senhora das Dores Church presented the most severe damage with a total of 1000 scores for the crack in the central arch of the main nave. The second most severe was the Nossa Senhora do Rosário Church with a total of 384 scores also for a crack in the main altar. And finally, the third most severe damages were the fissures present in the main facade near the opening of the upper window, in the lower part of one of the columns of a tower and in walls of the internal part of the Menino Deus Church with a total of 216 scores. Figure 13 shows the comparison between the most severe damages of these churches.
