## Diagnostic of damage in a building of the early twentieth century in Havana. Case study

A. H. Oroza<sup>1\*</sup>

This paper aims to discuss the results of the diagnosis made to a reinforced concrete building erected between 1900 and 1906 for the firm Casteleiro & Vizoso (Figure 1). Eclectic style and seven levels high, it was projected so that all levels had 4 m high struts, except for the ground floor with 6.3 m. The building was erected on a steel structure, covered in hydraulic concrete with foundations and reinforced concrete roof. The foundations consisted of support rafts calculated to support an average load of 3 Kg/cm<sup>2</sup>. The concrete prepared to form all the midlevel and stairs was dosed in proportion to 1 volume of cement, 3 of sand and 5 of gravel. The calculation of the accidental load of the floors was estimated for 366 Kg/m<sup>2</sup> and a safety factor of 4 was applied to the metal structure.

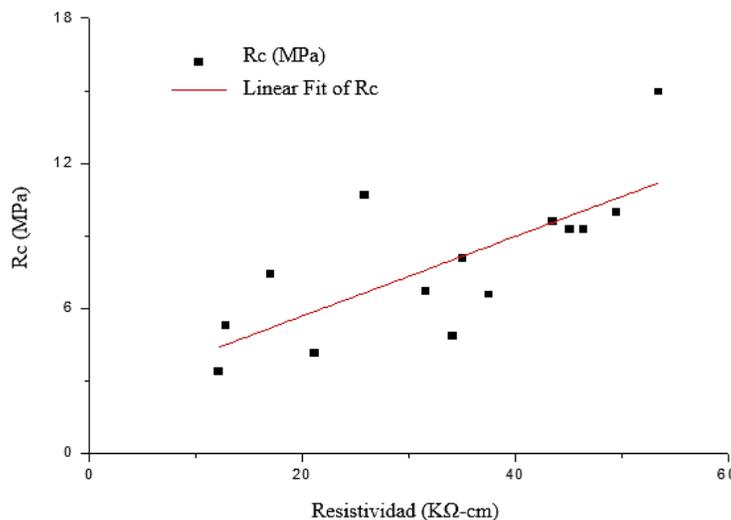
Figure 7. Relationship obtained between  $R_c$  and  $\rho$  of the slabs

Other authors (Ramezaniapour et al., 2011) demonstrated that for the same cement mix design, there is a linear relationship between compressive strength and  $\rho$  due to the chemical similarity of the pore solution. To assess the correspondence between the concrete permeability of reinforced concrete slabs and the  $\rho$  measured directly on the slabs, both results were correlated based on the strengths of the extracted probes. Figure 7 shows the graph obtained regarding the correlation between the  $R_c$  and  $\rho$  for the mid-level slabs of the studied property.

<b>Rc</b>	<b>Intercept</b>	Value 2,38046	Error 1,56301
	<b>Slope</b>	0,16484	0,04373
	<b>Statistics R-Square</b>	R <sup>2</sup> 0,50396
