Inspection and evaluation of roofing systems: a case study

The roof system of one of the buildings of the University of Brasília - DF is characterized and evaluated. The main existing anomalies in the roof systems are analyzed and the intervention priority is systematized, in order to correlate them with the corrective measures. The limiting factors for the inspection of the structures were accessibility as well as the lack of intervention projects. The results obtained reported that the main anomalies found in the systems are related to the lack of maintenance. The study also brings, as a contribution, indications and technical recommendations for the resolution of situations.

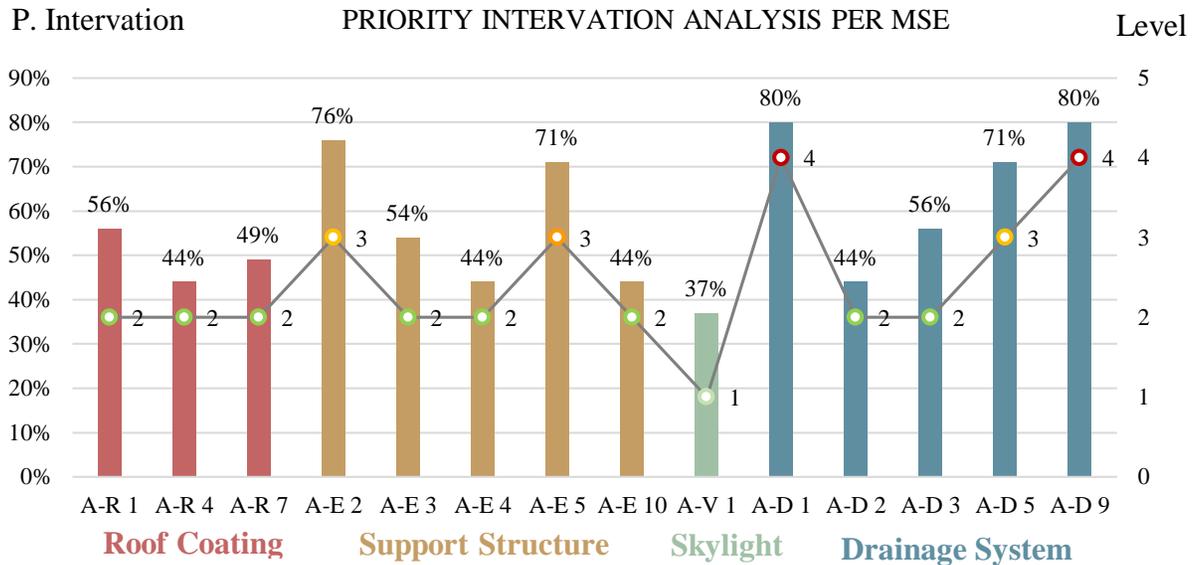
Figure 12. Intervention priority per MSE (Author, 2018).

It is noticed that the Support Structure and Drainage System obtained the highest Intervention Priority Levels. This means that for levels 3 and 4 found in the MSE resulted in an Intervention Priority in the range of 70% to 80%.

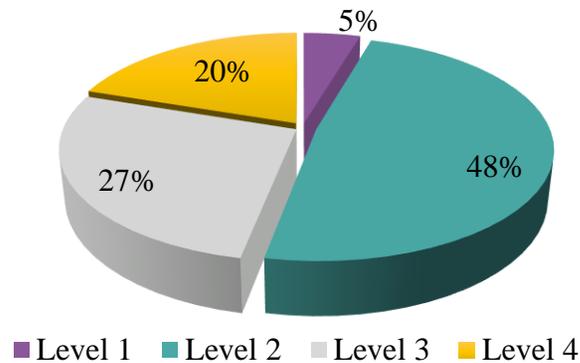
Figure 13. Distribution of priority intervention levels for detected anomalies (Author, 2018).

Figure 13 shows the distribution of intervention priority levels. It is worth noting that level 3 requires short-term actions, and concentrate a total of 27% of the anomalies, while for level 4, with an immediate priority action, a total of 20% was obtained. Thus, the priority intervention given at level 3 and level 4 corresponds to almost 50% of the total observed anomalies, concentrated in cracks, disintegration, surface dirt, and no-drain points.
