JAMES E. IVEY

NATIONAL PARK SERVICE, UNITED STATES DEPARTMENT OF THE INTERIOR

The Completion of the Church Roof of San Antonio de Valero

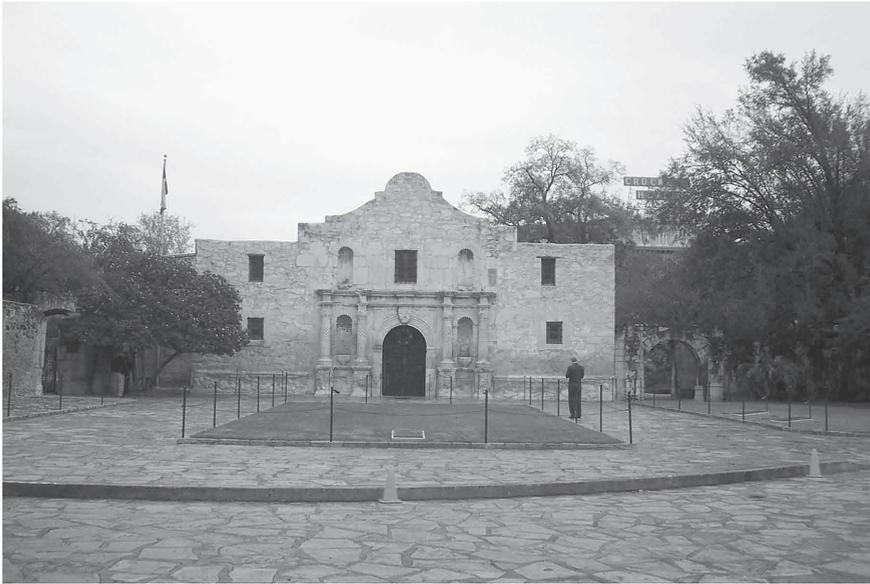
1. The mission church of San Antonio de Valero (the Alamo) today. The distinctive shape of the top of the façade is the result of the construction of a stone gable in 1850 to cover the end of the wooden roof built over the roofless building in that year by the U. S. Army so that it could be used as a military storehouse. Photograph by the author.
