Article

## **Daño a la infraestructura (pavimento) causado por el arbolado urbano en Puerto Vallarta, Jalisco**

### **Damage to infrastructure (pavement) caused by urban trees in Puerto Vallarta, Jalisco**

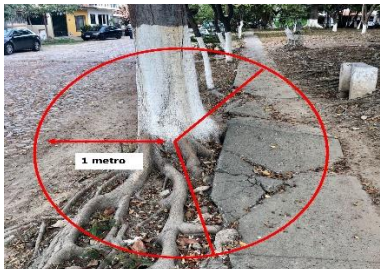
**Table 2.** Infrastructure damage percentage categories and scores.

Illustrative image of the visual assessment	Damage percentage category	Score

No damage	0
	1-20	1
	21-40	2
	41-60	3
	61-80	4
	81-100	5

The percentage of damage to the infrastructure was evaluated on the basis of the visible damage around the tree or palm. For the aims of this work, damage to foundations, drains, fences or any other type of construction was not considered because these were absent from the green areas. Having drawn an imaginary circle around the individual tree, with a radius of approximately one meter, the percentage of damage within the circle was determined, corresponding to one of the five categories already established and having an assigned score value (Table 2).

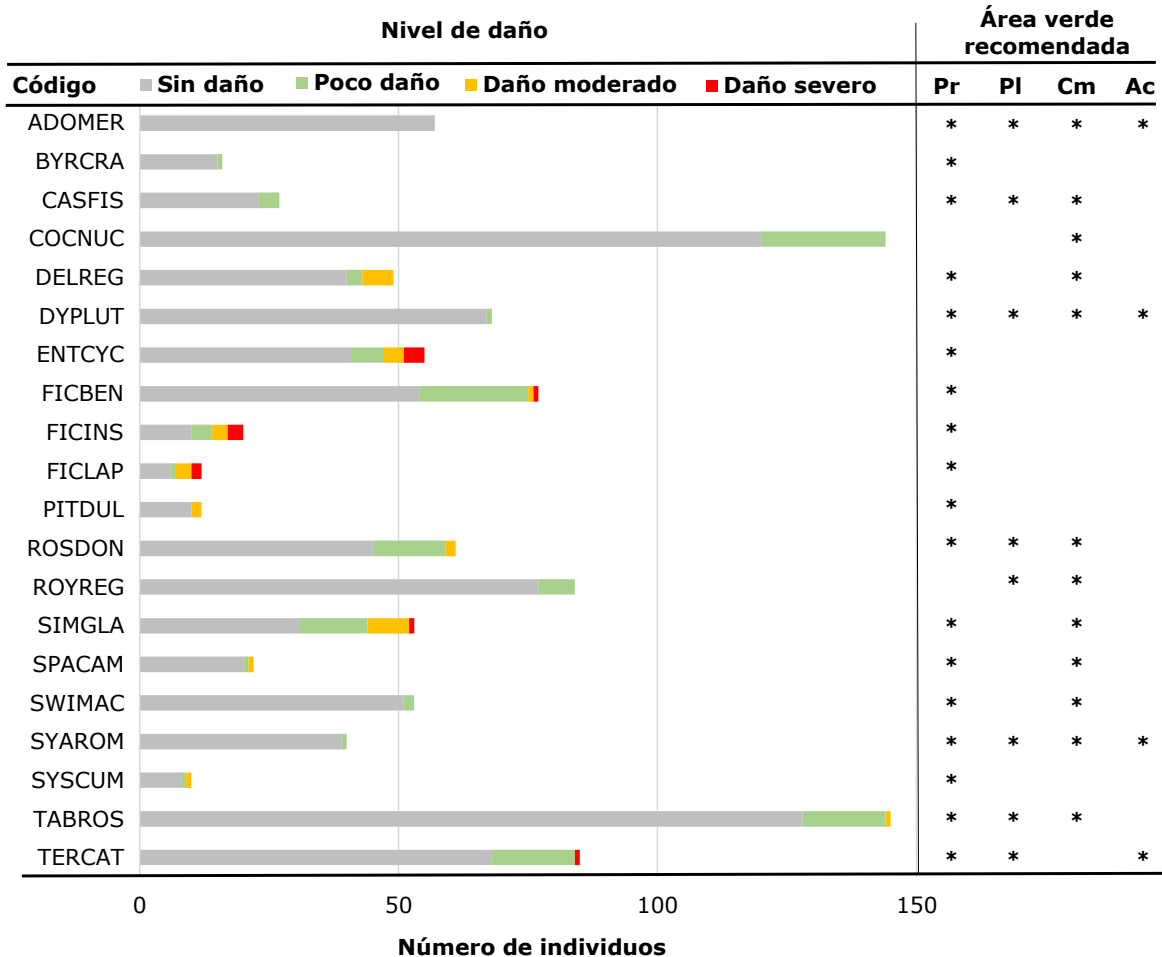
**Figure 2.** Level of pavement damage in parks and public squares associated with the size and location of individuals of 20 selected tree and palm species.

*Código* = Code; *Número de individuos* = Number of individuals; *Sin daño* = No damage; *Poco daño* = Slight damage; *Daño moderado* = Moderate damage; *Daño severo* = Severe damage; *Área verde recomendada* = Recommended green area.

Pr = Park; Pl = Square; Cm= Median strip; Ac=Sidewalk.

Of the total number of individuals evaluated, 83.5 % caused no damage to the pavement due to their location; 12.5 % reached the level of slight damage; 2.9 %, of

moderate damage, and 1.1 % were classified as causing severe damage (Figure 2). Species that caused moderate and severe damage were *Enterolobium cyclocarpum* (ENTCYC), *Ficus lapathifolia* (Liebm.) Miq. (FICLAP), *Ficus insipida* Willd. (FICINS), and *Simarouba glauca* DC. (SIMGLA). According to the level of damage caused by the 20 taxa, a recommendation was assigned for their use in different urban green areas.

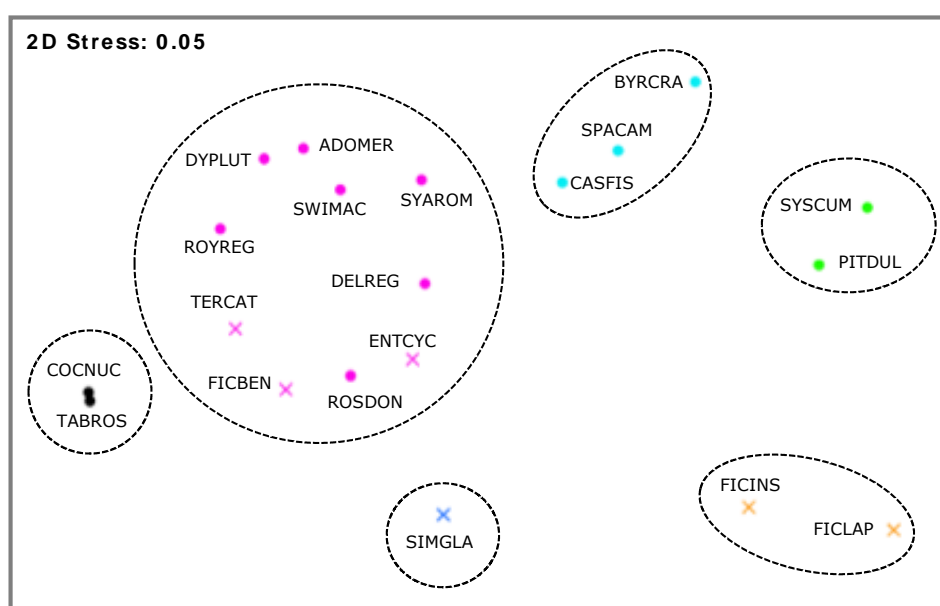
**Figure 3.** Non-metric multidimensional scaling analysis (NMDS) for the 20 species of trees and palms associated with pavement damage in parks and public squares in *Puerto Vallarta*.

The colors represent the six groups identified. Species shown with x's have individuals that caused severe damage. The full name of the species can be consulted in Table 4.

Six groups of species were formed according to the level of damage associated with the pavement (Figure 3). The non-metric multidimensional scaling analysis (NMDS) showed that one of the groups is made up of 10 taxa with intermediate abundance levels —of 40 to 85 individuals—, which tend to occupy all damage categories. Another group was made up of the most abundant species: *C. nucifera* (COCNUC) and *T. rosea* (TABROS), most of whose individuals were not associated to damage. The NMDS result was shown to be significant, with a stress value of 0.05.

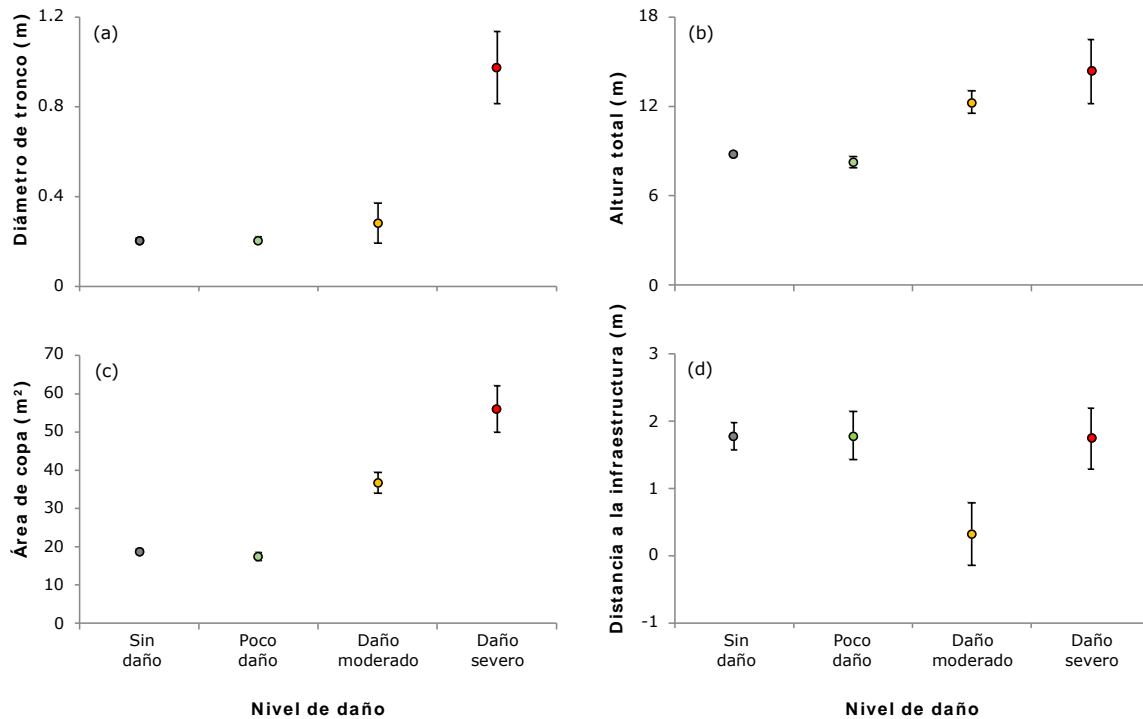
**Figure 4.** Relationship between the level of pavement damage in public parks and squares and variables related to biological factors, a) stem diameter at breast height, b) total height, c) crown area, and the environmental factor d) distance to the infrastructure.

*Nivel de daño* = Damage level; *Sin daño* = No damage; *Poco daño* = Slight damage; *Daño moderado* = Moderate damage; *Daño severo* = Severe damage; *Diámetro de tronco* = Stem diameter; *Altura total* = Total height; *Área de copa* = Crown area; *Distancia a la infraestructura* = Distance to the infrastructure

Biological, or dasometric variables significantly explain the level of pavement damage caused by the size and location of individual trees and palms (Figure 4).

The highest level of damage was generated by individuals with a larger stem diameter ( $\chi^2 = 36.82$ ,  $p < 0.001$ ; Figure 4a), greater height ( $\chi^2 = 33.33$ ,  $p < 0.001$ ; Figure 4b) and larger crown area ( $\chi^2 = 54.02$ ,  $p < 0.001$ ; Figure 4c). The Kruskal-Wallis nonparametric test showed differences in the level of damage at different distances from the infrastructure ( $\chi^2 = 12.08$ ,  $p = 0.0071$ ; Figure 4d).

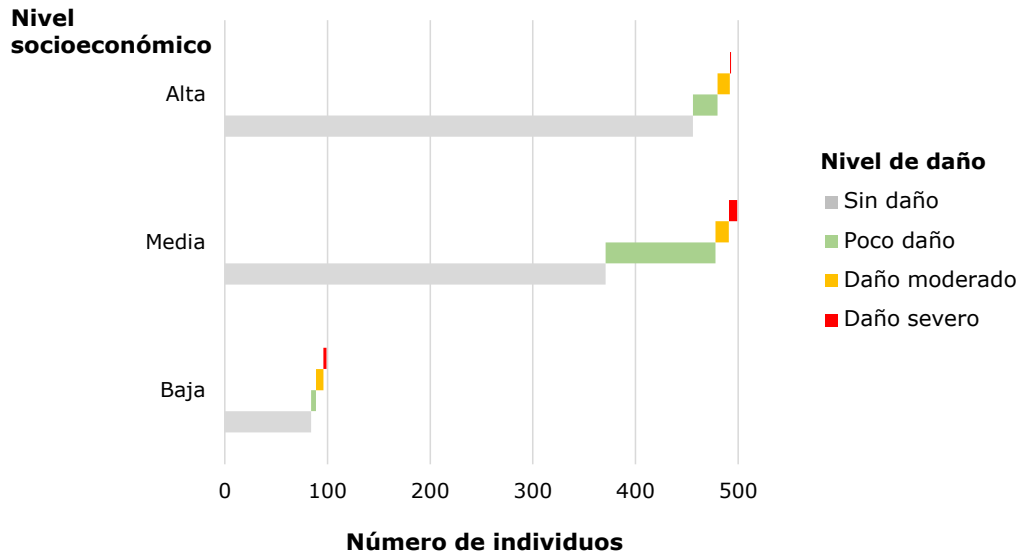
**Figure 5.** Relationship between damage to the infrastructure of parks and public squares and socioeconomic status.

*Número de individuos* = Number of individuals; *Nivel de daño* = Damage level; *Sin daño* = No damage; *Poco daño* = Slight damage; *Daño moderado* = Moderate damage; *Daño severo* = Severe damage; Socioeconomic level; Alta = High; Media = Medium; Bajo = Low.

Socioeconomic level, as a social factor, significantly explained the possibility of repairing the damage caused by woody individuals to the infrastructure (Figure 5).

Based on the total number of trees and palms by socioeconomic level, the highest percentage of individuals that caused severe damage was significantly higher in the low socioeconomic level (3 %) than in the average (1.6 %) and high levels (0.2 %;  $\chi^2 = 83.1, p < 0.001$ ). In parks and squares located in high socioeconomic areas, there was a significantly higher number of individuals not associated with damage (92.5 %), compared to the medium (74.3 %) and low (84.9 %) socioeconomic areas. This is because the high socioeconomic areas have the possibility of repairing the damaged infrastructure, which gives an appearance of absence of damage due to the poor location of the tree species.
