Experimental study of infiltration through subsidence-reactivated surface discontinuities

Martín Hernández-Marín^{1,3}, Norma González-Cervantes¹, Lilia Guerrero-Martínez¹,
Christian Emmanuel Rodríguez-Padilla², and Jesús Pacheco-Martínez^{1,3}

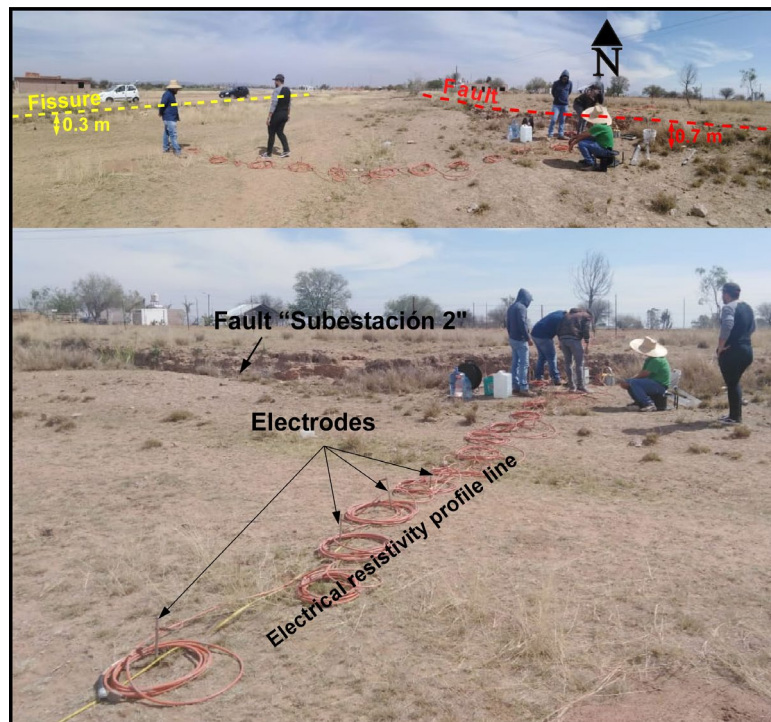
Figure 3. Photograph during fieldwork where both discontinuities are shown. The photographs were taken during the application of the ERT method.

In general, the methodology consisted of applying Electrical Resistance Tomography (ERT) and subsurface permeability techniques in the experiment area (Figures 2 and 3). The first basically involved applying an electrical current to subsoil through surface electrodes and analyzing the soil response. Under this technique, the less moisture and salinity in pore water in the soil the more resistive the soil. While the permeability test consisted of measuring the hydraulic conductivity and infiltration rate parameters of the soil. Both techniques were initially applied in a line on the surface approximately perpendicular to the planes of both discontinuities (line A-A', Figure 2c), obtaining general profiles of ERT (38 m) and permeability (33 m). These general profiles were performed to observe the overall behavior of both discontinuities to the application of the two techniques.

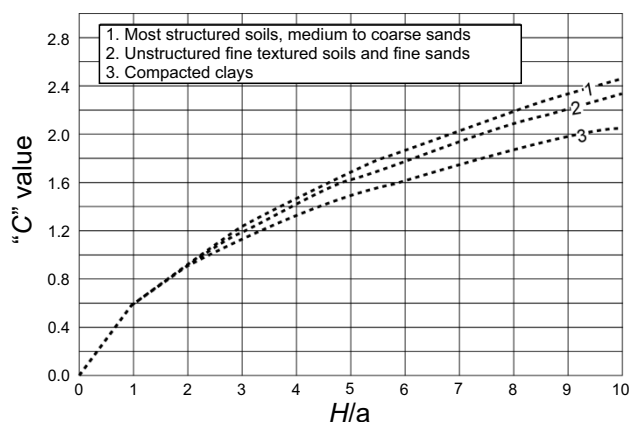
Figure 5. Graph to obtain the values of the parameter C as a function of the parameters H and a , according to (Reynolds, 1993). Each curve corresponds to a type of soil as explained in the figure.

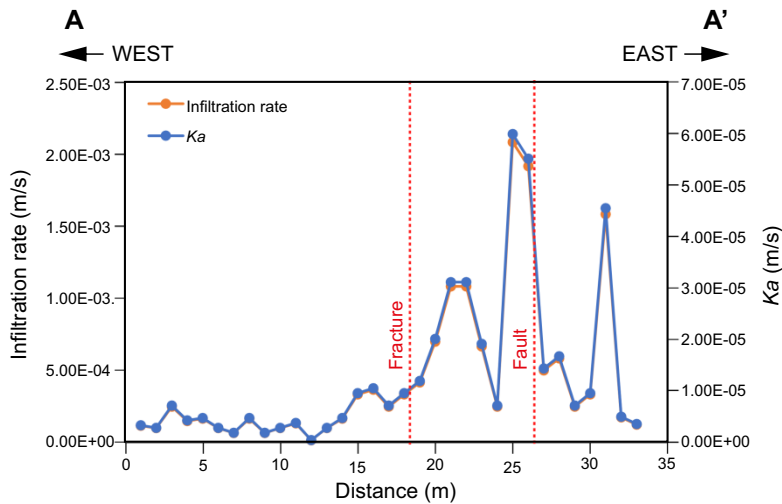
Figure 7. Variation profile of both the infiltration rate and the hydraulic conductivity (K_a), obtained from the tests with the Pask-type permeameter. As can be seen, both parameters maintain an approximate linear variation.

Figure 7 shows the profile A-A' (see Figure 2c) with the results of the permeability tests. It should be noted that the two points with the highest values of both parameters are located near the fault and in general, the higher values are mainly presented between the fault and the fracture. As observed, the values of both parameters are lower by several orders of magnitude to the west of the fracture and at the east of the fault, except for a single point with high values at 8.5 meters to the east of the fault. In the area between both discontinuities, several small surface cracks (openings less than 5 mm) were observed, likely influencing the values of the hydraulic parameters. These small cracks are probably related to the mechanical activity of both discontinuities and form a network of subsurface cracks, although further investigation is required to confirm this.

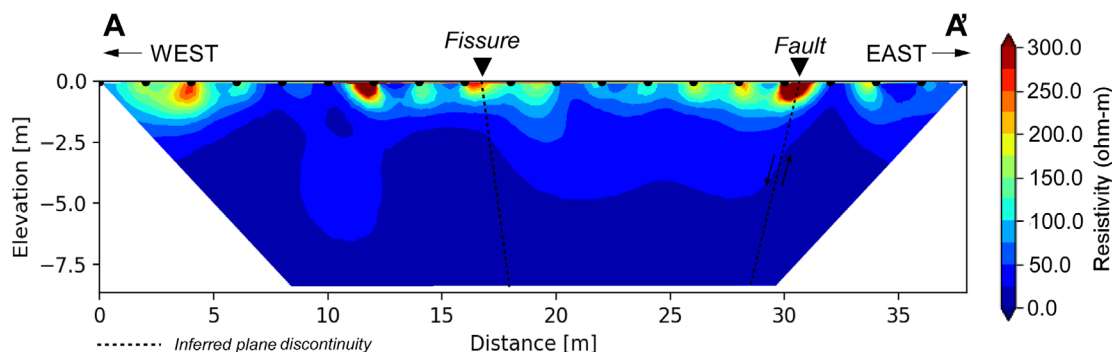
Figure 8. General ERT profile of the study area, which includes both discontinuities observed in the study area.

As mentioned above, a general ERT profile was applied to characterize the study area and to better understand the initial conditions of the local subsoil in response to an electric current (line A-A'). As can be seen in Figure 8, the resulting profile suggests that both discontinuities have almost vertical displacement. The areas of low resistivity, lower than 25 $\Omega\cdot\text{m}$, could be related to a number of features, such as the presence of clay, high compaction, etc. They could also be related to high moisture retained by the soil, for example, the one closest to the fault plane, which is observed to a depth of two meters. The areas with high resistivity, more than 300 $\Omega\cdot\text{m}$, are observed closer to the surface and could be associated with air, for example in the location of the fault. These areas of high resistivity could also be associated with compacted soil due to the presence of dirt roads and pedestrian paths.

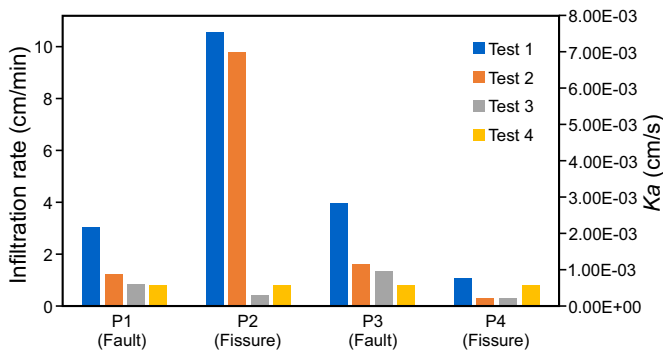
Figure 13. Comparison of the main hydraulic parameters obtained from the permeability tests for all infiltration points.
