Analysis of the short term geo-environmental evolution of an endorreic basin using satellite images: the case of Tecocomulco Lagoon, Mexico

Guadalupe de la Lanza Espino*
Gabriela Gómez Rodríguez**

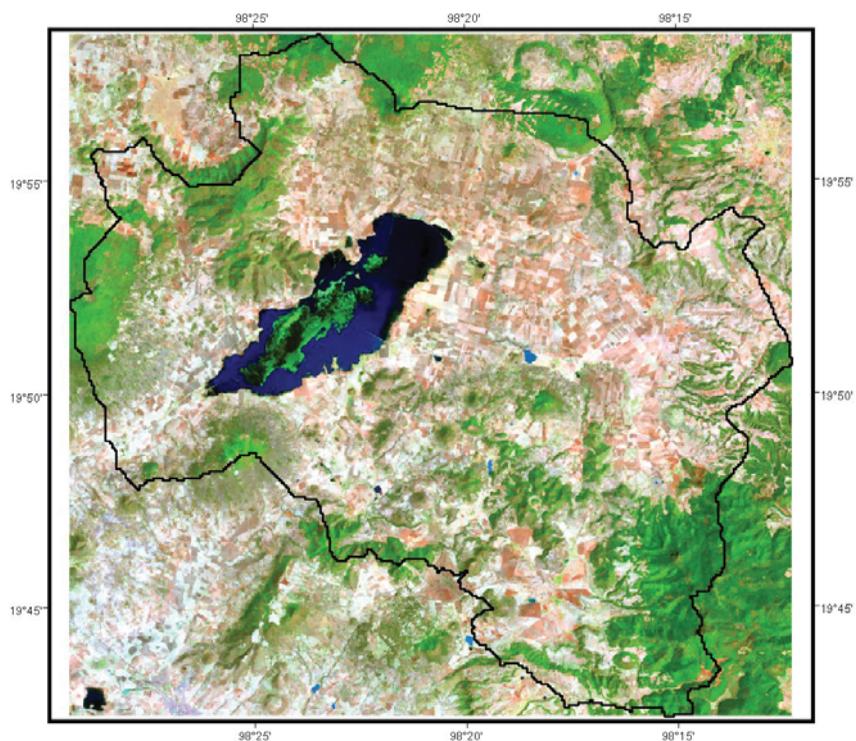
Figure 2. Landsat ETM +image of Tecocomulco Lagoon and its sub-basin (March, 2002).

Tecocomulco Lagoon is located on the north eastern region of the Great Basin of the Valley of Mexico and represents 5.59% of its total area, as part of a sub-basin measuring 564 km² (Comisión Nacional del Agua, CNA, for its initials in Spanish, 2002; Figure 1, 2), located between 19° 53' N and 98° 21' W (central parallel and meridian), within a basin found at 19° 03' - 21° 11' N and 98° 11' - 99° 30' W, in the central-eastern part of the Trans Mexican Volcanic Belt (Alatraste-Vilchis *et al.*, unpublished). This basin has a tectonic volcanic origin, bordered by several faults that run in a NNE – SSW direction (García Palomo and Macías, unpublished). The bathymetry of the lagoon is flat, with high plasticity clays and dispersed hard clays, with surrounding

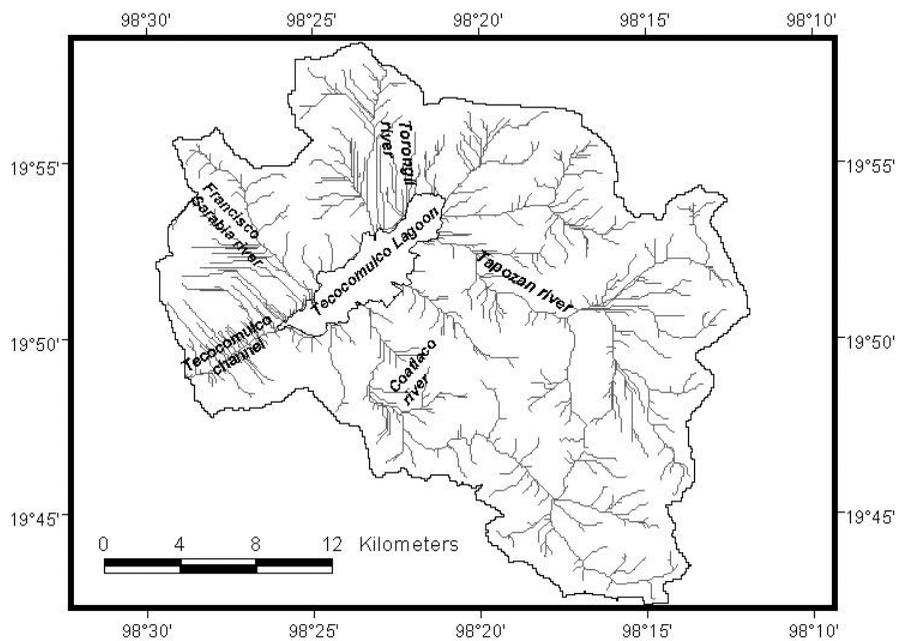
Figure 3. Lagoon of Tecocomulco with its drainage network calculated from digital elevation model.

The Tecocomulco sub-basin is endorreic, with a dendritic drains pattern, and four main fluvial contributions (rivers: Cuatlaco, Sarabia, Toronjil and Tepozan; Figure 3) which do not carry much water due to a low precipitation rate, high evaporation and soil permeability. There are several natural springs in the basin, located mainly in at the south-eastern part (Ruiz-González, 2000). Most of the runoffs are intermittent, with heavy

INEGI's digital elevation model (DEM), with spatial resolution of 100 m, was also used to delimit the sub-basin. The flow's direction and accumulation were identified using the Arc/Info 7.2 program.

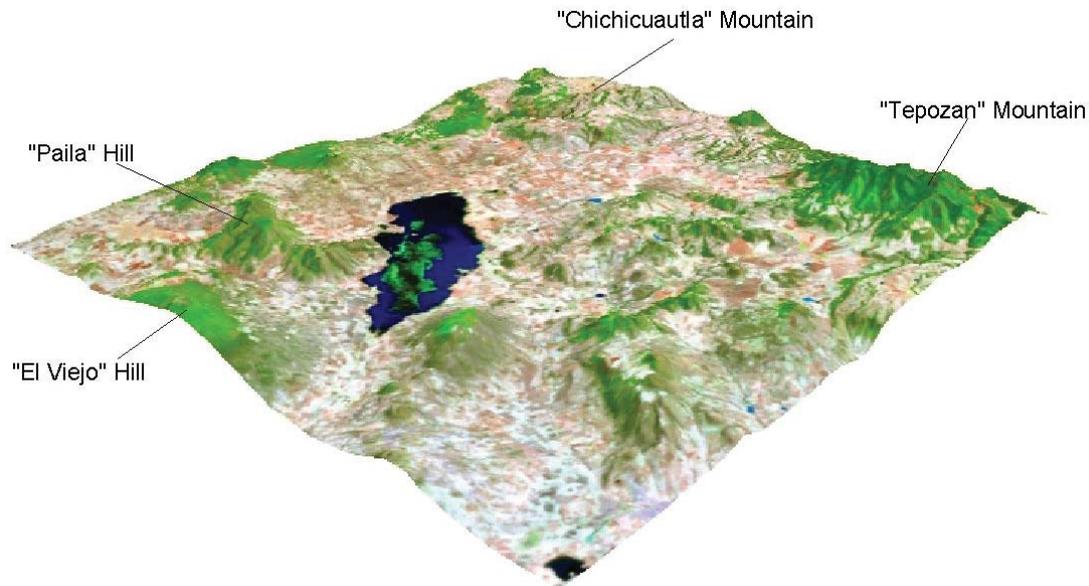
Figure 4. Landsat ETM +image with digital model overlaid.

The lagoon has an elongated and irregular shape, and a variable surface; Ruiz-González (2002) calculates a surface of approximately 27 km². Sediments have a volcanic, fluvial and windswept origin, a mixture that depends on the main activity (volcanic or weather related). The basin is surrounded by volcanoes, calderas, cineritic conus and the Tepozan and Chichicauautla Mountains (Figure 4).

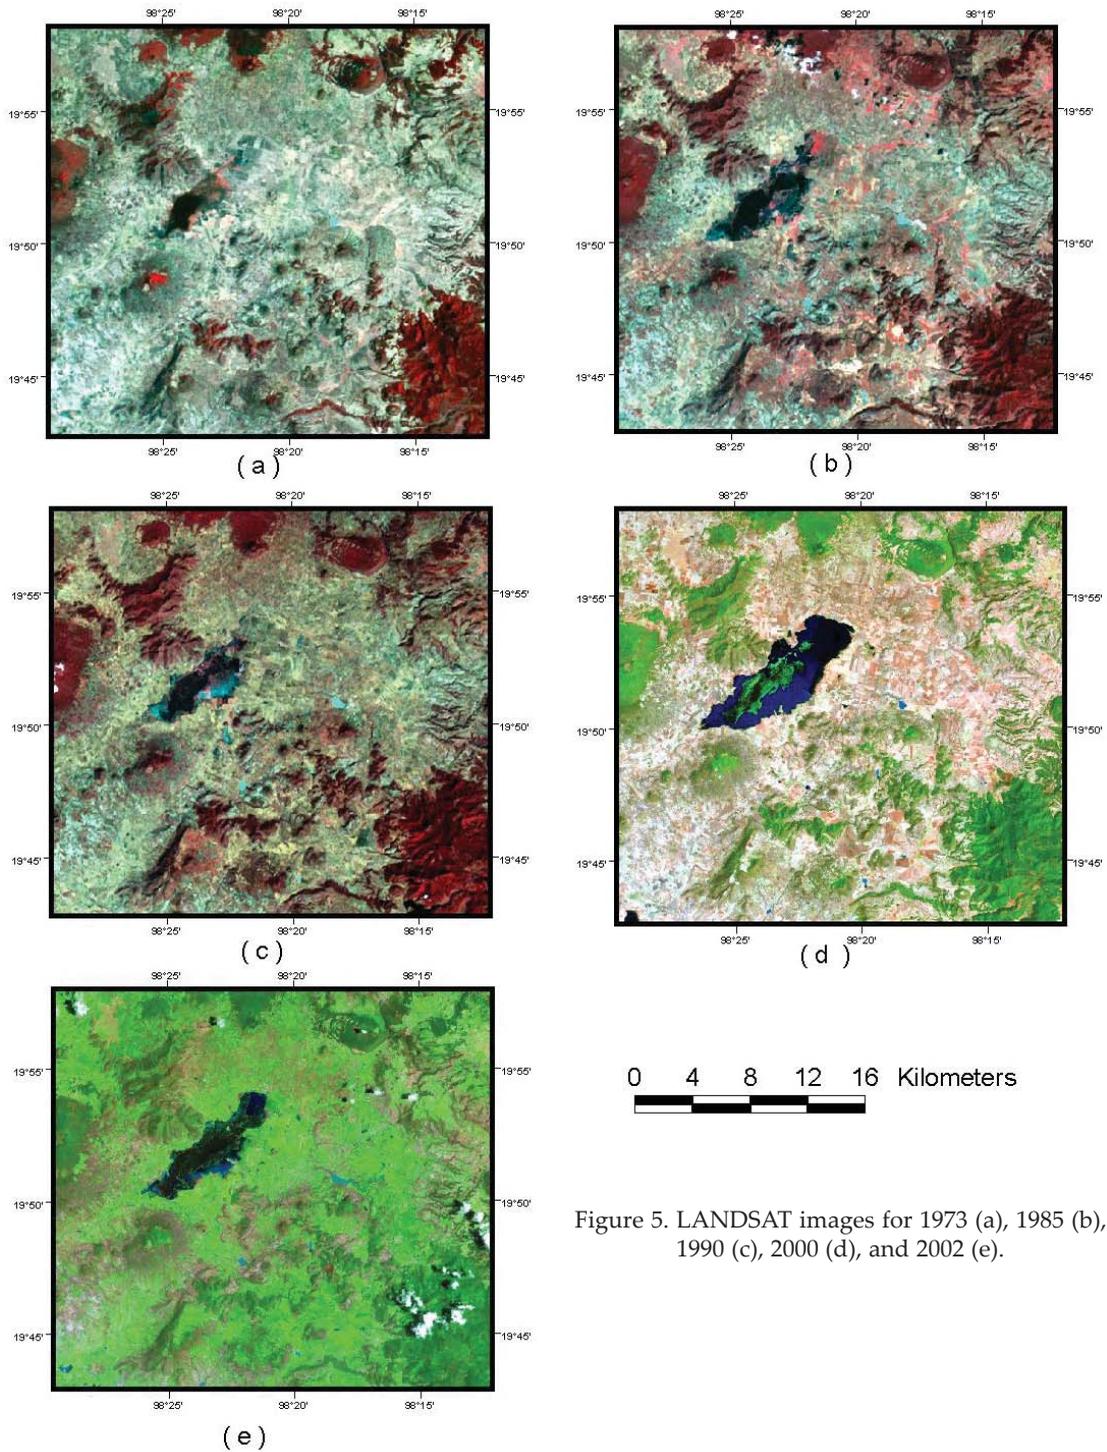
Figure 5. LANDSAT images for 1973 (a), 1985 (b), 1990 (c), 2000 (d), and 2002 (e).

- a) Landsat Image MSS, November 23, 1973
- b) Landsat Image MSS, October 30, 1985
- c) Landsat Image MSS, November 21, 1990
- d) Landsat Image ETM+, March 21, 2000
- e) Landsat Image ETM+ August 2002
- f) Landsat Image ETM+ 2002 classified
- g) Map of change land use and vegetation, INEGI 1976, 2000-2001 for the sub-basin.

The outline of the lagoon was drawn on screen with the 73, 85, 90 and 2001 images using Arcview GIS 3.2, then the surface of the water body in different years was calculated (Figure 5).

(27 km²), with the lagoon presenting a very irregular configuration. Based on the morphology presented by this author, the 1973 image (Figure 5) indicates that the area which lost the highest volume of water and was most silted was the NW area, which corresponds to the foot of the mountain, between the "La Paila" and "Del Viejo" hills (both of which belong to the Chicicuatla Mountain), the most eroded section and the source of sediments (> 12 ton/km²/year, Huízar-Álvarez *et al.* unpublished), and the place where the lagoon receives more direct tributaries. It must be said that in 1972-73 there was a strong draught associated with the "El Niño" phenomenon, (maximum) according to the NOAA scales (2004) that affected the entire country; thus, it is possible to consider that this climatic phenomenon had to do with the significant decrease in the lagoon's water. In support of this, Ruiz-González (2000) indicates that during 1996 and 1997 there was almost no rain and that in 1998 the lagoon dried completely, El Niño occurred during these years and was considered one of the most severe events in the 20th century.

The images for 1973, 1985 and 1990 (Figure 5) show that the desiccated areas which had a high degree of silting are associated with the two most important permanent rivers: the Tepozan to the east, with its water held by the Tezoyo Dam, and the Cuatlaco river to the southwest, which feeds the Benito Juárez dam. The Sarabia river, which passes through the El Viejo hill, is seasonal and feeds the lagoon only during the rainy season, as it infiltrates during the dry periods. It should be mentioned that there is a natural underground exit to the southwest, through faults and fractures.

In spite of Ruiz-González (2000,) who indicates that the Cuatlaco river is the only one feeding the lagoon throughout the year, the images for 1973, 1985 and 1990 show that the place where the river discharges is also where more surface has been lost; this can be the result of water management through the dam for agricultural purposes. In 1973, the advance of agriculture in terms of land was not evident as a cause for the reduction in the lagoon's surface for irrigation purposes or for gaining land from the lagoon's own body through the construction of small dams for future agricultural areas. Nevertheless, this study –based on INEGI's cartographies of 1976, and from the Instituto de Geografía de 2000 (Figure 7)– calculates an agricultural increase of 9.3%, as is shown in Figure 8 and, precisely the region where Ruiz-González (2000) indicates, is found the highest concentration of canals built to improve the drainage from agricultural areas and to stop the water from becoming stagnant. Agricultural workers have also built small dams to hold water for irrigation, and which, once dried, will provide extra land from the lagoon, as has happened in the northeastern area. This can be seen in the 1990 and 2000 images (Figures 5).

The tendency of the drain to increase, registered by Ruiz-González (2000) in a 14 year time lapse (Figure 6), from 1980 to 1994, can be corroborated with the tendency of the flooded area to increase from 1973 to 2002 (Figure 5), as can also be seen in figure 9. In 2000, considered as a La Niña year, the surface of the lagoon was calculated on the image, as having 35 km², against the 27 km², quoted by the author. It should be said, nevertheless, that the northeastern side had a low water table, referred to as a muddy area (Figure 10) and which borders with the high density (irrigated) agricultural area as well as with the area located to northwest, in the foot of the mountain at the Chichicuautila mountain, which is smaller and has seasonal agriculture. This last area coincides with the highest input of sediments from erosion (between 3.1

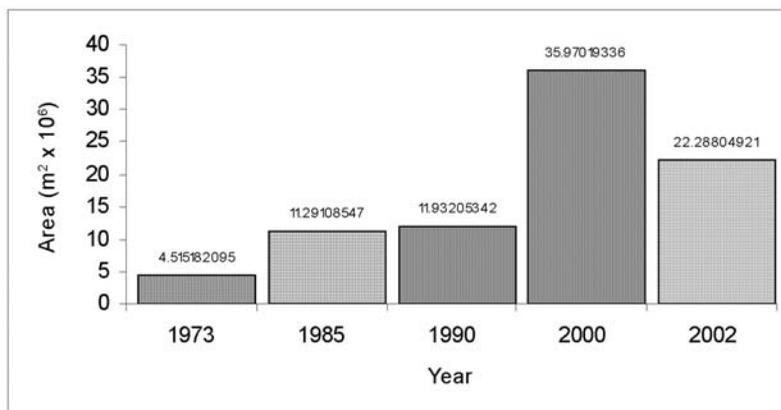
Figure 6. Coverage fluctuations calculated from LANDSAT images. Coverage fluctuations calculated from LANDSAT images.

According to Ruiz-González (2000), from 1981 to 1994 there was a tendency of the drain to increase, although oscillations due to draughts and severe rainfall can be associated with phenomenon El Niño that have a certain periodicity, as can be seen in Figure 6.

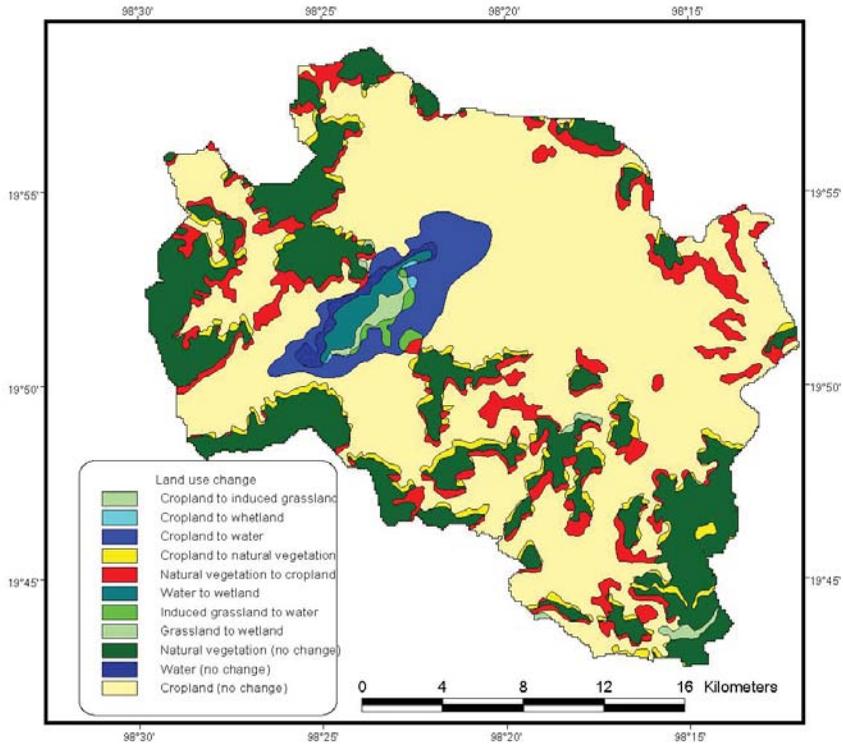
Figure 7. Land use changes in Tecocomulco sub basin from 1976-2000.

Land use and vegetation map from INEGI (1976) and the National Forestry Inventory 2000-2001 map were used to assess land use change.

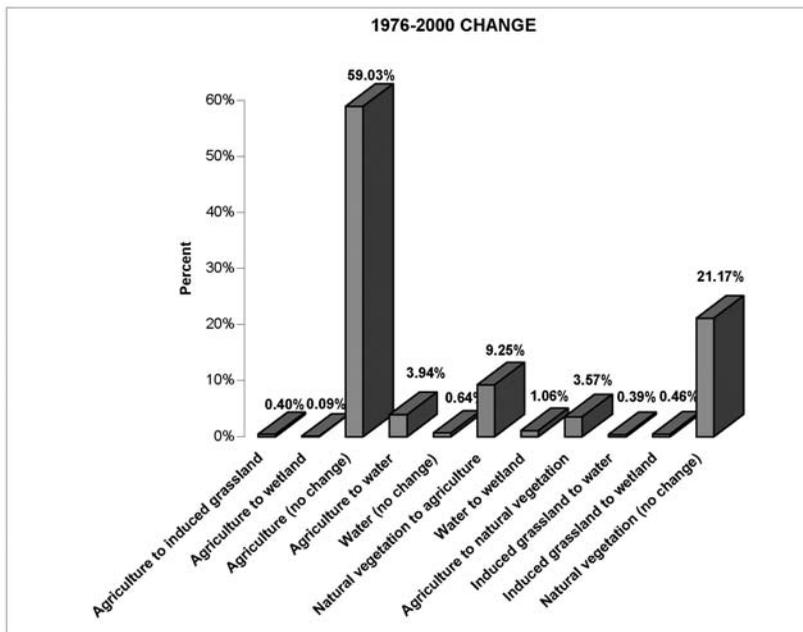
Figure 8. Land use change from 1976 to 2000.

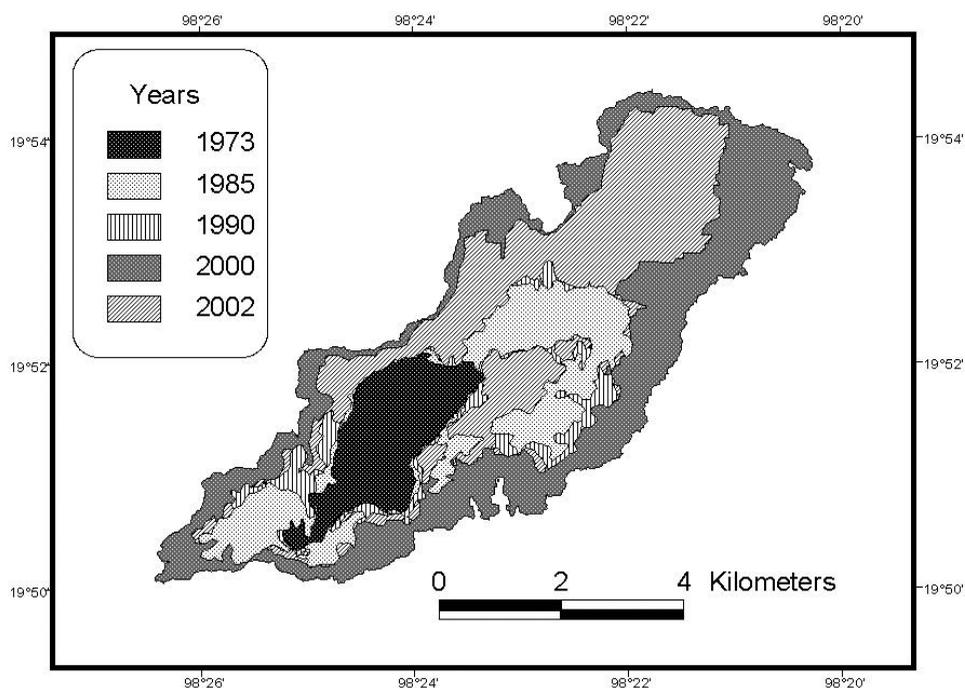
Figure 9. Coverage change of the Tecocomulco Lagoon between 1973-2002.

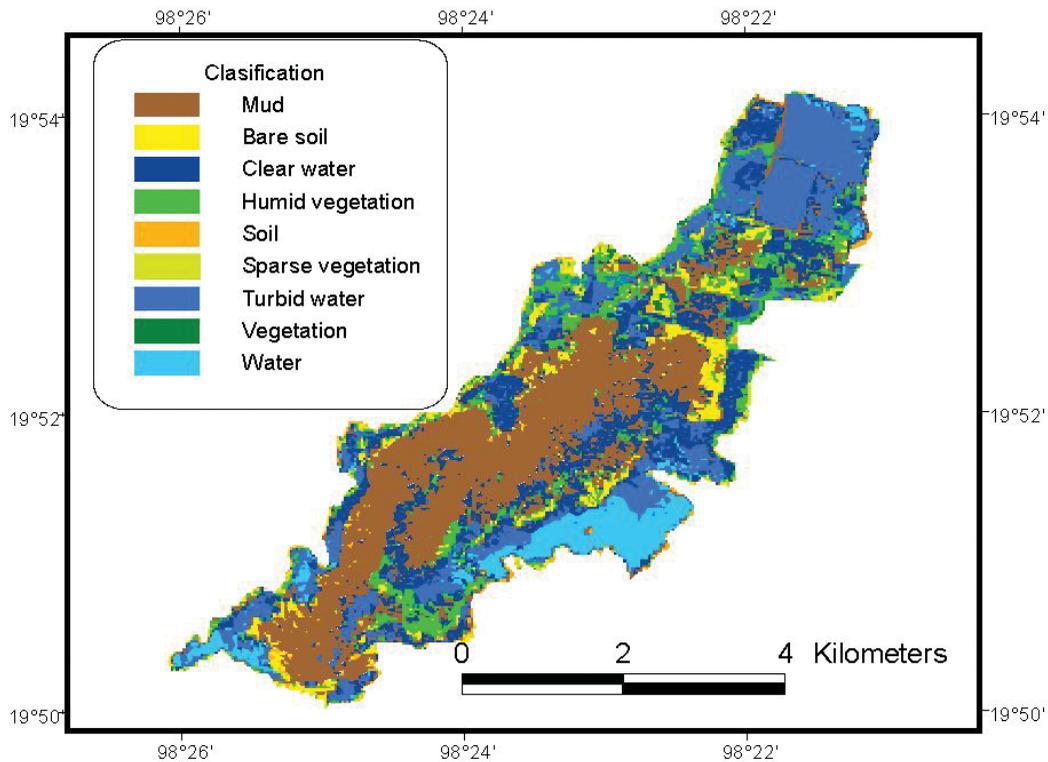
Figure 10. Classified Landsat ETM+ of 2000.

to 8.1-12.0 tons/km², according to Huízar-Álvarez *et al.*, 2003), seen desiccated in the 1973, 1985 and 1990 images, with high possibilities of flooding during periods of intense rainfall, and with shallow depths (muddy areas) as seen in the 2001 image (Figure 10). It is important to state that the heterogeneity in flooded and desiccated areas can be the result, among other things, of the sediments moving to form deltas at a sedimentation rate of 5.7 cm/year, as indicated by Ruiz-González (2000).
