'In Vitro' Comparison of K3XF and TFA Cyclic Fatigue Resistance in Continuous Rotation and Adaptive Motion

A. G. Carrillo-Vázquez¹, L. H. Carrillo-Vázquez¹, B. González-Vizcarra², L. J. Villarreal-Gómez^{2,3}, R. Valdez-Castro⁴, M. A. Cadena-Alcántar¹

¹Facultad de Odontología, Universidad Autónoma de Baja California, Tijuana, México

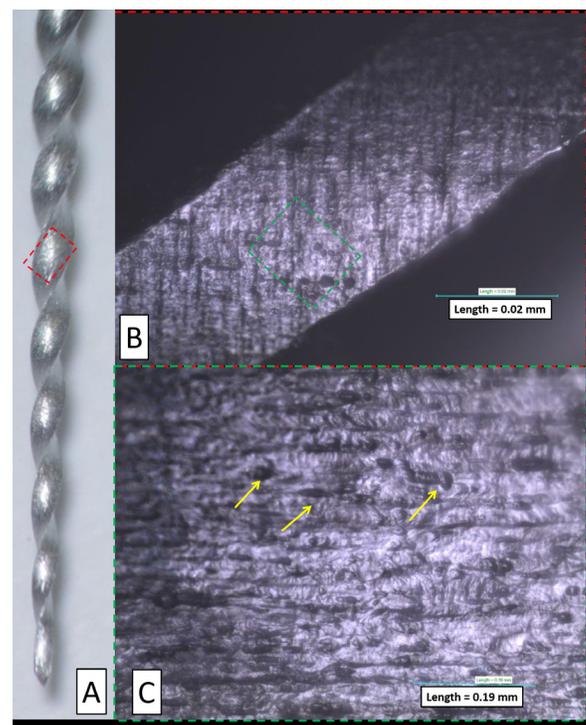
Figure 1a shows the general appearance of the longitudinal surface of a TFA-type file. Figure 1b shows a close-up view of the cross-sectional area of the file, in which the marks of the manufacturing process of the file are appreciated. Figure 1c can be seen in more detail, the manufacturing lines described above, see yellow arrows.

FIGURE 1. Morphological inspection of a TFA file.

- a) General view of TFA file (50 x).
- b) Cross-sectional area of a TFA file (100 x).
- c) More detailed amplification of a TFA file (200 x).

Firstly, a morphological inspection was performed with an inverted metallographic Nikon Eclipse MA 100 microscope under 3 magnifications: 50X, 100X, 200X (Figure 1).

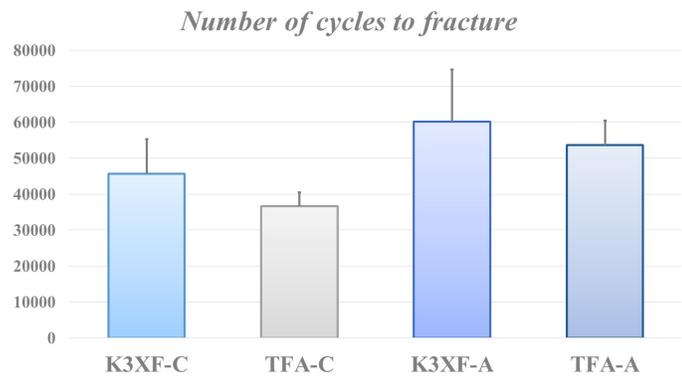
On the other hand, 60,083 cycles were reported for the K3XF-A group at a speed of 500 rpm. Finally, it was found that for the TFA-A group 53,583 cycles were required to reach its fracture at 500 rpm. The K3XF-A group was the most resistant of the 4 groups evaluated (Figure 2).

FIGURE 2. Comparison of means of the cycles until the fracture of the 4 groups.

In the case of the K3XF-C group, the average number of cycles up to the fracture at 350 rpm was 45,675 cycles. For the TFA-C group this number was 36,667 cycles at 500 rpm.

When comparing the groups K3XF-C (45675 ± 9541 cycles) and the TFA-C (36667 ± 3869 cycles). The difference is statistically significant, since the files of the K3XF-C group require a greater number of cycles for the fracture than the files of the TFA-C group. About the comparison between the K3XF-C group with K3XF-A (60083 ± 14572 cycles). There is not an important difference in the number of cycles for the fracture.

Among the groups K3XF-C and TFA-A (53583 ± 6873 cycles), the number of cycles for the fracture are similar. On the other hand, the difference is wide between the TFA-C and K3XF-A groups, since the K3XF-A files require a greater number of cycles for the fracture than the TFA-C group.

Finally, the comparison between the TFA-C and TFA-A groups showed that the difference is evident, the TFA-A files require more cycles for the fracture than the TFA-C files.

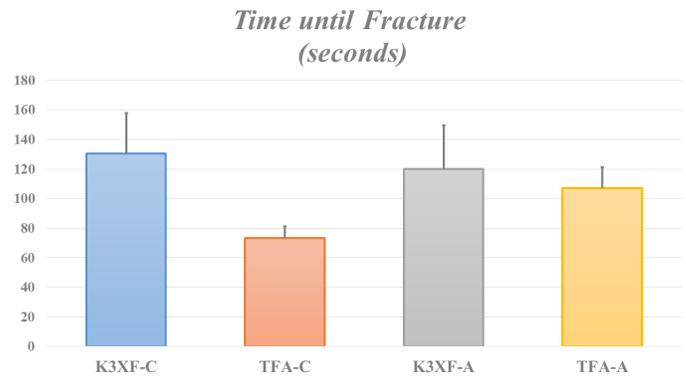
With respect to the time in seconds (s) required to reach the fracture. The K3XF-C group needed a time of 131 s, the TFA-C group was fractured in only 73 s, with respect to the K3XF-A group, a time of 120 s was reported and the TFA group A took a time of 107 s to attain the fracture (Figure 3).

FIGURE 3. Comparison of means of time in seconds (s) until fracture of the 4 groups.

Regarding fracture time, the K3XF-C group had a mean of 130.5 ± 27.3 s and the TFA-C group averaged 73.3 ± 7.74 s, hence TFA-C group files break faster than the K3XF-C.

K3XF-A group has an average of 120.2 ± 29 s, compared to the K3XF-C group. There is not an important difference in time for fracture. Comparing the groups K3XF-C (130.5 ± 27.3 s) and the TFA-A group (107.2 ± 13.8 s). There is no statistically significant difference in time for fracture. On the other hand, TFA-C files break faster than the K3XF-A. Statistically evaluating the groups TFA-A and TFA-C, it was found that TFA-C group files break faster than the TFA-A.

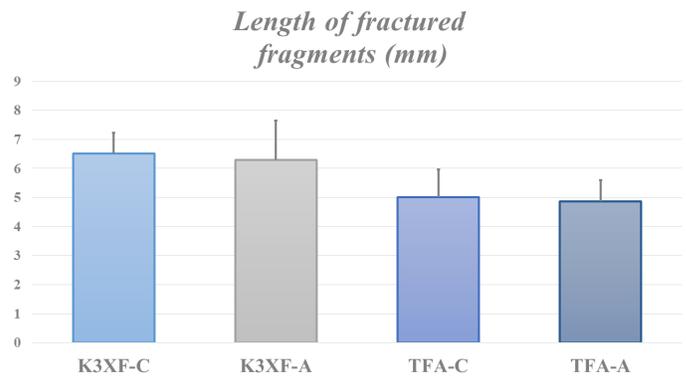
area of the instrument. For the K3XF-C group, the measured fragments had a length of 6.51 mm, for the group K3XF-A a mean of 6.29 mm, in the case of the group TFA-C a length of 5.02 mm and finally, the group TFA-A obtained the smallest length of 4.86 mm (Figure 4).

FIGURE 4. Comparison of mean lengths of the fragments of the 4 groups after being subjected to cyclic fatigue.

After the fracture of the rotating instruments, the length of the fractured fragments was measured to determine if mechanical damage occurred in the same

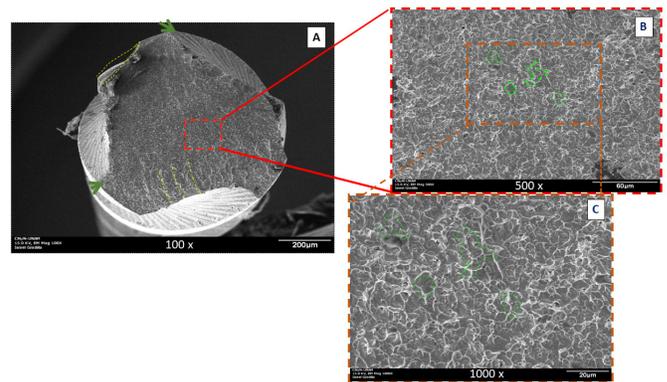
Figure 5a shows the general appearance of the fracture of a K3XF-C file in which a flat surface and multiple fracture beginnings (green arrows) are observed,

also the advancement of the fracture propagation lines by fatigue (yellow dotted lines). This image also highlights the rupture of one of the edges (yellow circle). Figure 5b shows a close view of the fragile fracture zone in which the grain fractures (green lines) can be seen. On the other hand, figure 5c shows grain breakage in which the flat fracture morphology (green dashed lines) is more obvious. It is important to note that these samples had an average rupture force of 6.84×10^9 GPa, with a fracture diameter of 0.75 mm and a fracture length of 6.51 mm. Whose average area was 4.4×10^{-7} m².

FIGURE 5. a) General appearance of the fracture surface of a K3XF-A file; this image also highlights the rupture of one of the edges. b) and c) Close views of the fracture surface in which the fracture after granularity is appreciated and many characteristic starts of fatigue fractures.

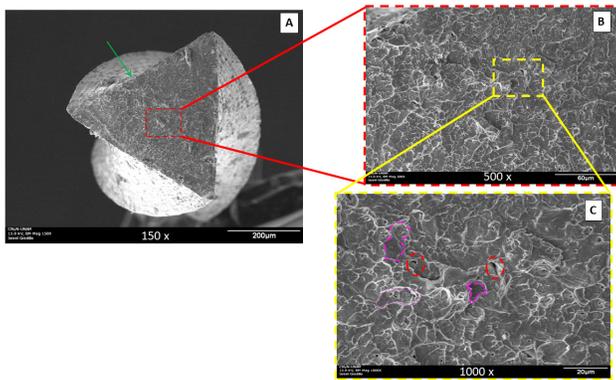
In the case of TFA-C files, Figure 6a shows the general appearance of the fracture of a TFA-C file in which a flat surface is well as the beginning of fracture (green arrows). It is important to note that the edges of the file are complete. Figure 6b shows a close view of the fragile fracture zone in which the fractures of the grains (green lines) can be seen.

Figure 6c shows in greater detail the transgranular morphology rupture, typical of fatigue fractures (green dashed lines). In this image, we can see some cavities (black dotted lines) which could act as stress concentrators. It is important to note, that these samples had

an average breaking stress of 1.18×10^{10} GPa, at a fracture diameter of 0.66 mm and a fracture length of 5.02 mm . Average area: $3.45 \times 10^{-7} \text{ m}^2$ (Figure 6).

FIGURE 6. a) General appearance of the fracture surface of a TFA-C file. b) and c) Close views of the fracture surface in which the fracture after granularity is appreciated and many characteristic starts of fatigue fractures. It is important to note that the edges of the file are complete (200X).
