Evaluation of the adherence of ceramic tiles applied as facade lining

P. Valentini¹, C. S. Kazmierczak².

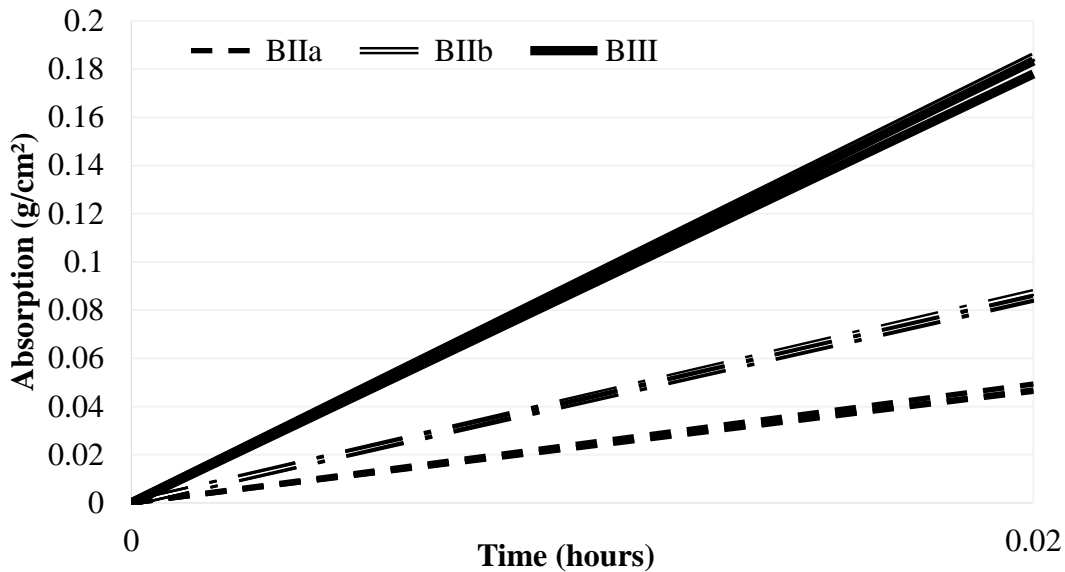
The water absorption profile (in g/cm^2) obtained by the procedure of the RILEM can be observed in Figure 1.

The average capillarity coefficient value of the type BIIa ceramic tile is of $0.046 \text{ g/cm}^2 \cdot \text{min}^{1/2}$, of the BIIb tile it is of $0.085 \text{ g/cm}^2 \cdot \text{min}^{1/2}$, and of the BIII tile it is of $0.185 \text{ g/cm}^2 \cdot \text{min}^{1/2}$. The ceramics of group BIIa have the lowest capillarity coefficient, followed by BIIb and, finally, the BIII tiles show the same behavior observed in the water absorption tests.

Figure 1. Water absorption per capillarity profile of the ceramic tiles

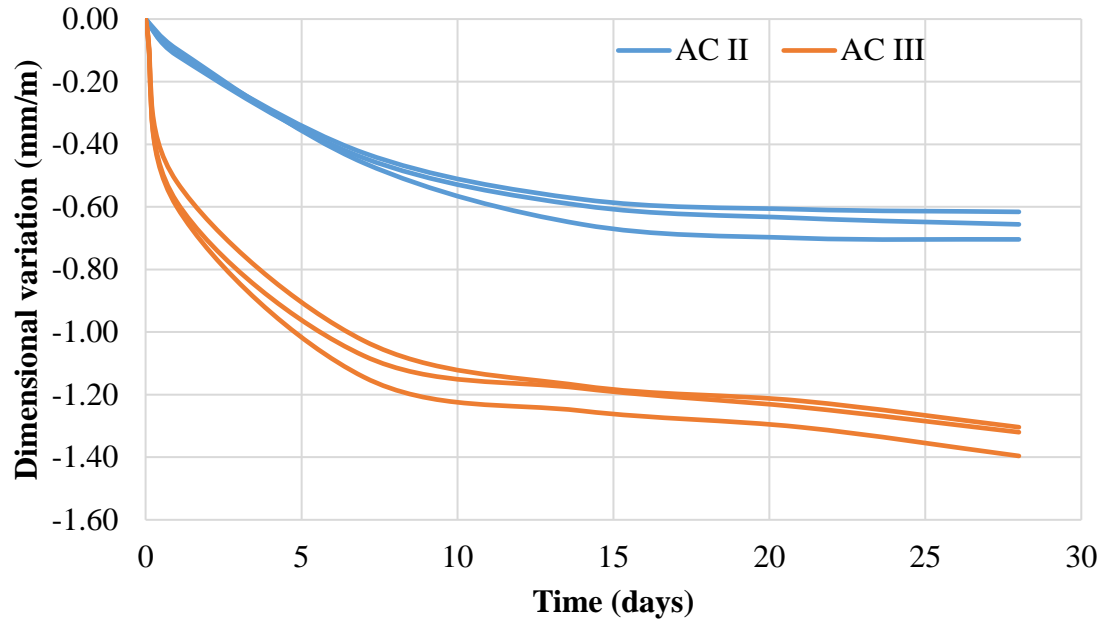
In the fresh state, both adhesive mortar AC II as well as AC III obtained very close results, not being possible to distinguish them from the properties measured in those tests. In the Sliding Determination test the mortars showed the same value, which was lower than maximum 2 mm allowed by the NBR 14.081-5 (ABNT, 2012). In the determination of time in open sky, AC II had a result of 0.50 MPa and AC III of 0.62 MPa. The values obtained in the tests correspond to the NBR 14.081-3 (ABNT, 2012), which specifies a minimum value of 0.50 MPa. In the hardened state, the results for both mortars have very close values, except for capillarity, where mortar AC III obtained a higher value than that of AC II. The adhesive mortar type AC III has a dimensional variation greater than that of type AC II, with significant variation in the early ages, which can be observed in Figure 2.

Figure 2. Dimensional variation of the mortars.

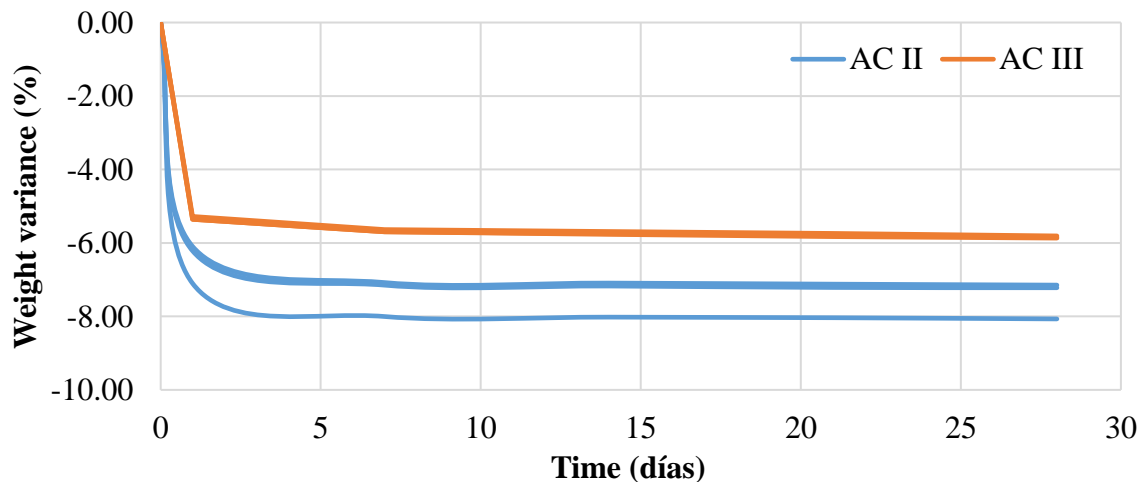
Both mortars show great weight variation in the first couple of days (with a variance of 5 to 8%), therefore, contrary to what was verified in the dimensional variation, the weight variation was greater for the type II adhesive mortars. Starting on the seventh day the variation of the two mortars began to stabilize, with little variance until the end of the test, in accordance to what is shown in Figure 3.

Figure 3. Weight variance of the adhesive mortars.

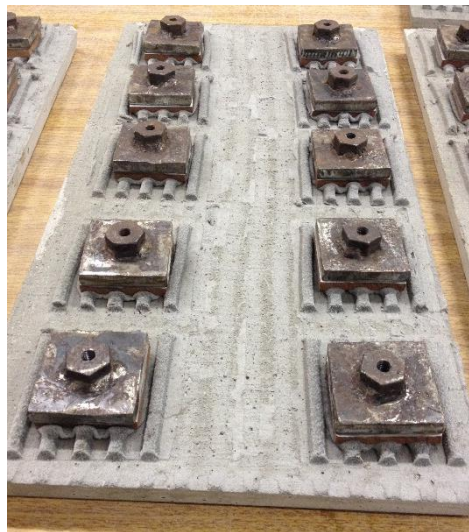
Following the setting of the ceramic tiles with the use of the mortar on the substrate-pattern, the sets were subjected to three curing conditions. In normal curing (N) the sets remained for 28 days in laboratory environmental conditions (a temperature of $23 \pm 2^\circ\text{C}$ and a relative humidity of $60 \pm 5\%$), in accordance to the specifications of the NBR 14.081-2 (ABNT, 2012). In curing with water immersion (IA) the sets were subjected to laboratory conditions for seven days, subsequently they were immersed in water at $(23 \pm 2)^\circ\text{C}$, where they remained for twenty days. In curing with stove heating (AE) the sets were subjected to normal curing in a laboratory environment for 14 days, after which they were placed in a stove with forced ventilation at a temperature of $(70 \pm 2)^\circ\text{C}$ until the age of 28 days. The adherence resistance to traction test was carried out per the NBR 14.081-4 (ABNT, 2012), as can be observed in Figure 4. Ten tests were carried out in each substrate, evaluating the adherence resistance to traction and the extension of the adherence, following the curing period of the sets. The tests were carried out following the specifications of the NBR 14.081-4 (ABNT, 2012), using Dinatest brand equipment, model DS2-DPU-1100, with a maximum capacity of 5000N.

Figure 4. Metallic pieces attached on the ceramic tiles adhered to the substrate-pattern.

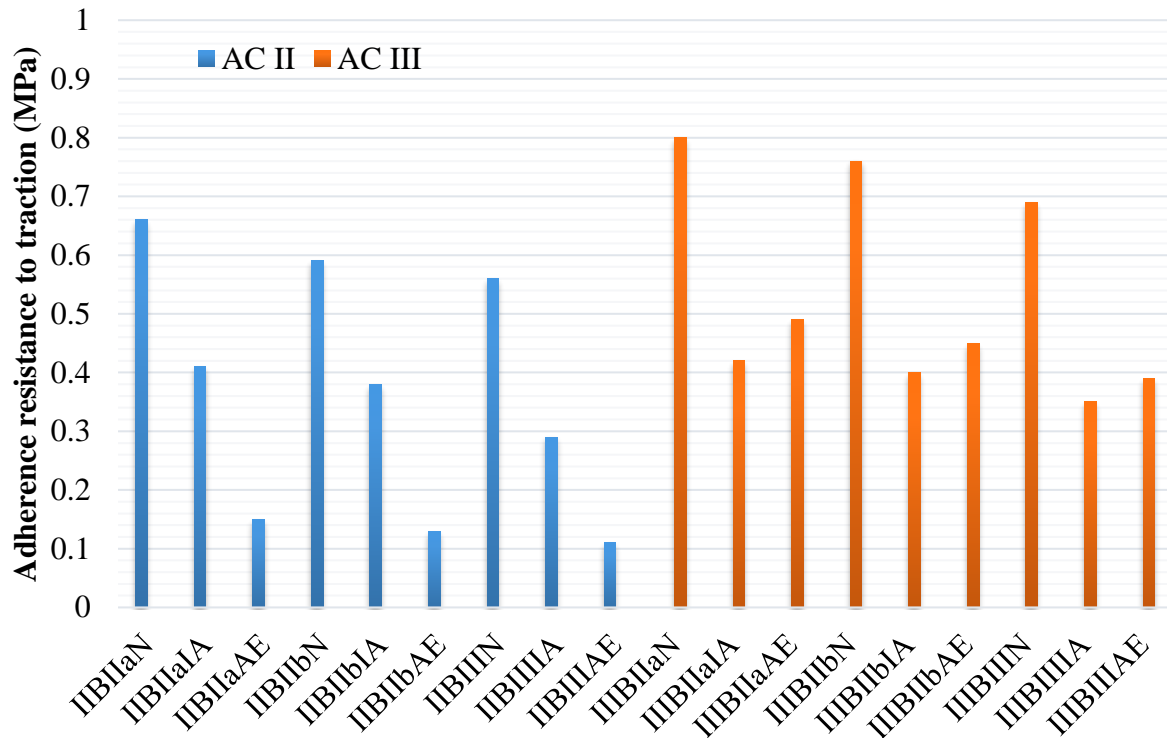
Figure 5 shows the average of the results obtained in the adherence resistance test carried out on the sets. Of the nine test sets of the type II adhesive mortar, only those subjected to normal curing complied with the minimum value of 0.5 MPa required by the NBR 14.081-1 (ABNT, 2012). Although the values of the adherence resistance to traction of the type III adhesive mortars were greater than those of the type II mortar, no set using the type III adhesive mortar achieved the minimum adherence value of 1.0 MPa required by the NBR 14.081-1 (ABNT, 2012).

Figure 5. Results of the adherence resistance to traction of the sets executed and the minimum values to be reached, per the NBR 14.081-1 (ABNT, 2012).

The greatest adherence resistance was obtained in the N curing processes (curing at a laboratory environment for 28 days). In the IA (water immersion) curing process, the adherence resistance fell to 60% for the type AC II adhesive mortar and 52% for the type AC III adhesive mortar. In this process, the curing occurs at laboratory temperature and humidity for seven days, followed by the immersion of the pieces. Considering that the two mortars used in the study are Portland pozzolanic cement based (with pozzolan doses of 50%), it can be estimated that the degree of hydration at seven days is still small and that the ensuing saturation, due to the immersion, results in a differential expansion of the ceramic

tile and/or the substrate; this causes shear stress in the interface with the mortar, reducing the adherence of the system. In the AE (with stove) curing process, the adherence fell to 22% for the type AC II adhesive mortar and to 59% for the type AC III adhesive mortar. A period of 14 days is used in this curing process followed by heating in a stove until the age of 28 days, which significantly harms the curing process of the pozzolanic cement and causes the lowest adherence resistance. For the type, AC III adhesive mortar, losing the adherence resistance of the curing with water immersion is almost equivalent to losing the adherence resistance of the curing with stove heating, brought about by to the presence of calcium formate in its composition, which accelerates the increase of the adherence resistance at early ages.

It is observed that for all the mortars and curing conditions, the adherence resistance of the BIIa ceramic tiles was superior to that of the BIIb ceramic tiles, which was also superior to the adherence of the BIII ceramic tiles. This result has a direct relation with the water absorption of the ceramic tiles, indicating that excess water absorption can harm the adherence.

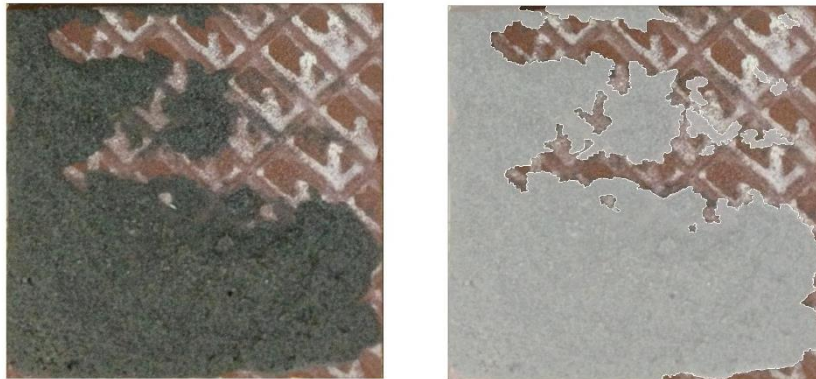
The internal face of the ceramic tiles used in the adherence test was photographed for the determination of the adherence extension. The program AutoCAD was used, implementing the “polyline” command and manually tracing the borders of the adhered region. Finishing the execution of the tracings, these were reticulated and the area was determined. Figure 6 (right) shows the reticule with the tracing highlighted in white and with the use of a transparency effect.

Figure 6. Visualization of the adherence extension of a ceramic tile.

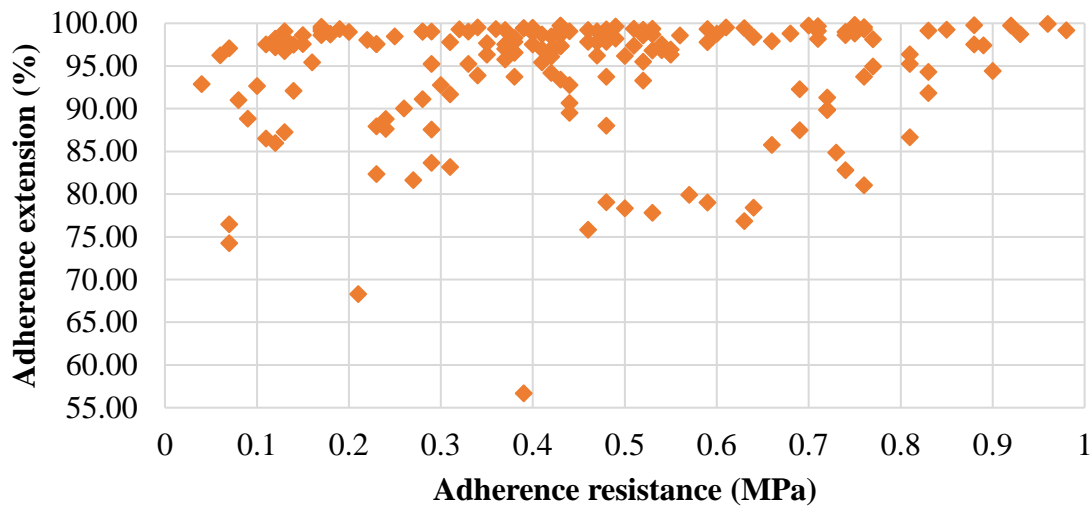
Adherence extension was elevated in all the sets, as only the sets IIBIIbN and IIIBIIbN have an average adhesion extension value below 90%. Figure 7 shows the individual results for the adherence extension of the 180 tiles tested, making it possible to affirm that there is no direct relation between adherence extension and resistance. The adherence extension can be influenced by the nature of the materials that comprise the substrates and the mortars, as well as the properties of the mortars themselves (Maura, 2007). A good adherence extension, even when basic, is not enough to guarantee a good fastening of the mortar applied to substrates of ceramic blocks (Pagnussat, 2013).

Figure 7. Adherence extension x adherence resistance.

- There is no statistically significant relation between the adherence extension and the adherence resistance of the ceramic tiles;
- The wait time between the mixture of the mortar with water and its use exercises great influence in the adherence extension of the ceramic tile and decreases its adherence resistance. This fact warns of the need for the specification of maximum times for the application of mortars, which ought to be controlled during the application;

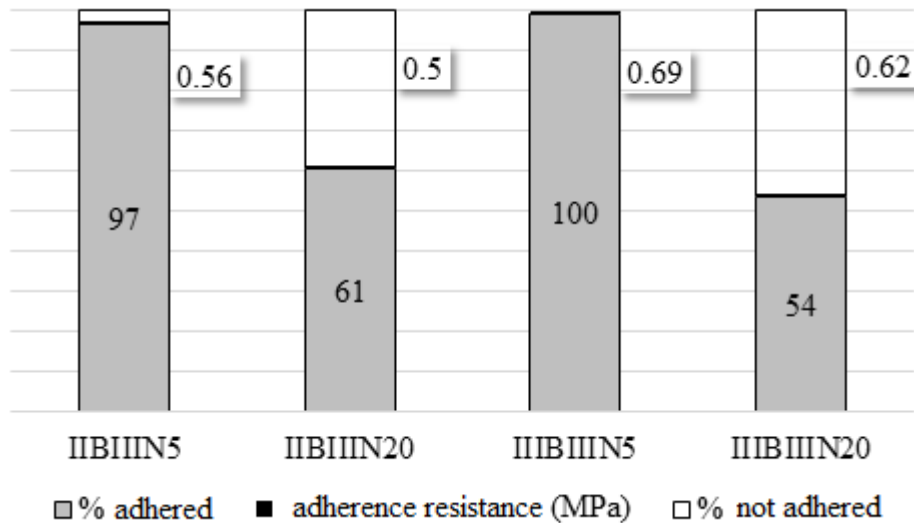
The influence of the open time of the mortar (time between the mixing of the mortar with water and its usage) in the adherence resistance and extension of the ceramic tiles was evaluated for type AC II and AC III adhesive mortars and was shown to be significant. An open time of 5 and 20 minutes was used. The adherence resistance decreased close to 10% and the adherence extension decreased between 40 and 50%, as can be seen in Figure 8.

Figure 8. Adherence extension in terms of the open time of the mortars.

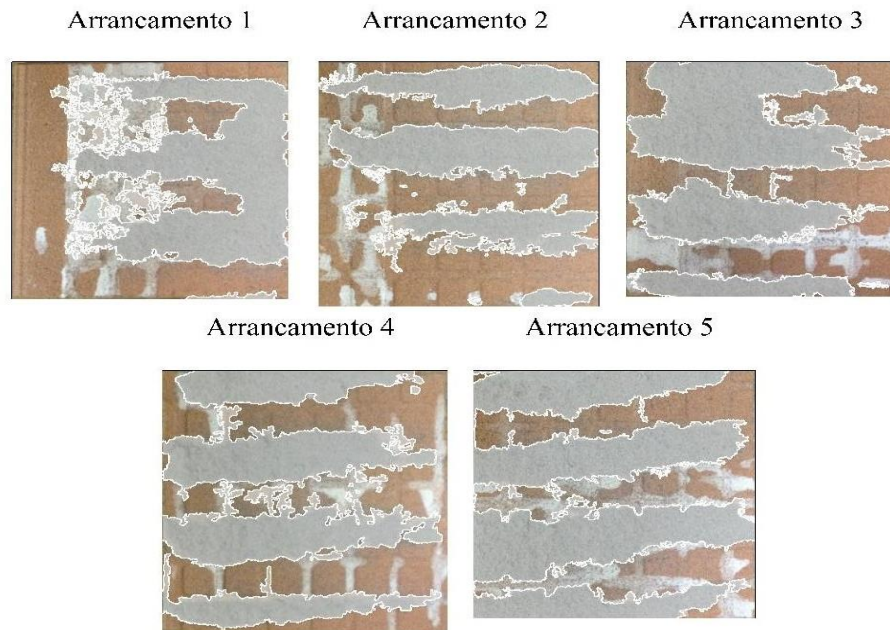
Figure 9 shows the adherence extension loss typical of the application of the ceramic tile after an excessive wait time, resulting in the loss of adherence extension and a decrease of the adherence resistance to traction. The phenomenon occurs due to the increase in the rigidity of the borders of the mortar, which hinders its distribution during the setting of the ceramic tile.

Figure 9. Adherence extension typical of the setting of the ceramic plate after an excessive wait time.
